# Design, Access & Heritage Report: Phase V

## Replacement Cottage

59 & 61 Langstone Road, Havant, Hampshire, PO9 1RB

August 2019

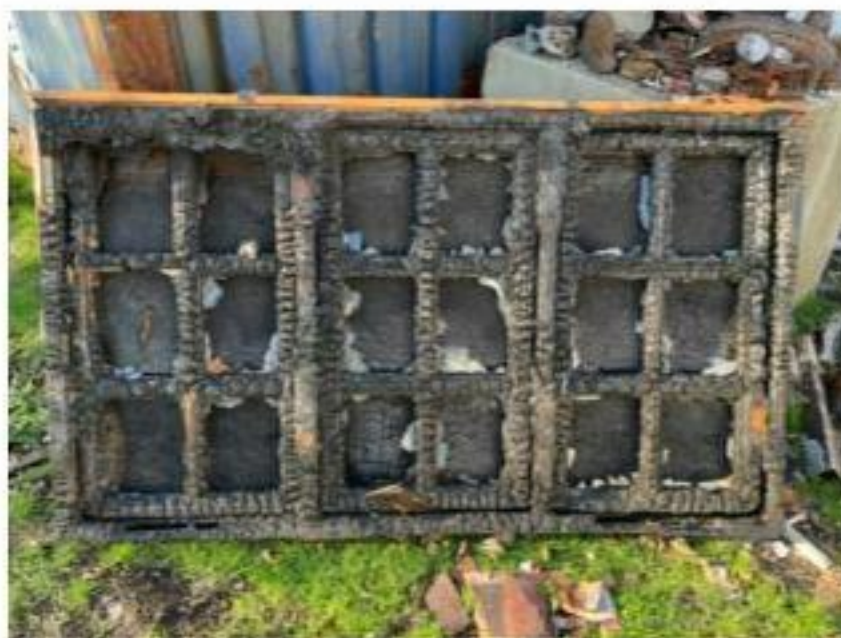
Figure 1: Window destroyed by the fire at 59 and 61 Langstone Road (Jan 2019)

- 3.15 The proposed windows are of a style and appearance which derived from the Georgian period of the previous cottages. The windows which were installed prior to the fire were single glazed with unsympathetic and over sized glazing bars. The proposed windows are specified in Appendix 1.

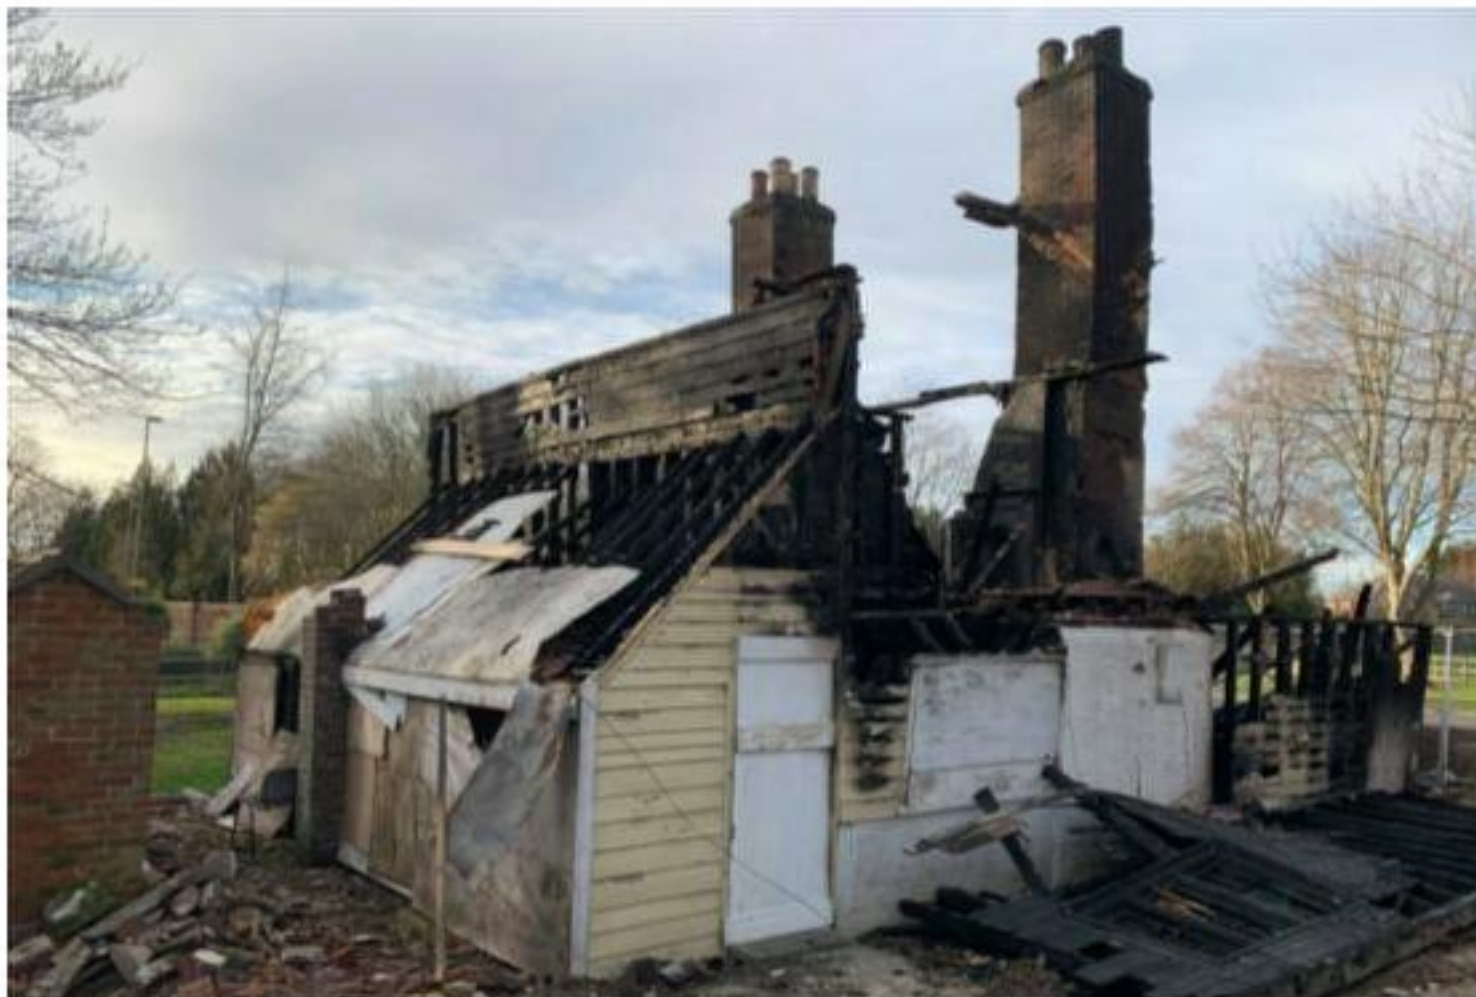
Figure 3: Post-Fire Damage (Jan 2019)

- 4.2 As shown in Figure 3 above, there is very little structure remaining of the Listed cottages. Almost none of the remaining structure is able to be retained. The fire service have confirmed the bricks will not be able to be re-used within the replacement cottage.
- 4.3 Structural scaffolding (Phase I) has been erected to support the chimney stacks, as they were unstable in their post fire condition. See below:

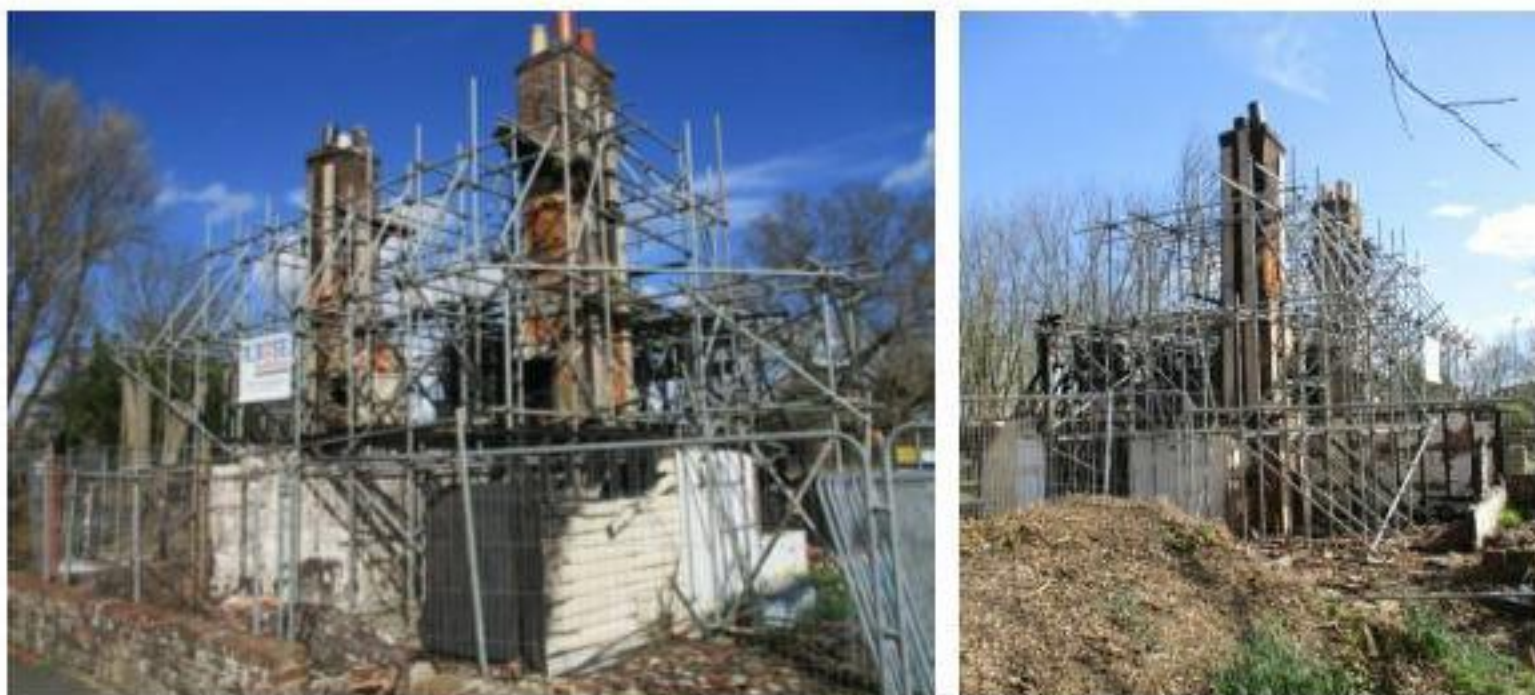
Figure 4 & 5 : Structural Scaffolding (March 2019)

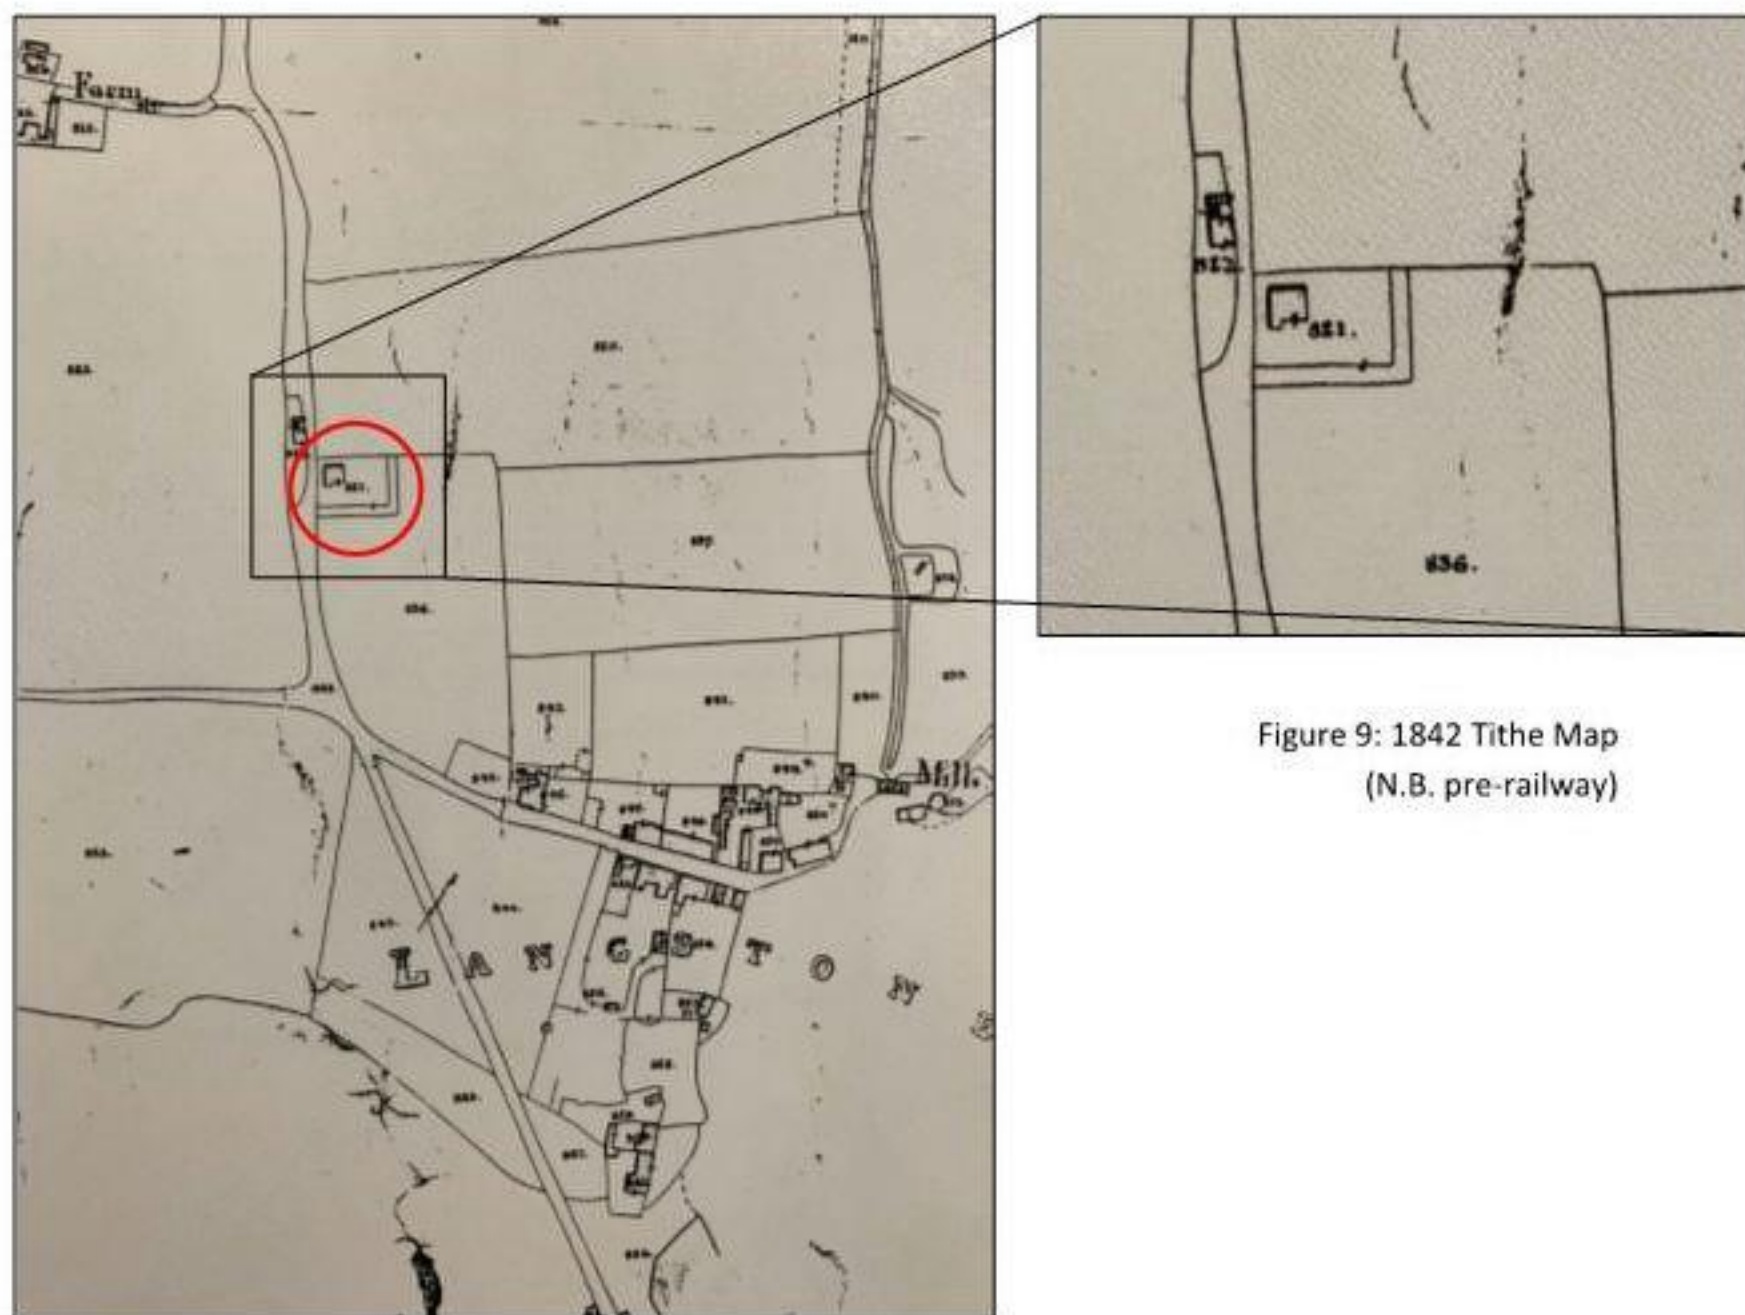
Figure 9: 1842 Tithe Map  
(N.B. pre-railway)

- 5.8 Figure 9 above shows the subject site as Field parcel number 821. This shows the subject building in more detail, with features (such as the southern porch) that can be related to what you could see in November 2018, prior to the destructing fire.
- 5.9 As explained in 5.8 above, the written Schedule that accompanies the map lists the details of the site at the time. The ownership details are as follows:

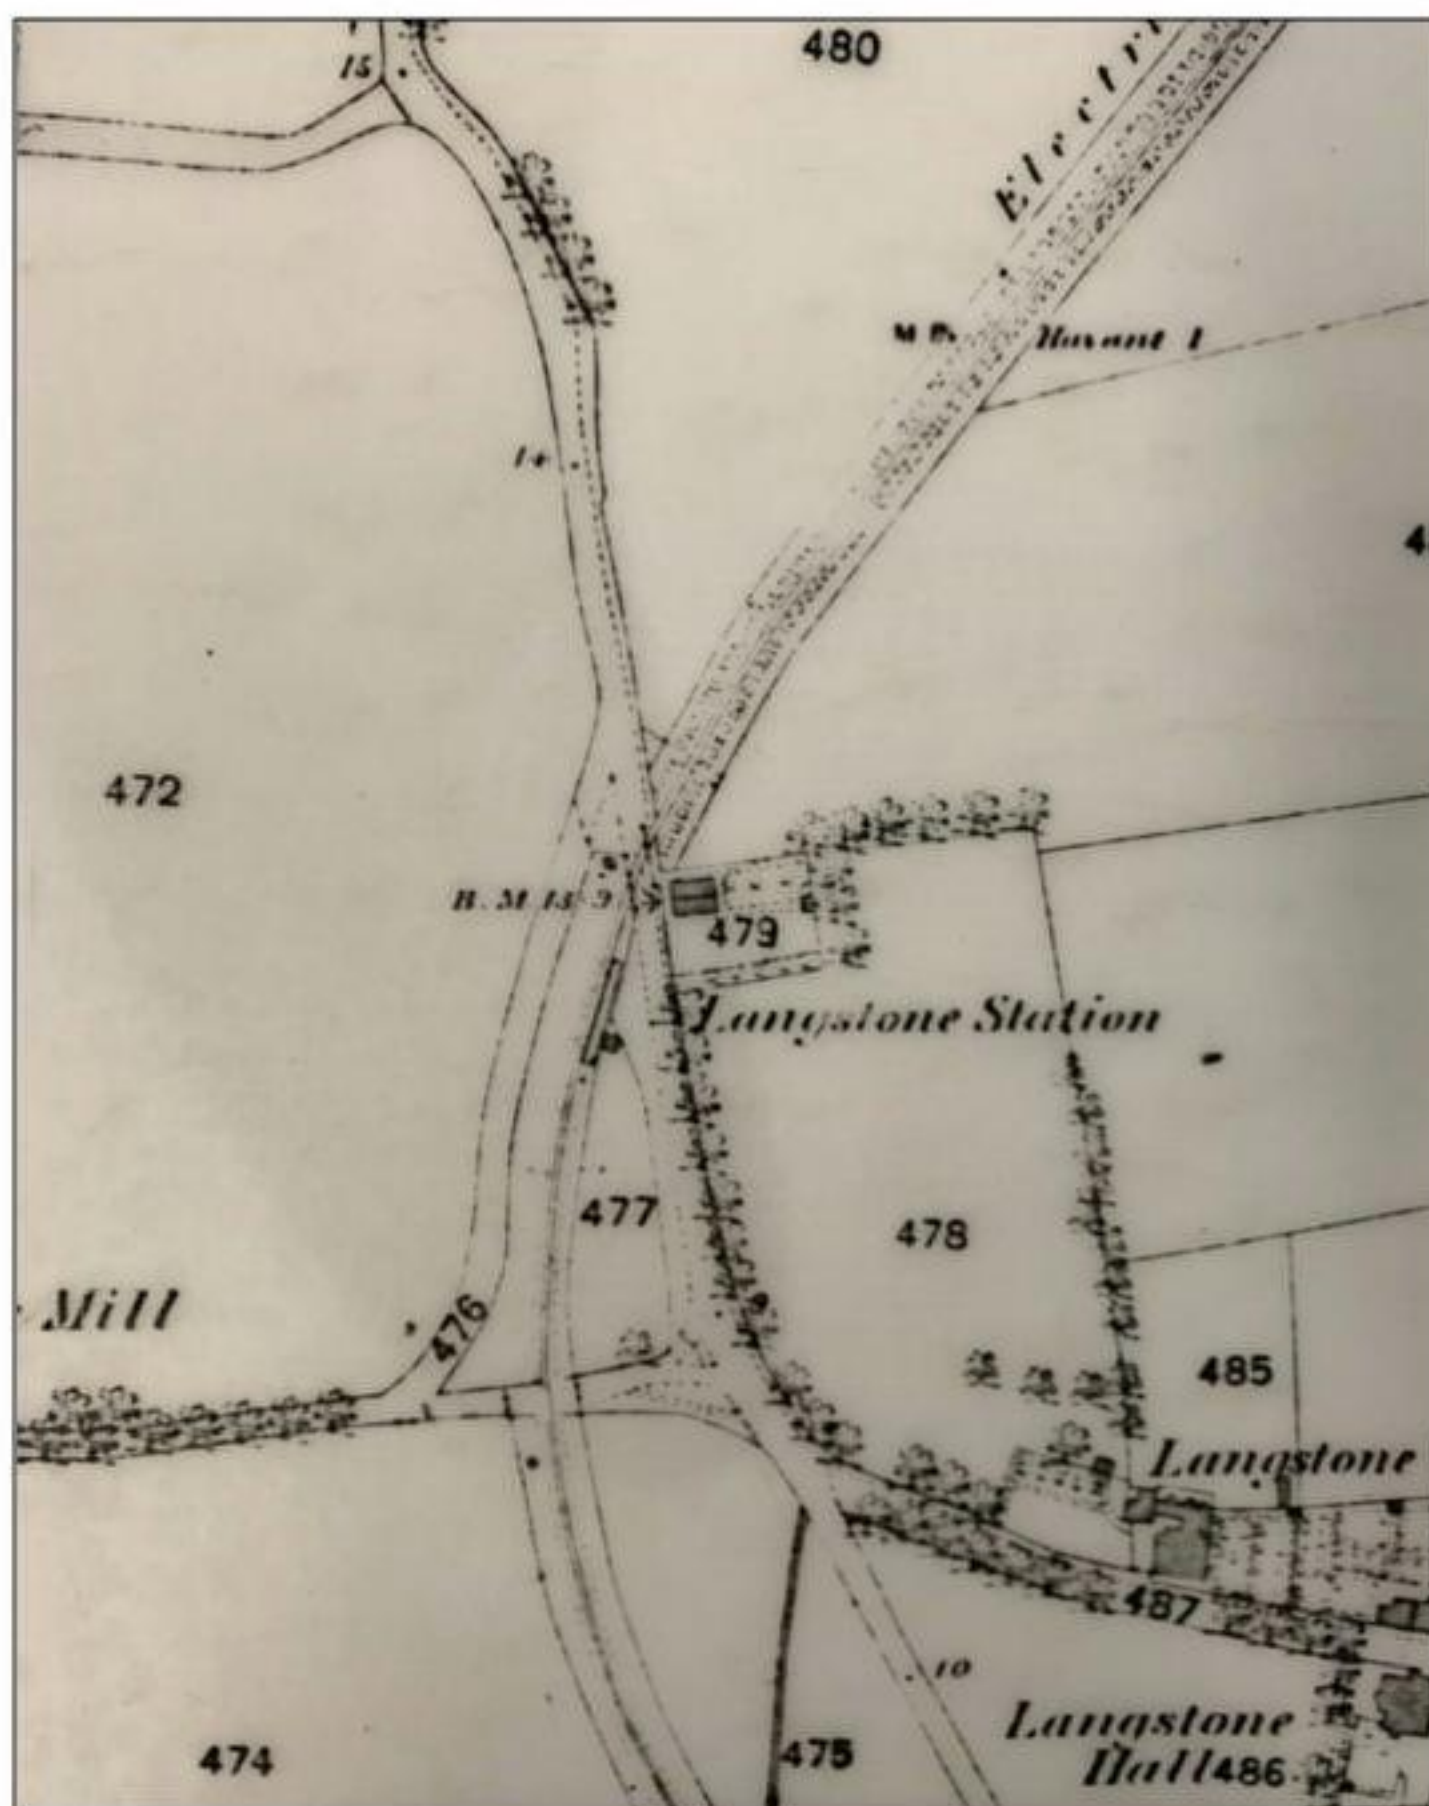
Figure 12: 1873 Map of Langstone Halt/Station

- 5.13 As shown in Figure 12, the subject site and cottages are labelled as Field parcel number 479. The Hayling Railway sits tightly to the northern boundary of the subject site. The lines drawn on Langstone Road to the west indicate the Langstone level crossing (which was actually unauthorised for the entirety of its use until the railway closed in 1963 (Cousins, 2017)). 'Langston' Halt/Station. Ralph Cousins (2017) describes the crossing:

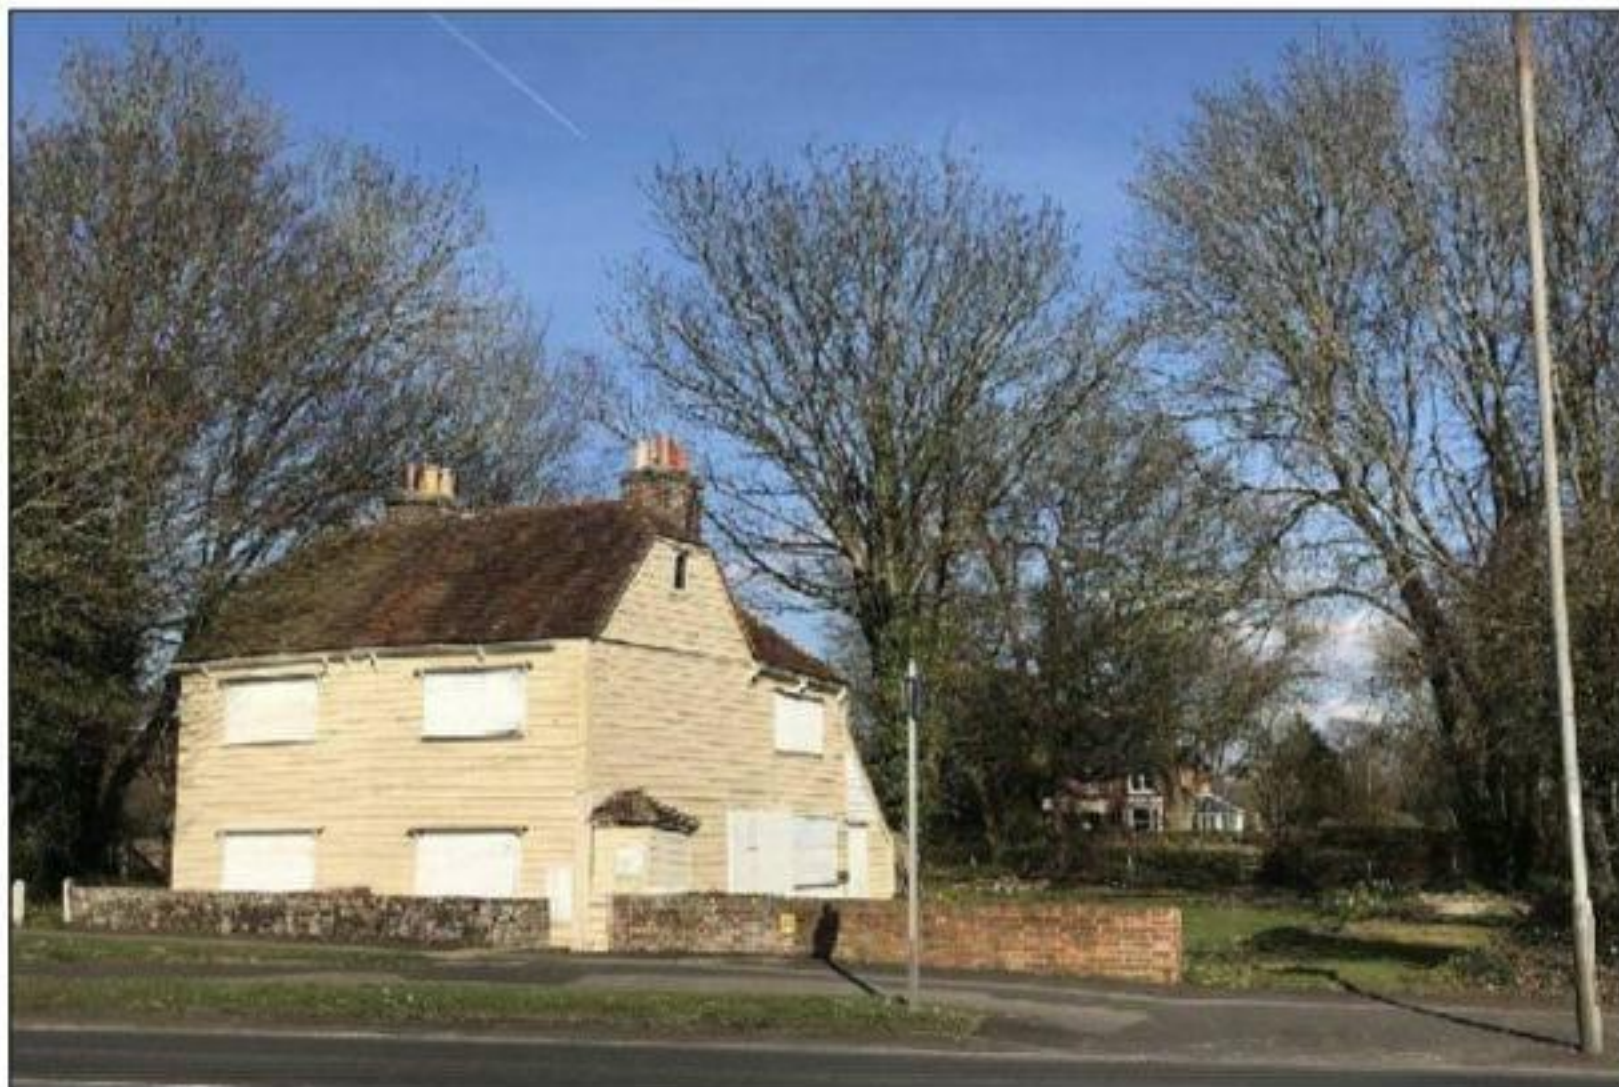
Figure 20: 59 & 61 Langstone Road. Vacant with boarded up windows. (The News, 2019)

- 5.16 59 & 61 Langstone Road fell in to disrepair in prior to 2000, with pressing need for upkeep and maintenance. In approximately 2015/2016 the cottages became empty and the windows were later boarded up. See figure 20 below:

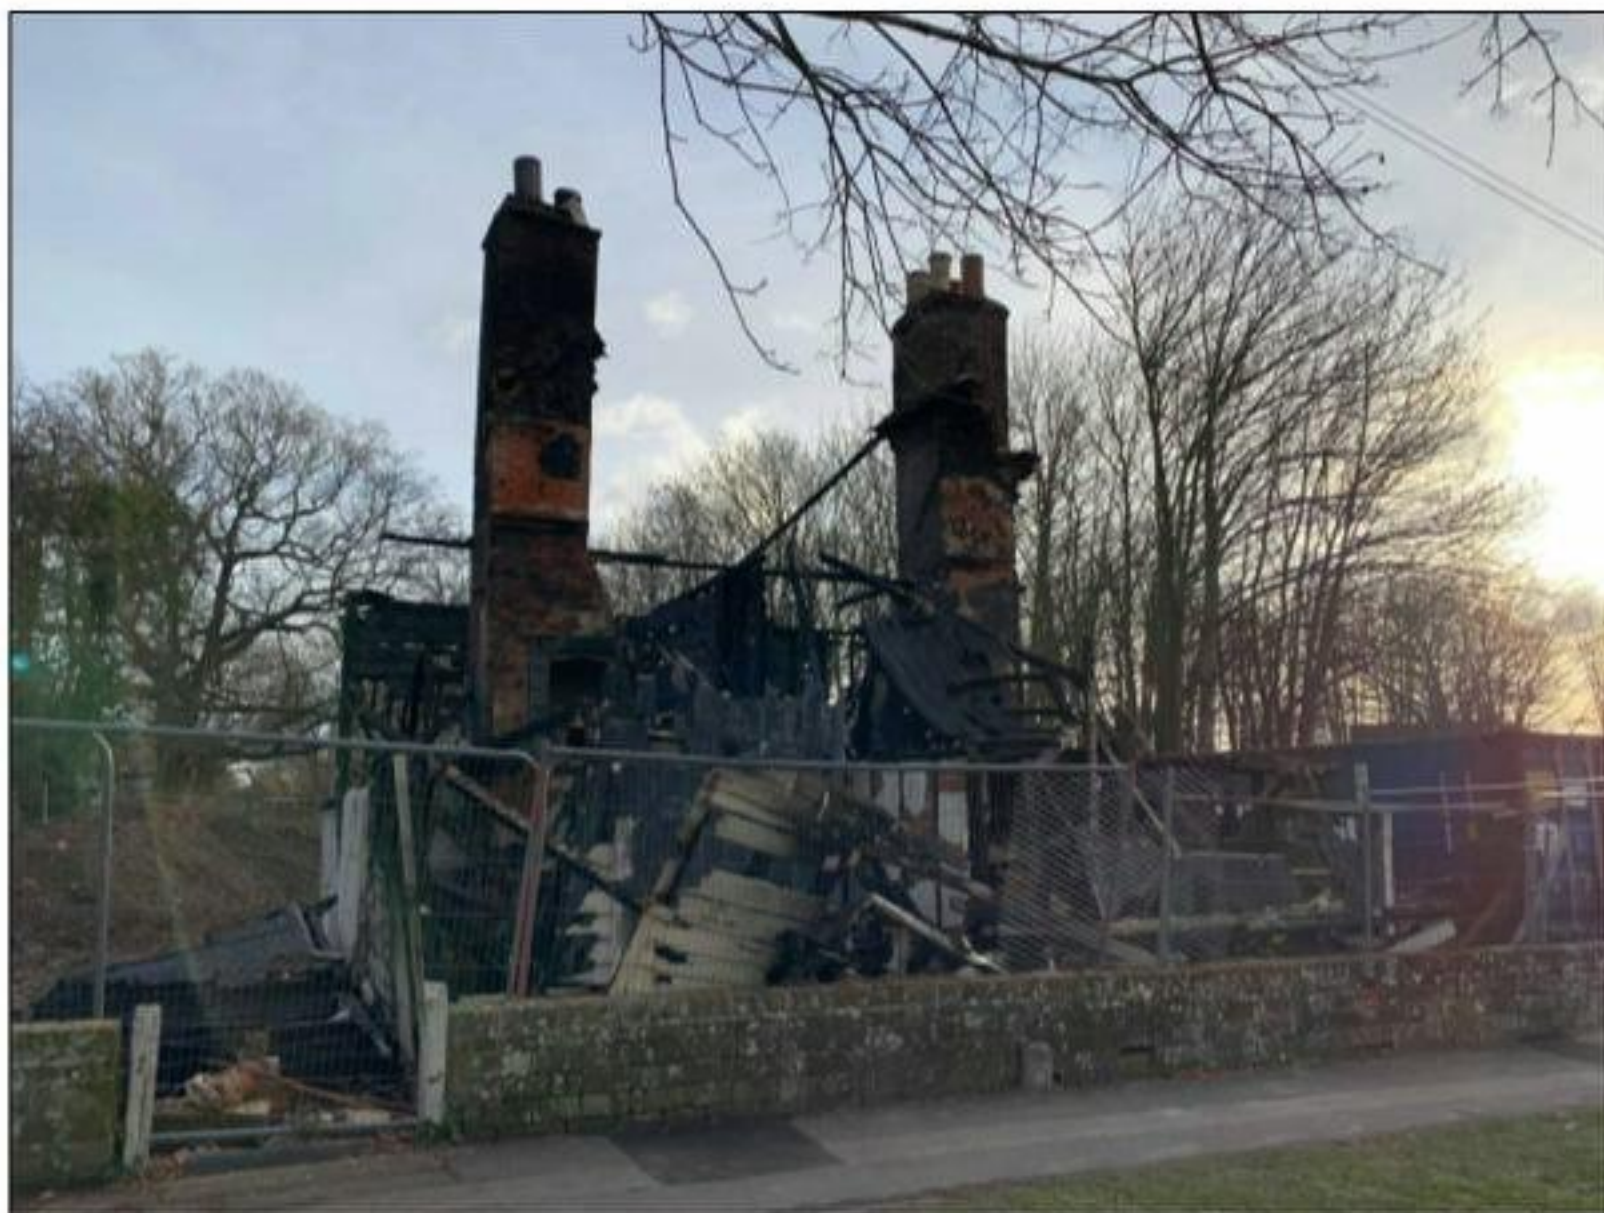
Figure 22: The cottages after the devastating fire (Jan, 2019)

5.23 Critchley Architecture And Design Ltd were appointed in January 2019 to manage the surveying, Planning and re-building of the cottages, which were completely destroyed. See figure 22-24 below:

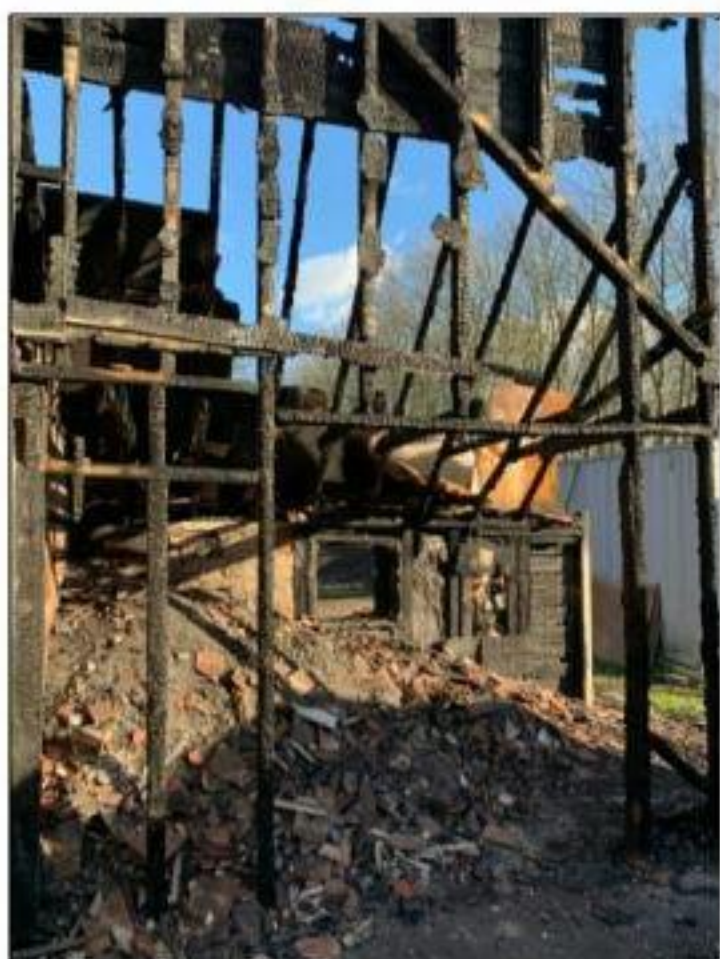
Figure 23: The cottages after the devastating fire (Jan, 2019)

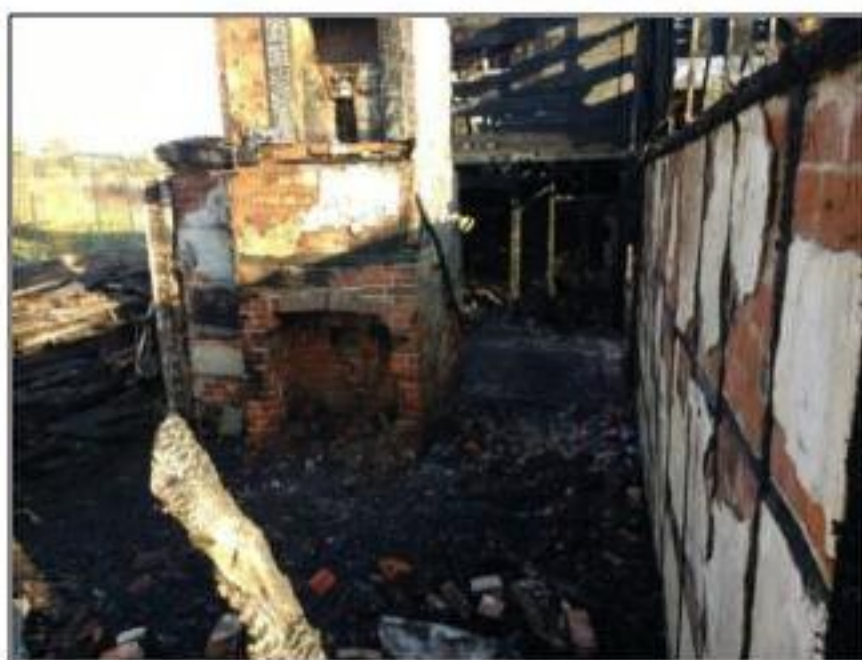
Figure 24: The cottages after the devastating fire (Jan, 2019)

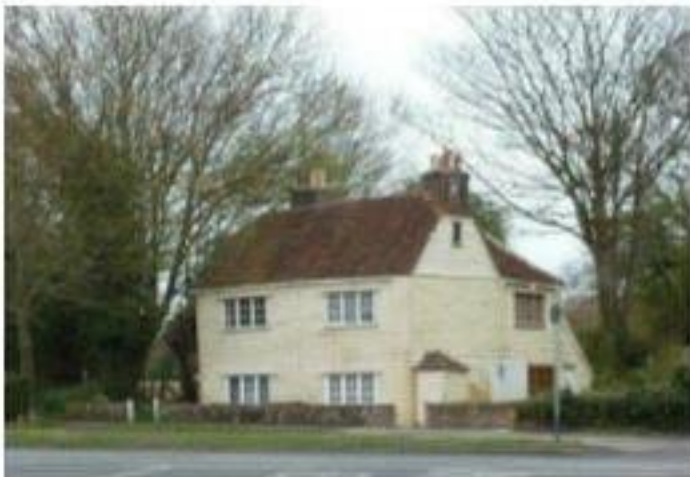
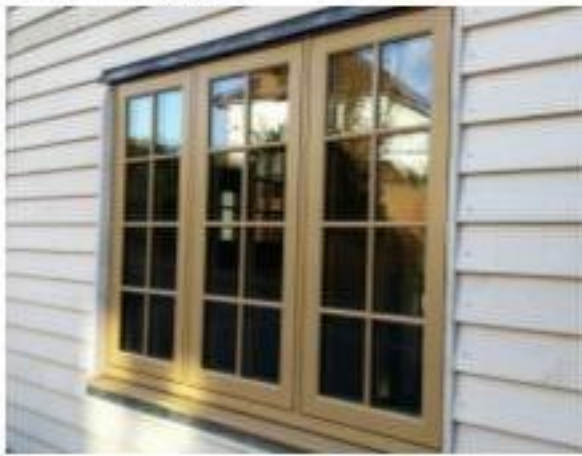
| Window Specification | |
|---|---|
| Painted Softwood, Glazing Bars and 6 light Casement Windows | Natural Oak, 6 light Casement windows with Glazing Bars, to match windows in previous cottages. |
| Colour: White/Natural | Colour: Natural Oak |
| | Precedent Image:<br> |

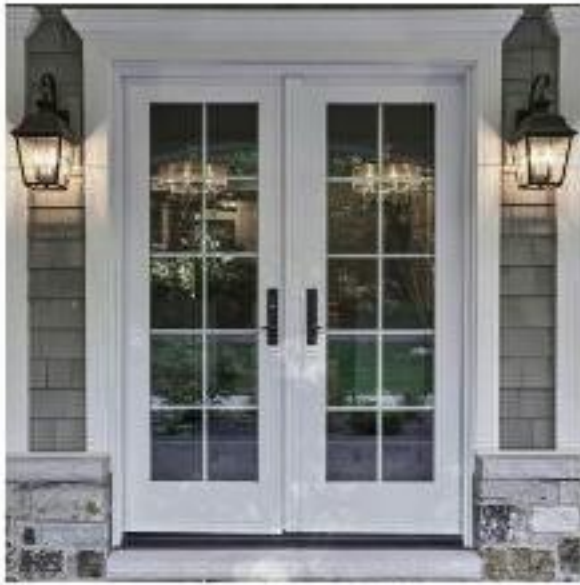
| French Door Specification | |
|---|---|
| N/A | Natural Oak, 10 light glazing bars, as style below (not in white colour): |
| N/A | Colour: Natural Oak, as window spec above. |
| N/A | Precedent Image:<br> |

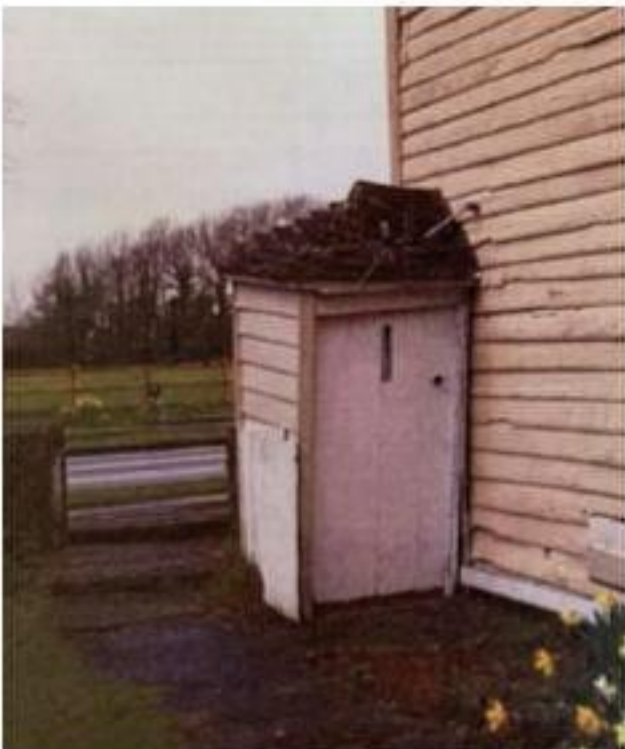
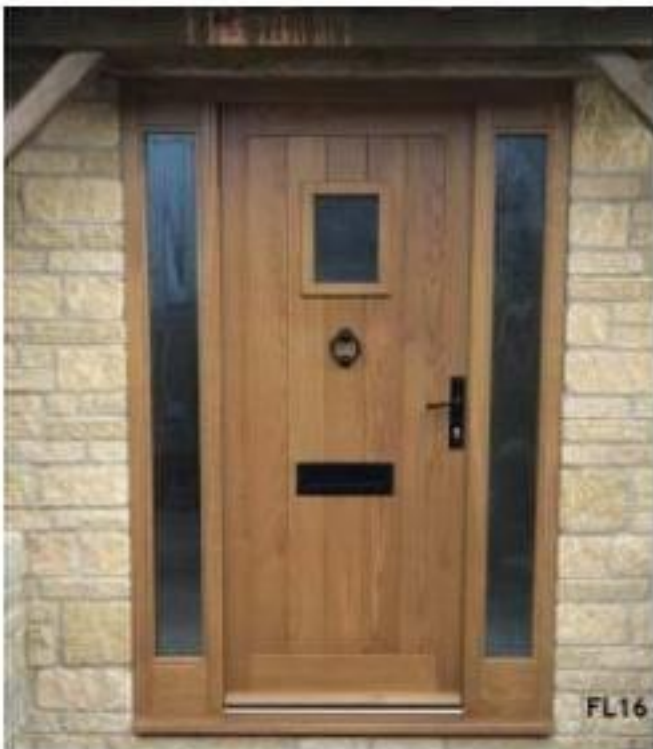
| Previous Cottages | Proposed Cottage |
|---|---|
| Solid Painted Softwood | Oak<br><br>Specification: Oak Doors 'Cottage' front door (without sidelights) |
| Colour: White | Colour: Natural |
| | Precedent image:<br> |

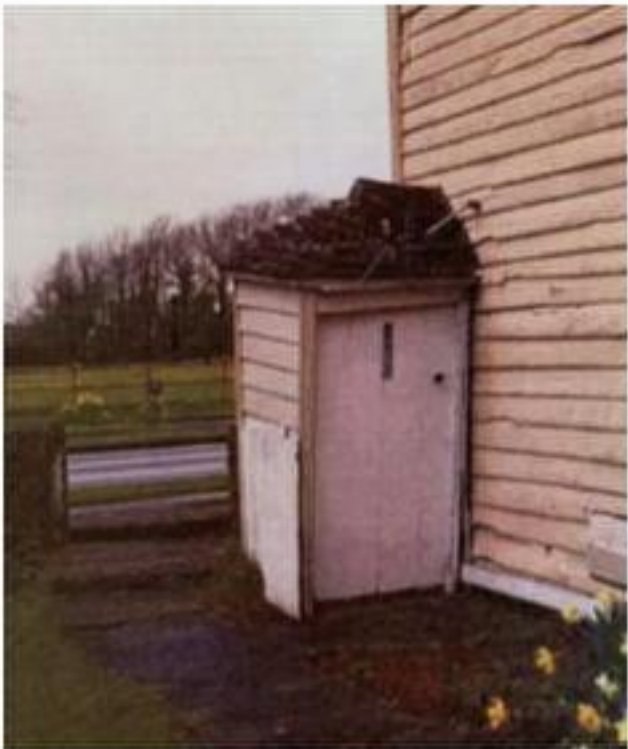
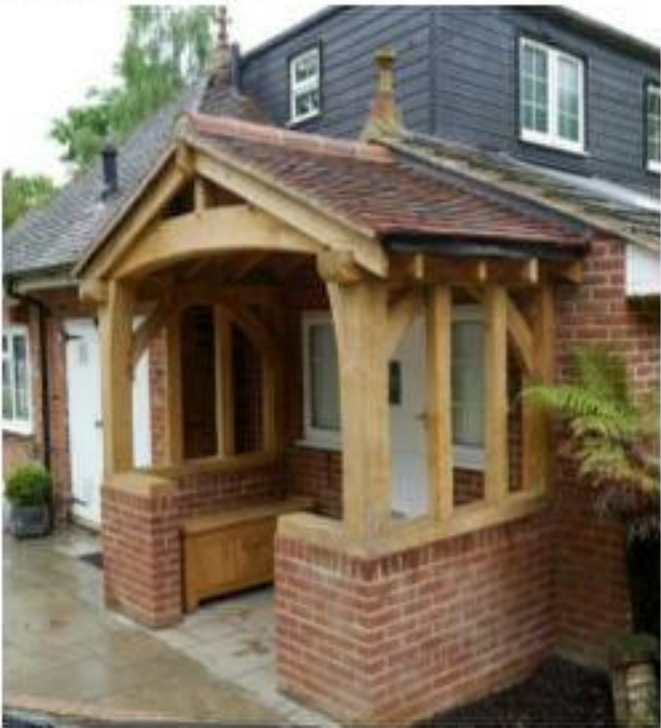
| Oak Canopy Specification | |
|---|---|
| Pine clad porch with clay tiled roof | <p>Oak posted canopy with reclaimed clay tiles.</p> <p>Bricks re-used from the dismantled privy where possible. Where bricks cannot be re-used there will be bricks specified as similar as possible.</p> |
| | <p>Precedent Image:</p> |
