# **LAND AT HAVANT ROAD EMSWORTH**

## **SIGNAL JUNCTION & PEDESTRIAN CROSSING**

### **STAGE 1 ROAD SAFETY AUDIT**

**APRIL 2017**

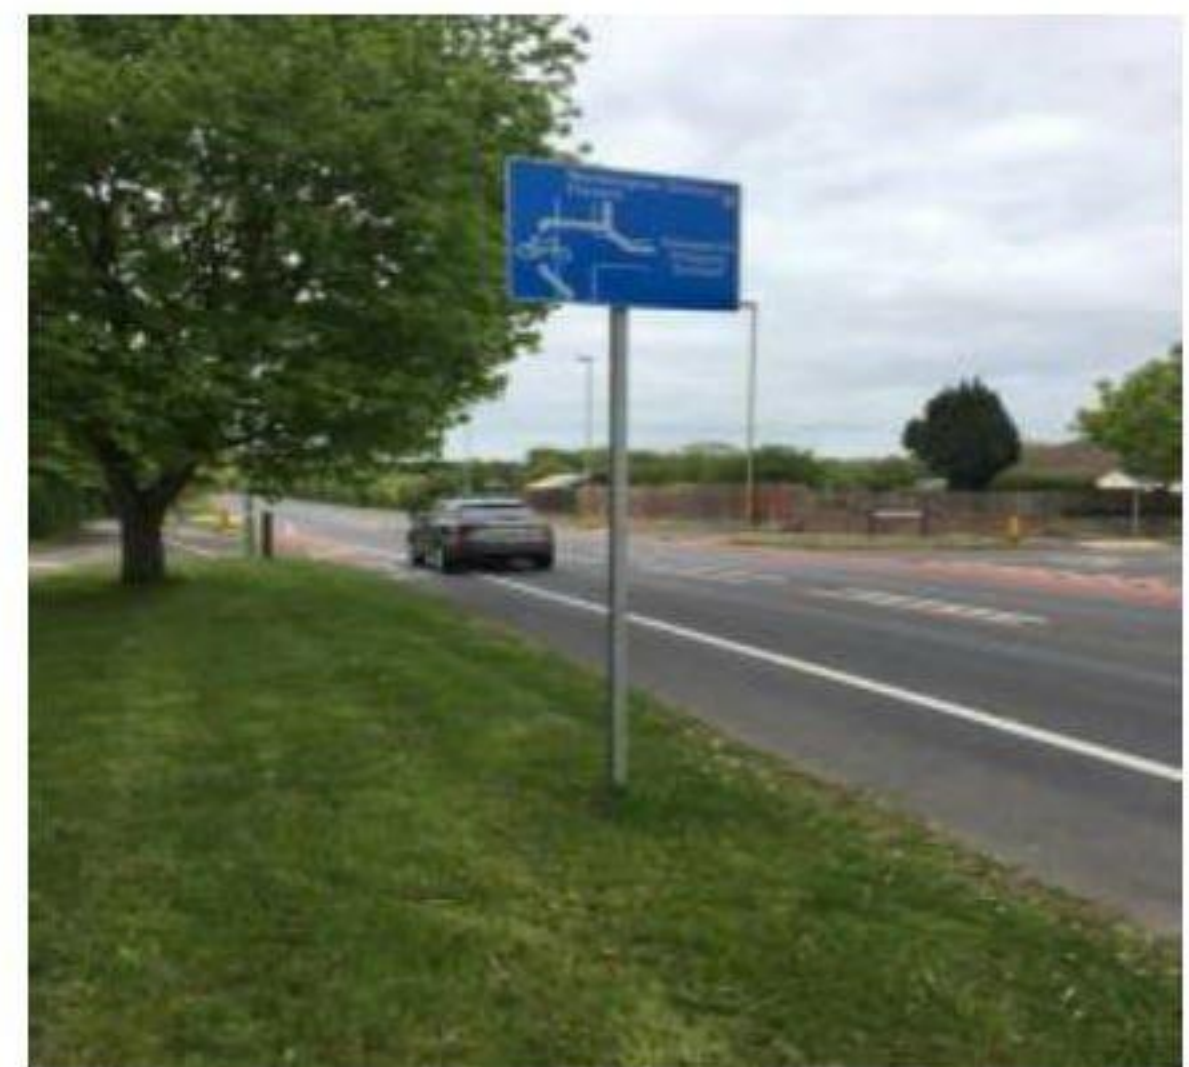
LOCATION: Havant Road westbound approach to Toucan Crossing

SUMMARY: Risk of cyclists exiting carriageway at wrong location

It is unclear from the information provided if the existing map type sign is to be replaced. Failure to replace and relocate the sign may result in cyclists exiting Havant Road at the access to Nore Farm Meadows and use the footway to access the Toucan which may lead to collisions with pedestrians.

Replace the sign with one informing cyclists to use the Toucan Crossing and relocate closer to the crossing.

| Problem no.<br>in safety<br>audit report | Problem<br>accepted<br>(yes/no) | Recommended<br>measure accepted<br>(yes/no) | Alternative measure (detail description) |
|---|---|---|---|
| 3.3 | Yes | Yes | Whilst the comment is accepted, details of directional/advisory signage will be picked up at the Section 278 stage |
