## Subsidence Investigation Report

Ms Lisa Sheppard  
95 Sutton Road  
Waterlooville  
PO8 8PT

We were asked to perform investigations in relation to reported subsidence.

HEAVE ASSESSMENT AT - 95 Sutton Road, Waterloooville, PO8 8PT

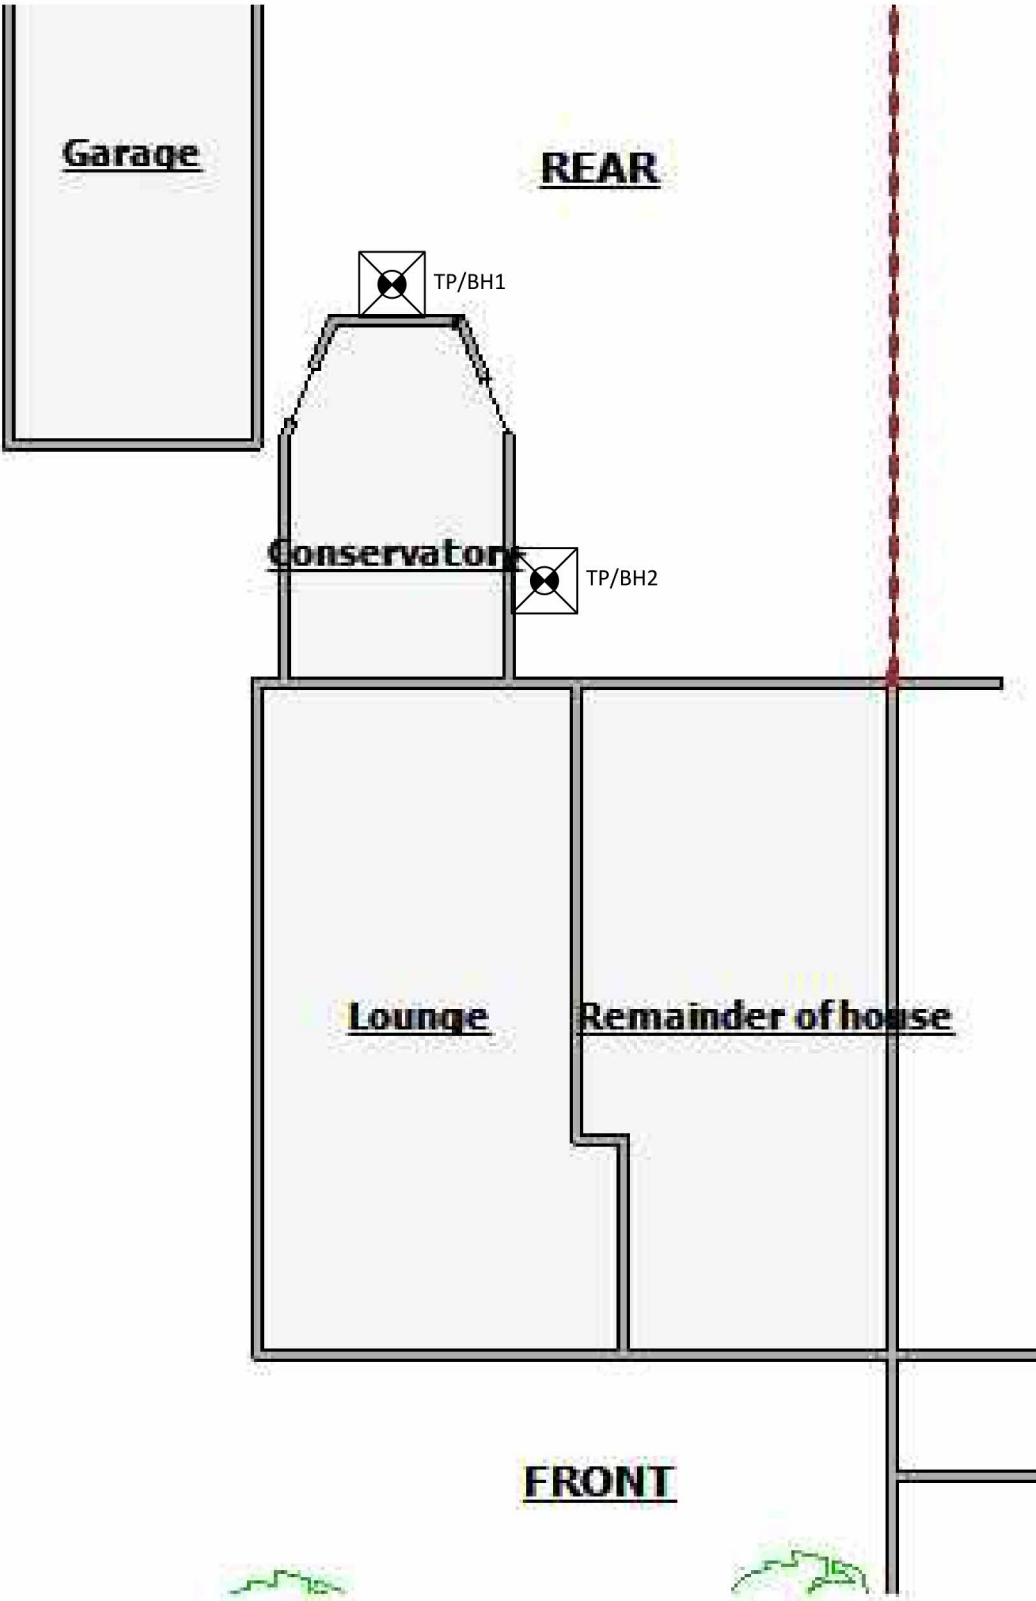
| <b>Sketch Site Plan</b> | | 31.10.23 | PJE | MCE | DJE | Sheet 1 of 1 |

| <b>Remarks:</b> On site tree identification for guidance only. Not authenticated.<br>All dimension in metres unless stated otherwise. | <b>Key:</b> |

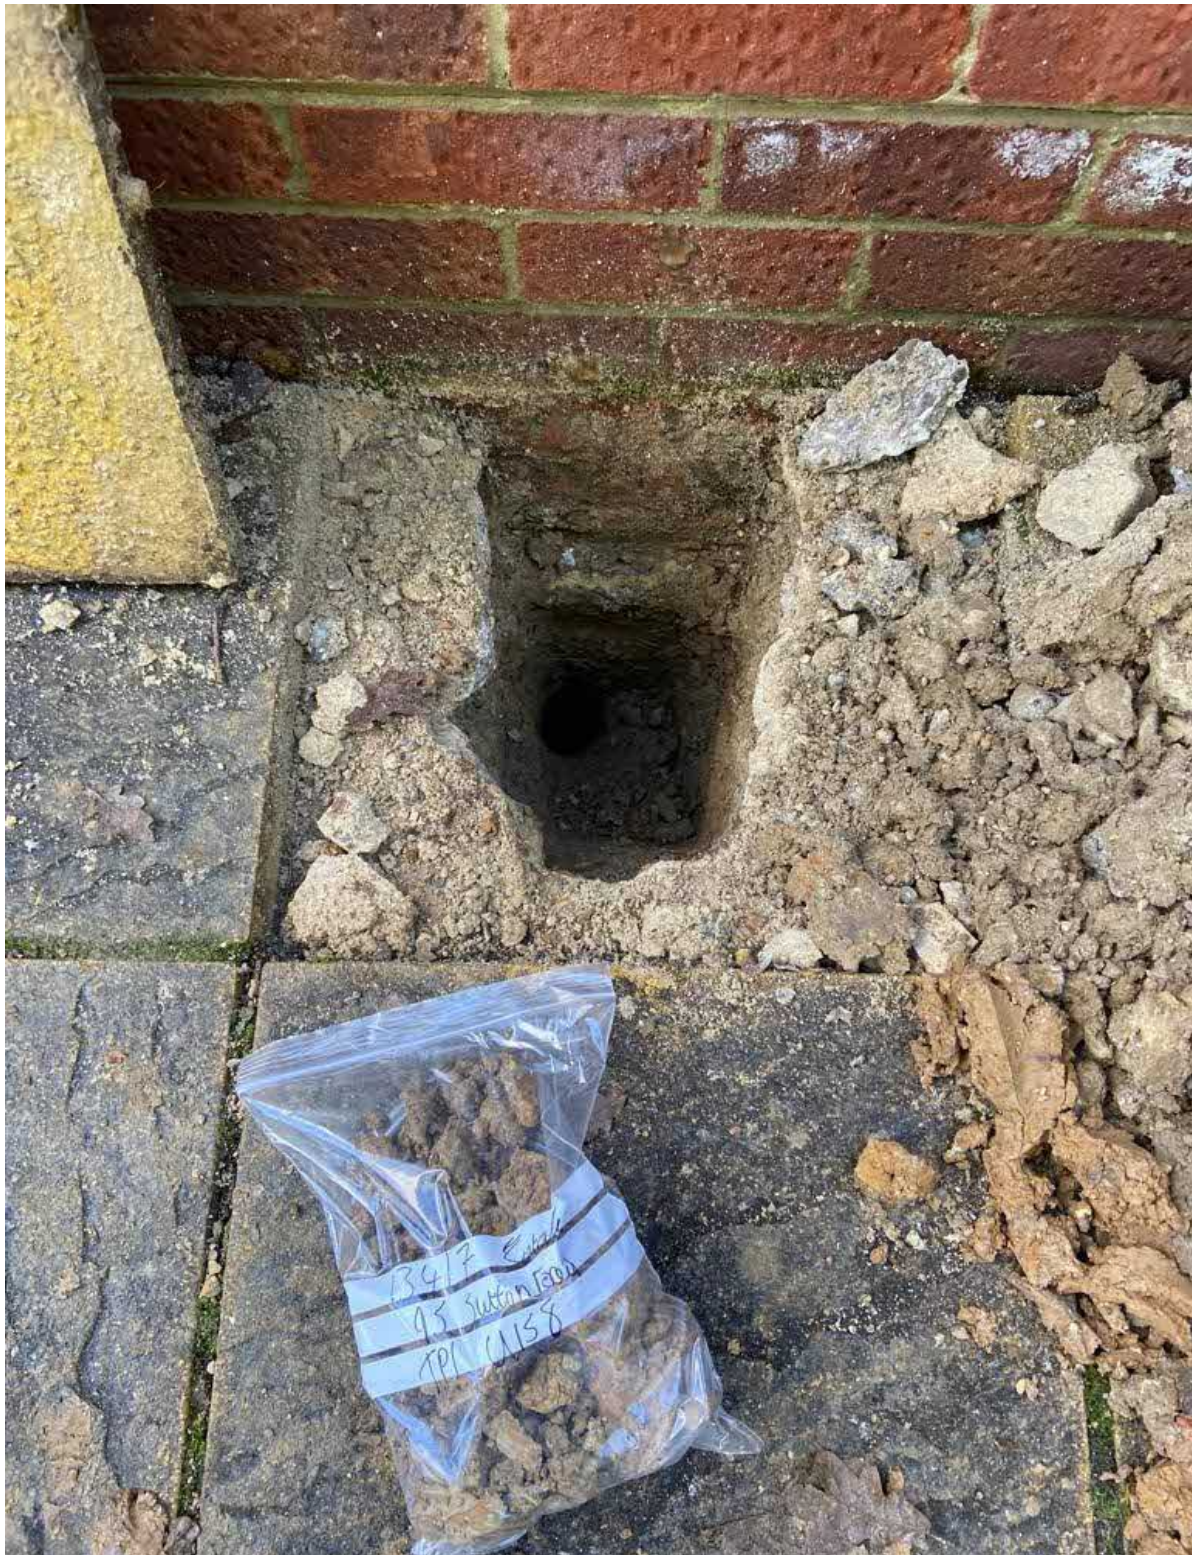
Photograph 1 - Trial Pit 1

At the location of TP/BH1, roots of 5mm diameter were noted to a depth of 200mm bgl, roots of 4mm diameter were also noted to a depth of 0.60m bgl. Roots of 2mm diameter were then also recorded to a depth of 2.00m bgl with Hair & Fibrous roots encountered to a depth in excess of 3.00m bgl.

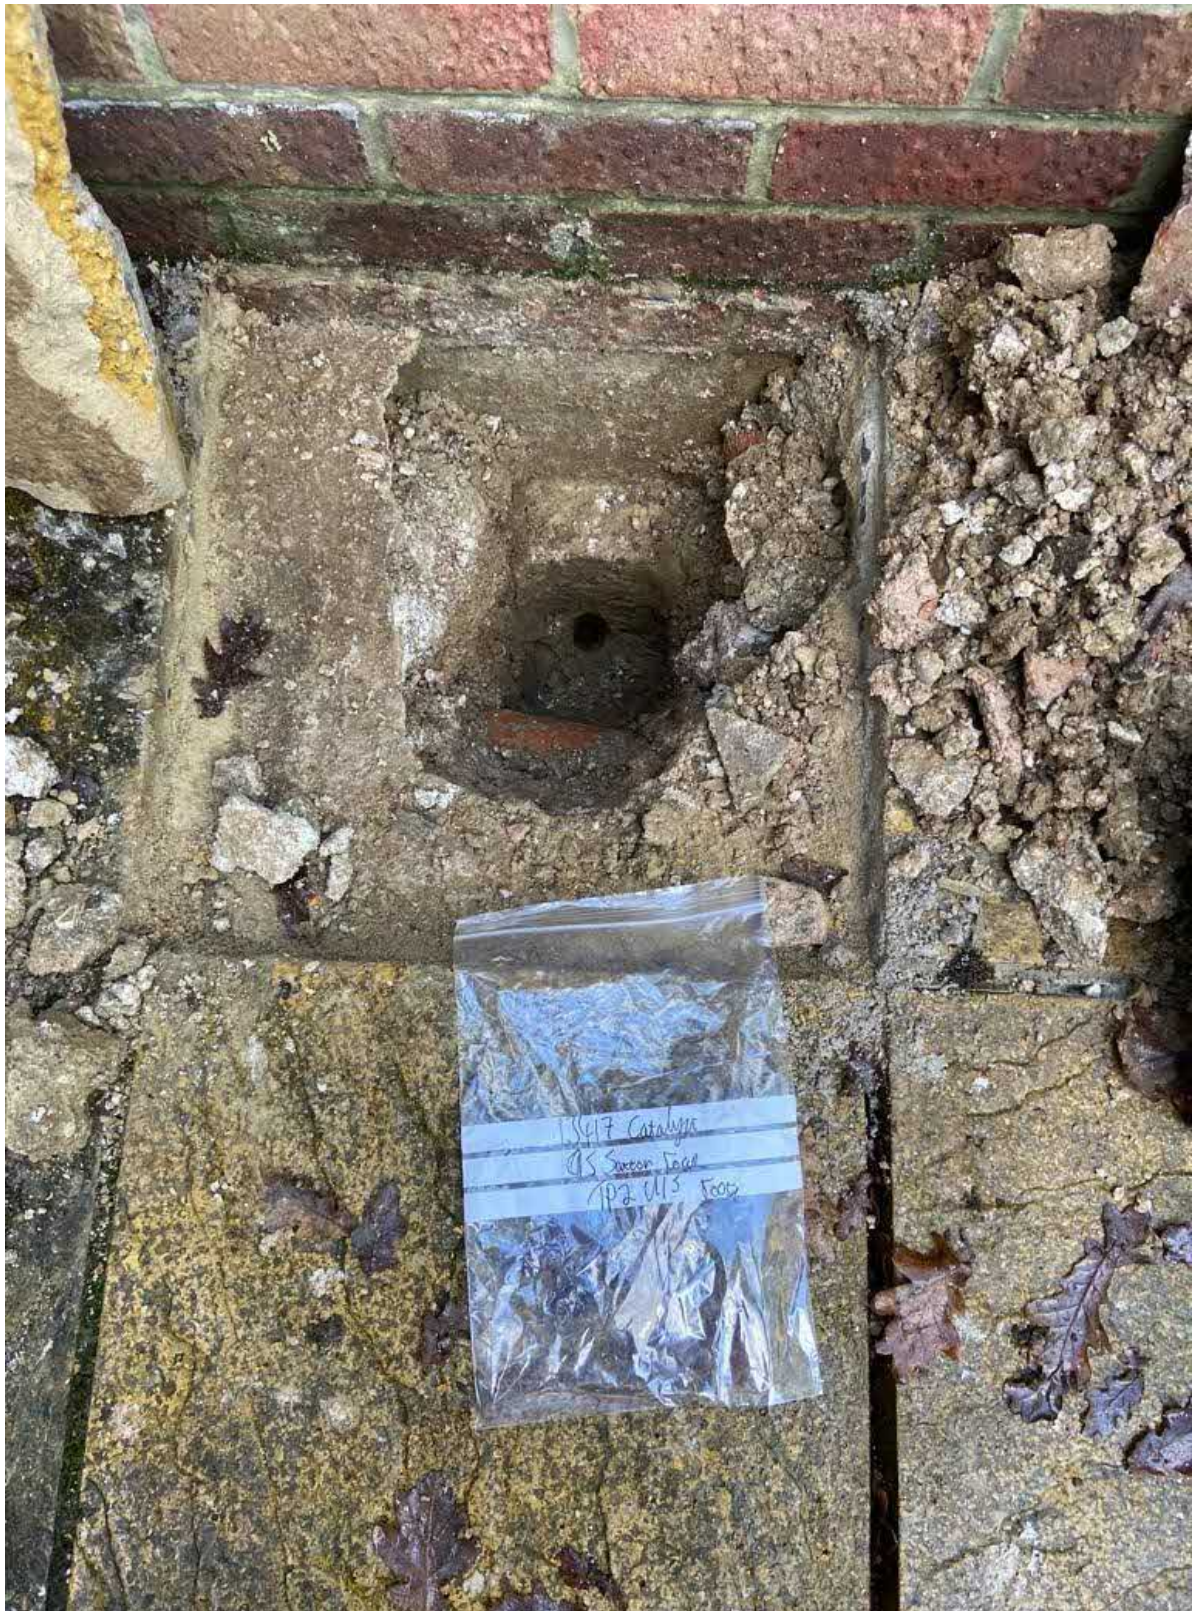
Photograph 2 - Trial Pit 2

At the location of TP/BH2, roots of 4mm diameter were noted to a depth of 300mm bgl, roots of 3mm diameter were also noted to a depth of 0.60m bgl. Roots of 2mm diameter were then also recorded to a depth of 2.00m bgl with Hair & Fibrous roots encountered to a depth in excess of 3.00m bgl.

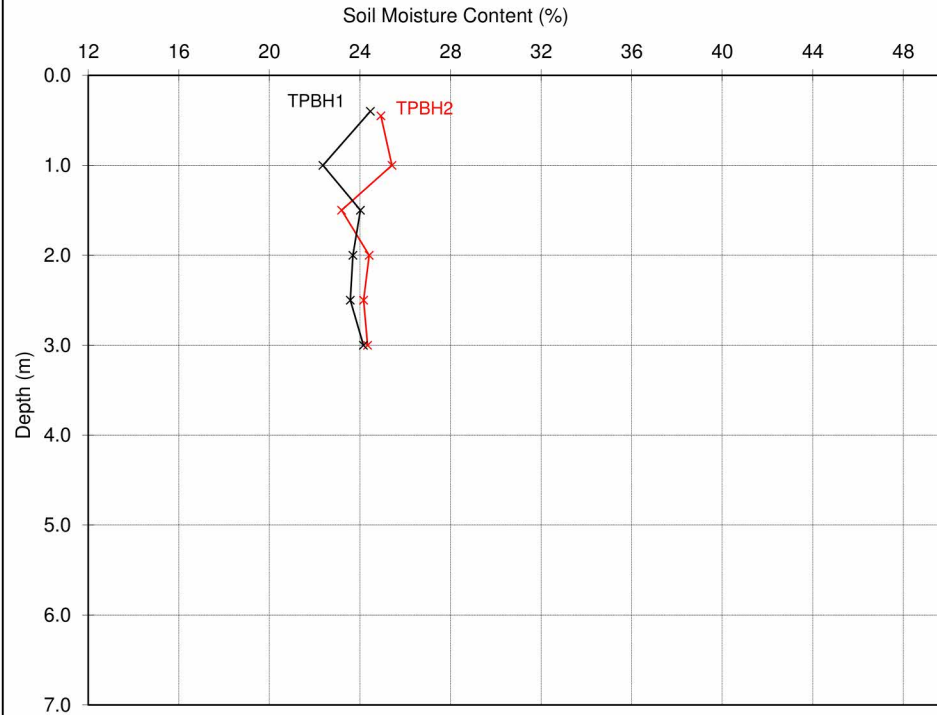
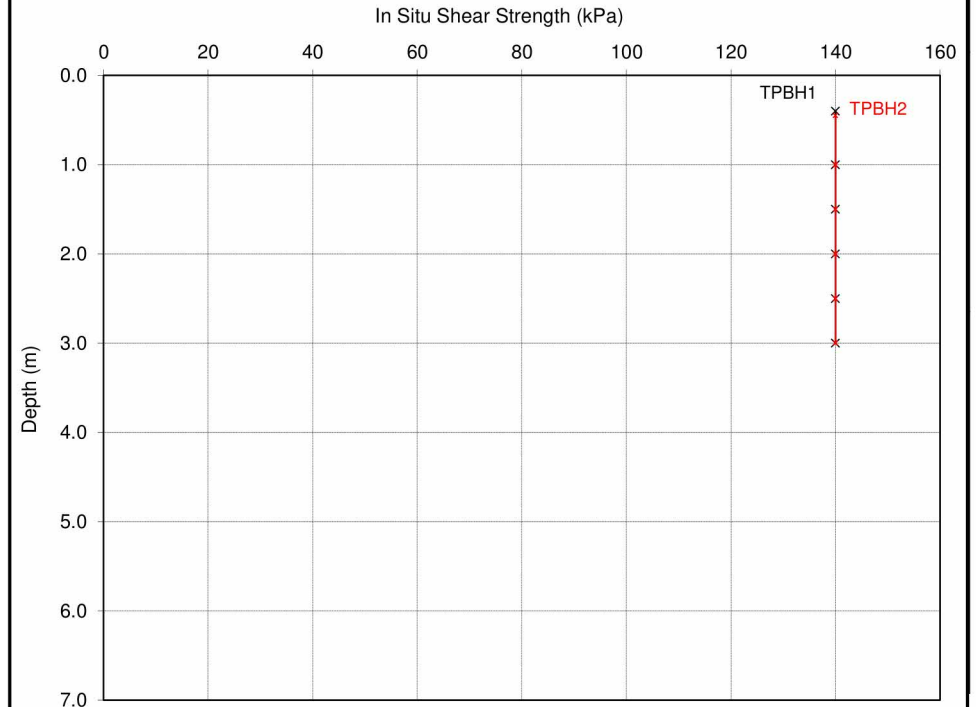
Moisture Content/Shear Strength Profile

1. If the Soil Fraction > 0.425mm exceeds 5% the Equivalent Moisture Content of the remainder ( calculated in accordance with BS 1377: Part 2 : 1990, cl.3.2.4 note 1 ) is also plotted and the alternative profile additionally shown as an appropriately coloured broken line.
2. If plotted, 0.4 LL and PL+2 ( after Driscoll, 1983 ) should only be applied to London Clay ( and similarly over consolidated clays ) at shallow depths.

Unless otherwise stated, values of Shear Strength were determined in situ using a Pilcon Hand Vane the calibration of which is limited to a maximum reading of 140 kPa. (Not UKAS accredited)

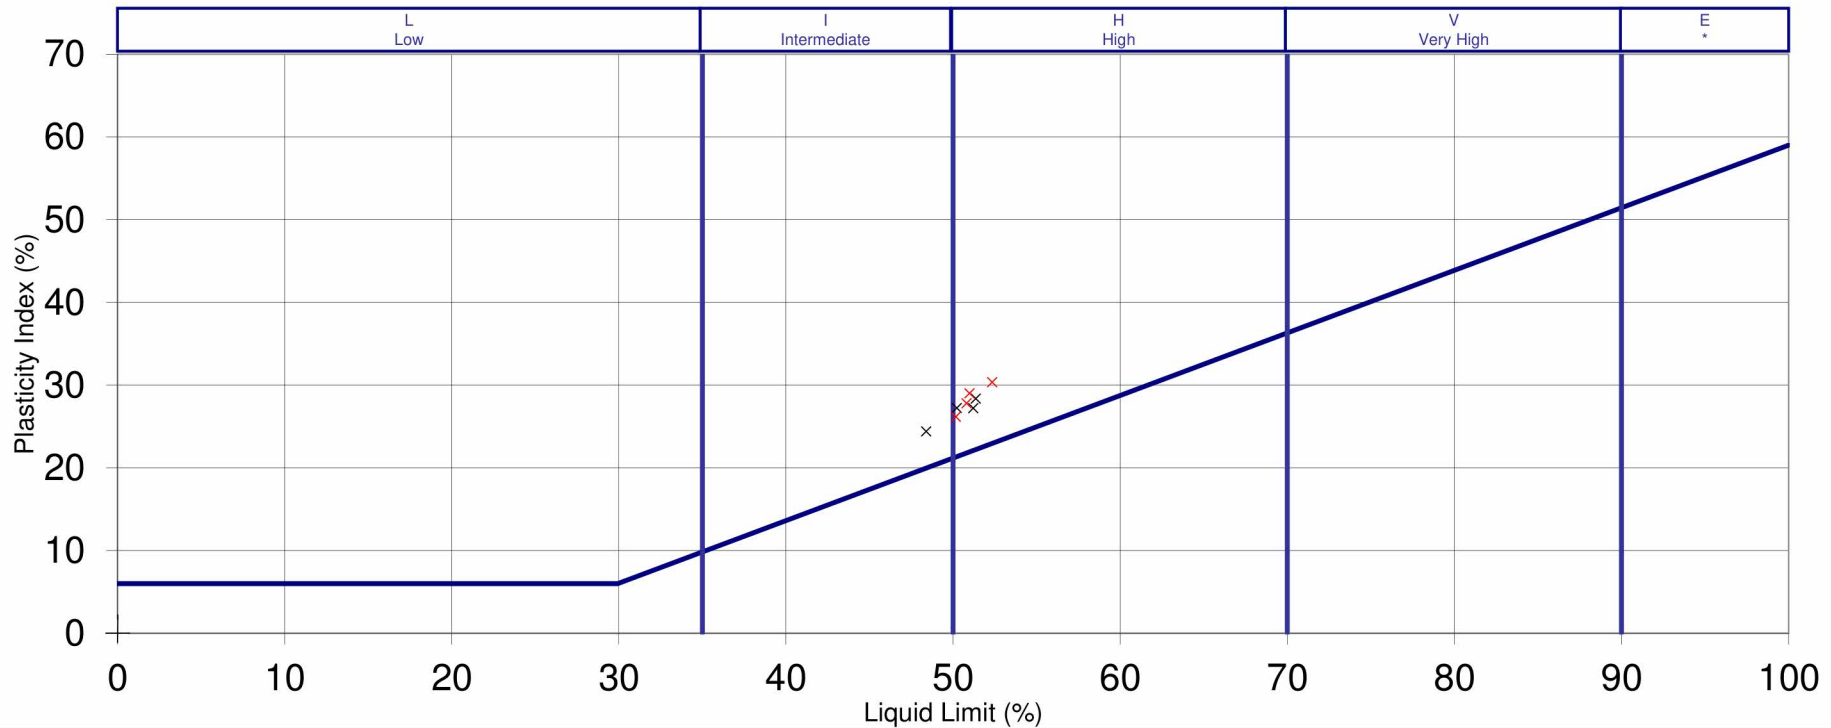
Plasticity Chart for the classification of fine soils and the finer part of coarse soils  
In Compliance with BS5930 : 1999

SILT (M-SOIL), M, plots below A-Line  
CLAY, C, plots above A-Line } M and C may be combined as FINE SOIL, F.

The superficial natural clay encountered beneath the site has been classified as having a 'medium' volume change potential as defined by the National House Building Councils (NHBC), indicating the soils have a potentially 'medium' sensitivity to moisture content changes therefore the possibility of heave occurring following tree removal is considered to be 'likely' at this stage.

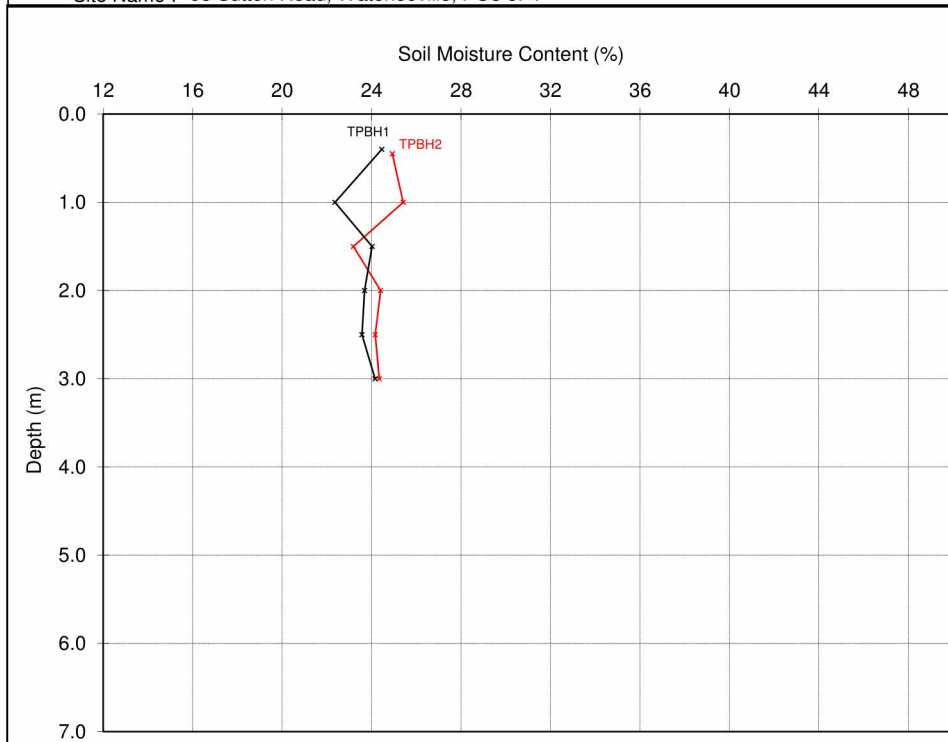
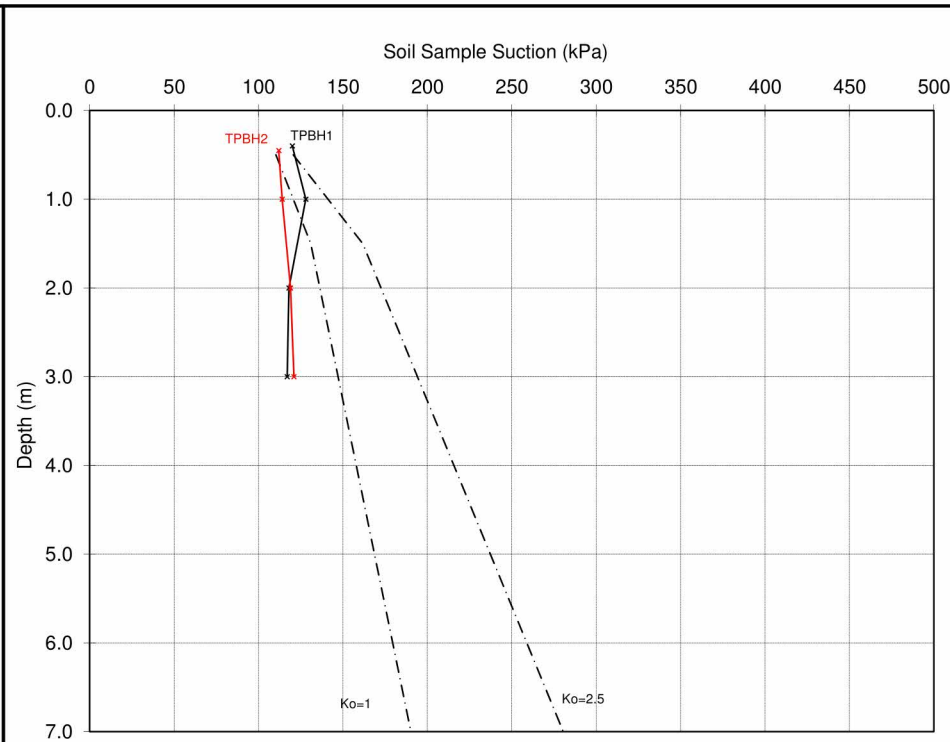
Moisture Content/Soil Suction Profile

For the samples tested from BH1 the suction was found to range between 117 kPa and 128 kPa. For the samples tested from BH2 the suction was found to range between 112 kPa and 121 kPa.

Driscoll's guidance suggests that that the natural clay encountered at the locations of BH1 and BH2 is 'not desiccated'.

The soil suction test data predicted a 'heave' of 7mm at a depth of 0.40m bgl at the location of BH1.

The soil suction test data predicted a 'heave' of 7mm at a depth of 0.45m bgl at the location of BH2.

If not already undertaken, it is recommended that a drainage survey of the existing system on site be undertaken in order to assess the condition of the existing system. In addition, it is also recommended, if not already commissioned, that an arboricultural report be carried out to determine the impact of tree removal.
