# Ground Investigation Report

Former Dairy Crest Depot, Dunsbury Way, Havant PO9 5BQ

On behalf of Foreman Homes Limited

| Report Reference: GWPR6068/GIR/September 2024 V1.01 | | | Status: Final |

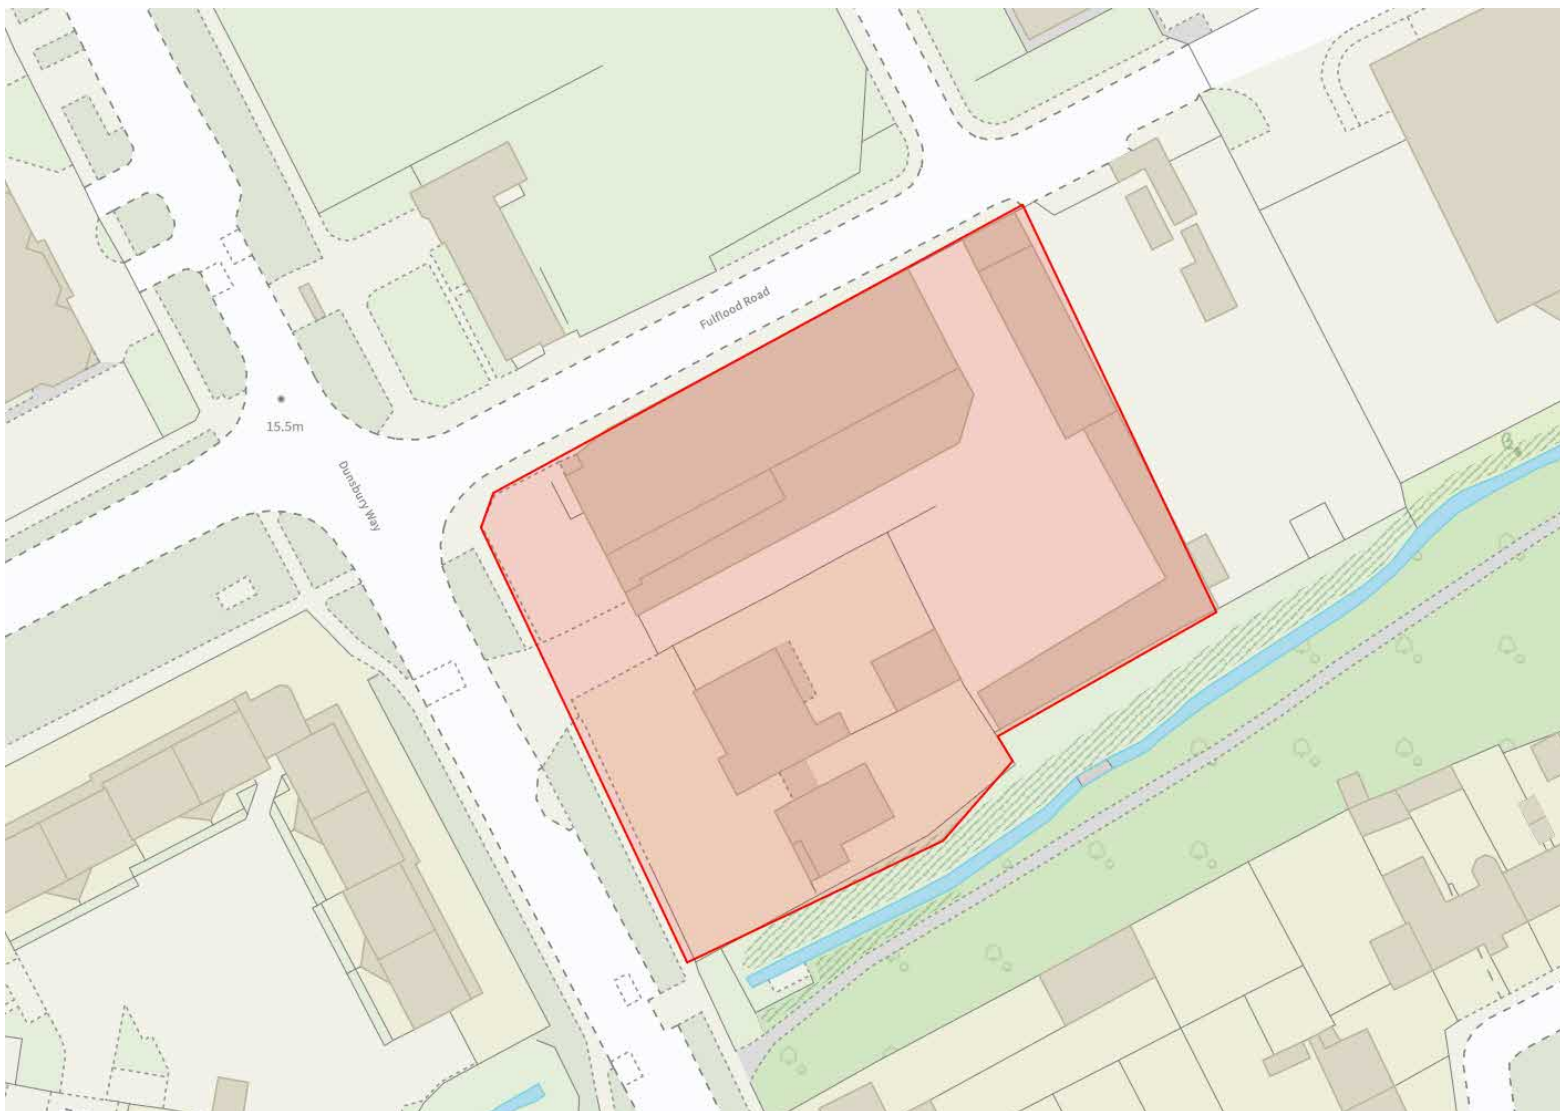
Figure 2 – Site Development Area

Site Boundary

| SITE DETAILS | <p>The site comprised a ~4,500m<sup>2</sup> roughly rectangular shaped plot of land, situated on the south-eastern corner of the junction of Dunsbury Way to the west and Fulflood Road to the north. The site was located in the northern portion of Havant, a mainly residential town within south-east Hampshire. A site location plan has been provided within Figure 1.</p> <p>The northern part of the site comprises a single storey masonry former milk packaging and distribution depot building along the north-west boundary with covered bays and a yard in the north-east and east, a toilet block in the north-east corner and parking bays in the west of the site. The building contains predominantly office accommodation at the western end with warehouse, storage, refrigeration and loading areas in the centre and west. The covered bays in the north-east and east of the site, where milk distribution vehicles are believed to have been parked, were noted to be of steel frame construction with brick rear walls and suspected asbestos cement sheeting forming the roofs. The yard was predominantly covered by asphalt surfacing with a concrete slab along the western edge of the yard. No evidence of fuel or chemical storage was observed during the walkover survey and it is understood from planning records that repair, servicing or refuelling of vehicles was not permitted on site under the planning permission for the development of the depot.</p> <p>The southern part of the site comprises a single storey brick funeral care facility with soft landscaping and parking fronting Dunsbury Way to the west of the building with a yard and garage to the rear (east) of the building. Adjacent to the south of the funeral care building is a residential bungalow, understood to have originally been constructed as the dwelling for the manager of the funeral care facility, with soft landscaping fronting Dunsbury Way and a rear garden to the east. No evidence of fuel or chemical storage was noted in relation to the funeral care facility or the bungalow. The southern boundary of the site is formed by a steep embankment down to the adjacent Riders Stream, approximately 2-3m below the general site level.</p> <p>A view of the site development area has been provided within Figure 2, with an aerial view of the site provided in Figure 3.</p> |

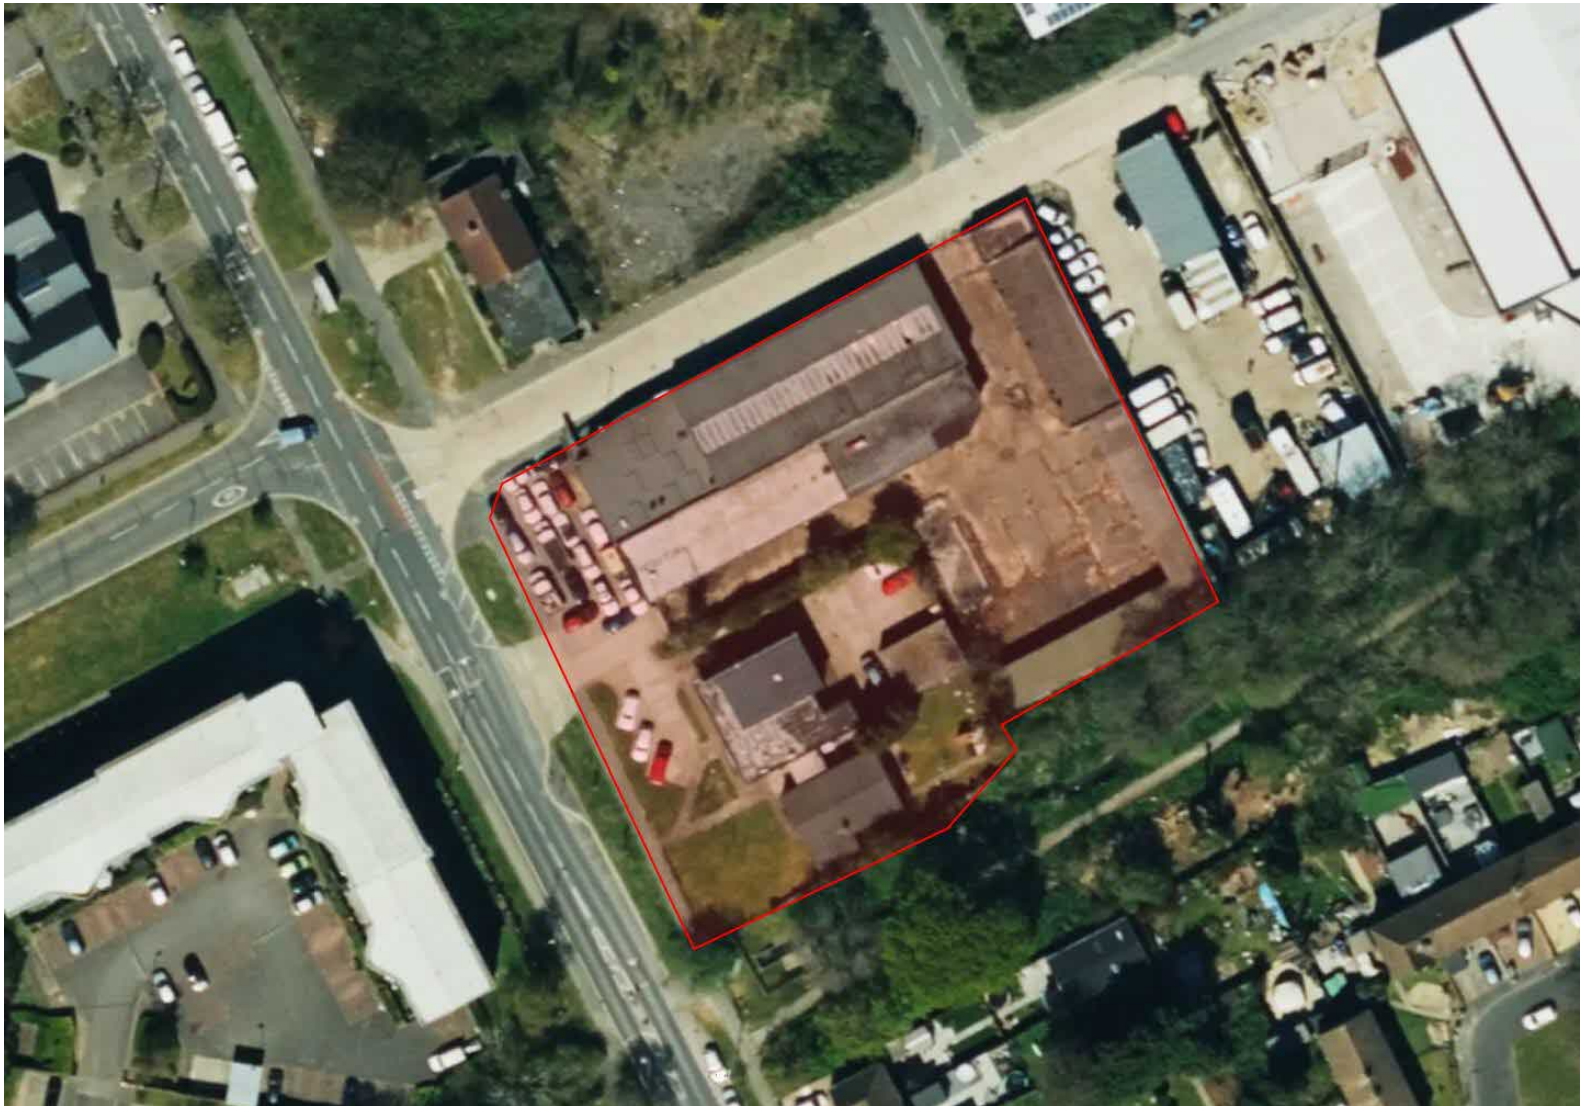
Figure 3 – Aerial Photograph

Former Dairy Crest Depot, Dunsbury Way, Havant PO9 5BQ

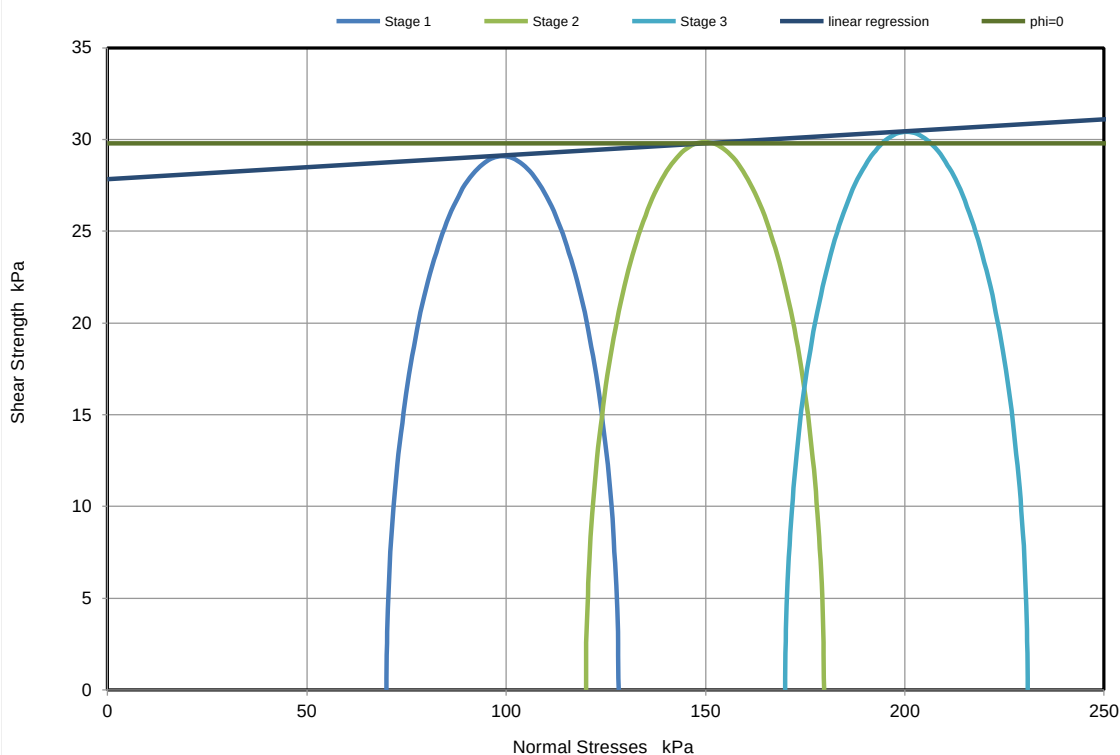
**Mohr Circles**

$\phi_u = 0$

Average  $c_u$  30 kPa

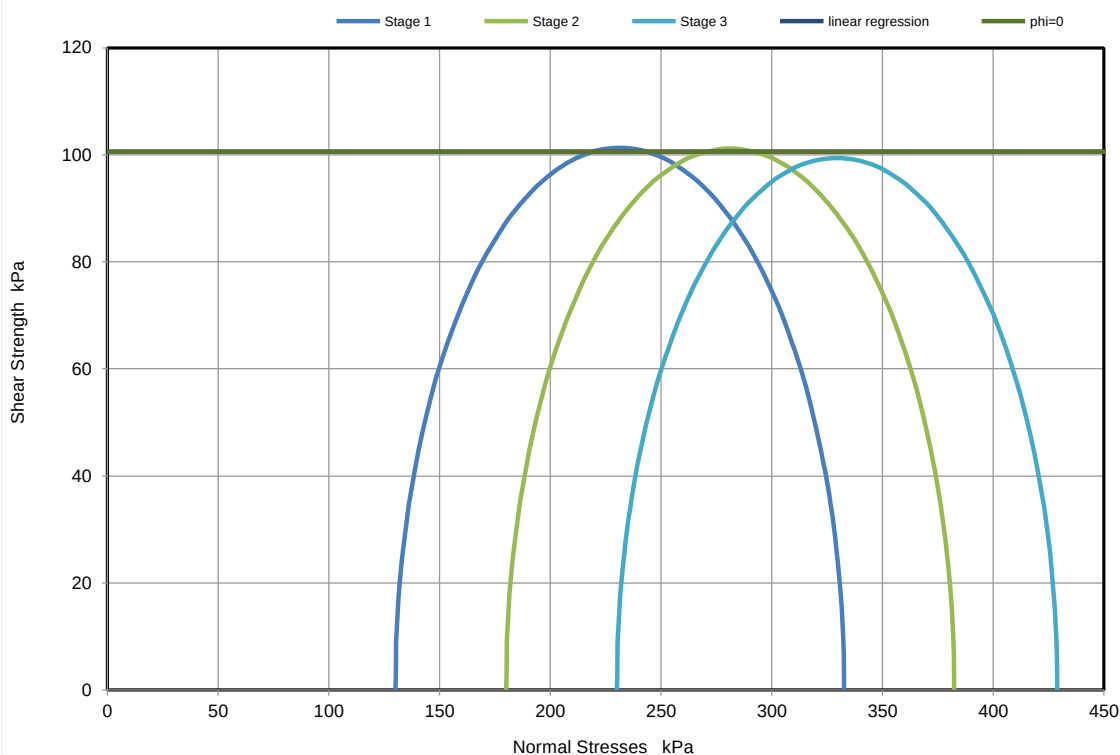
**Mohr Circles**

$\phi_u = 0$

Average  $c_u$  101 kPa

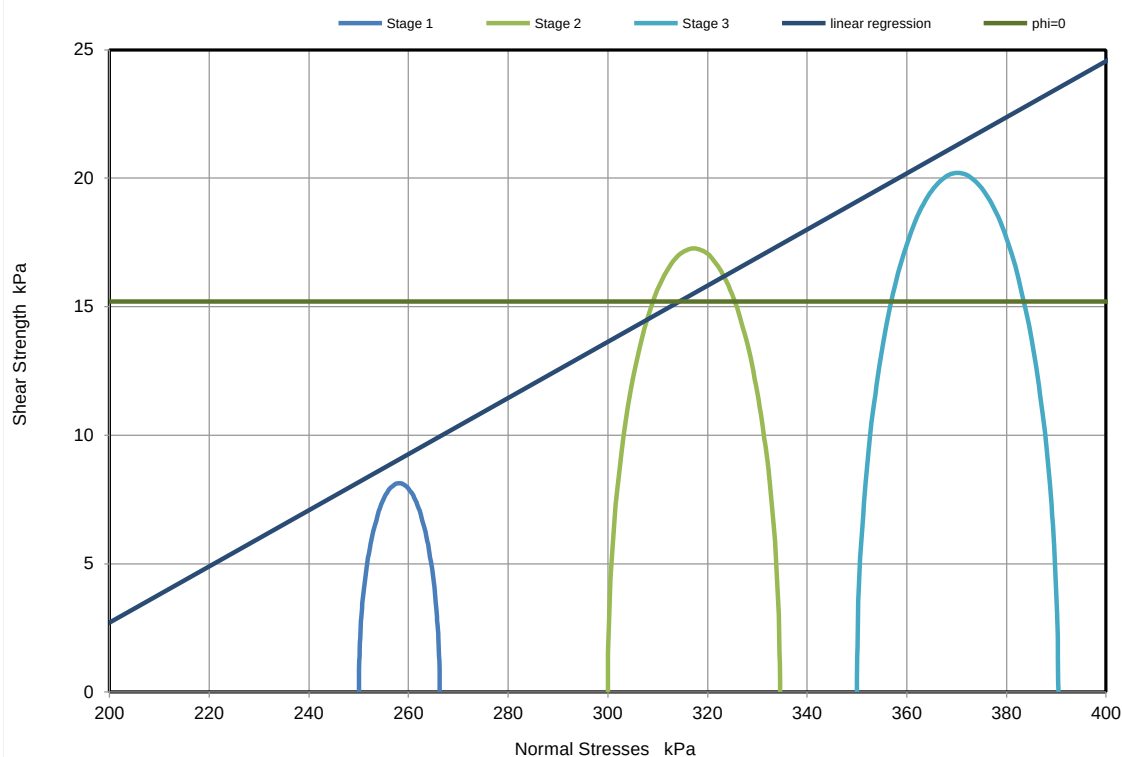
**Mohr Circles**

$\phi_u = 0$

Average  $c_u$  15 kPa

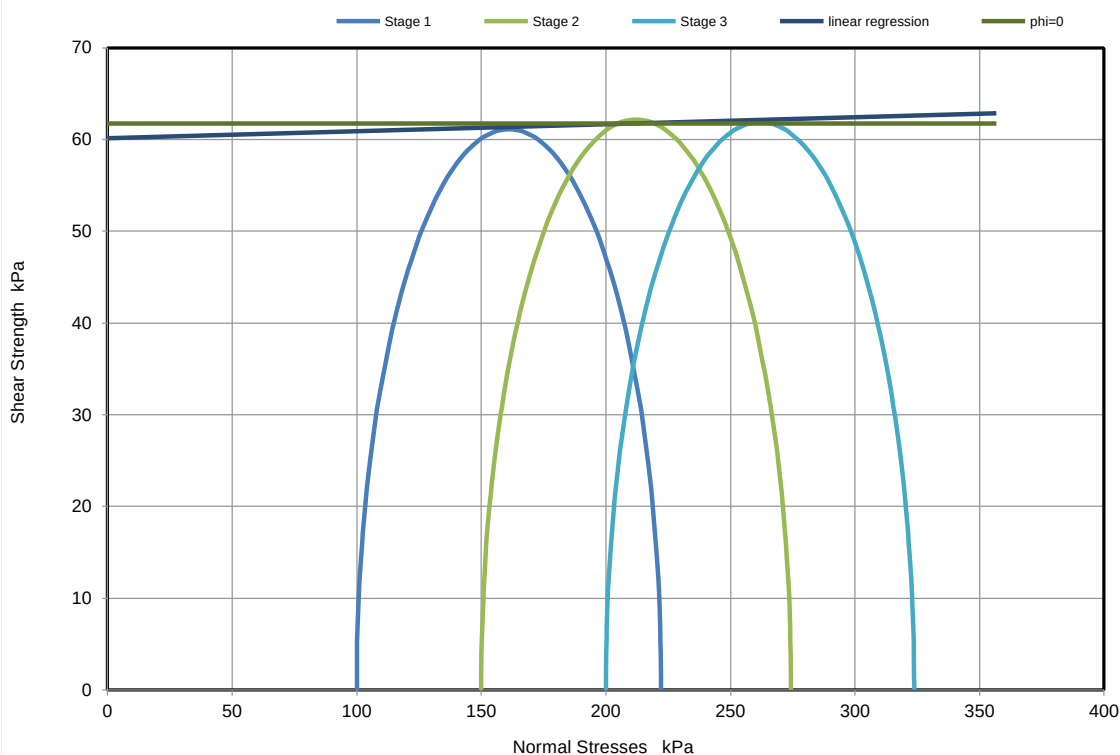
**Mohr Circles**

$\phi_u = 0$

Average  $c_u$  62 kPa

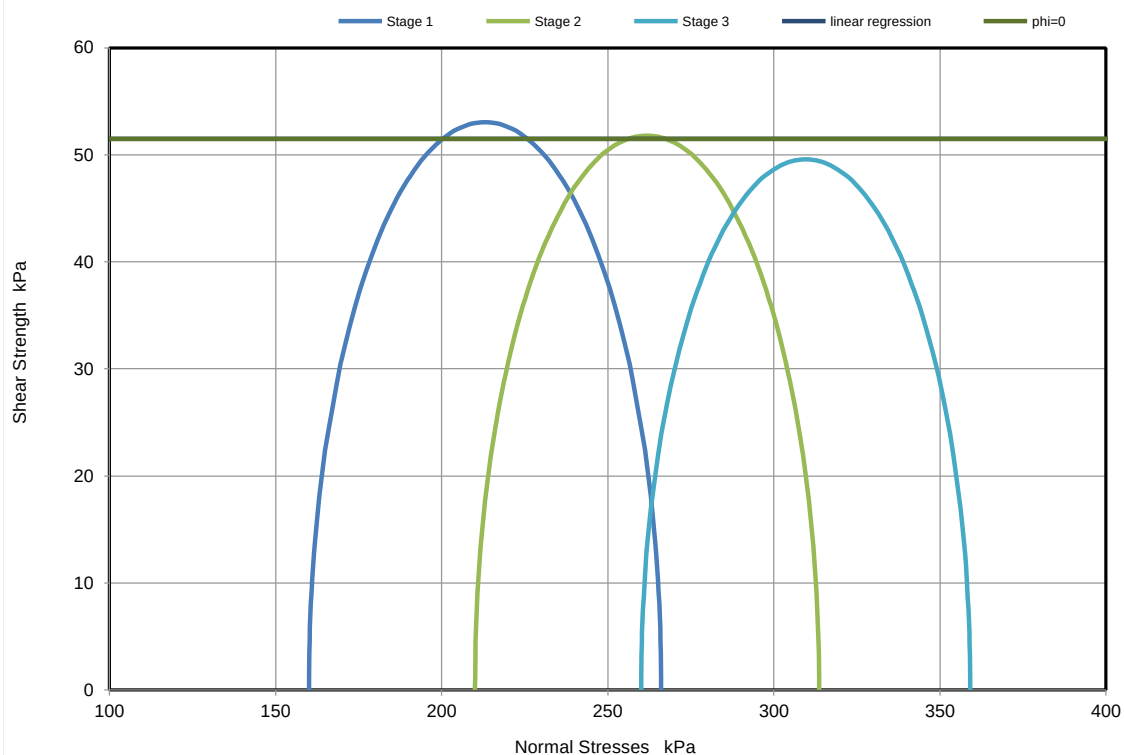
**Mohr Circles**

$\phi_u = 0$

Average  $c_u$  51 kPa

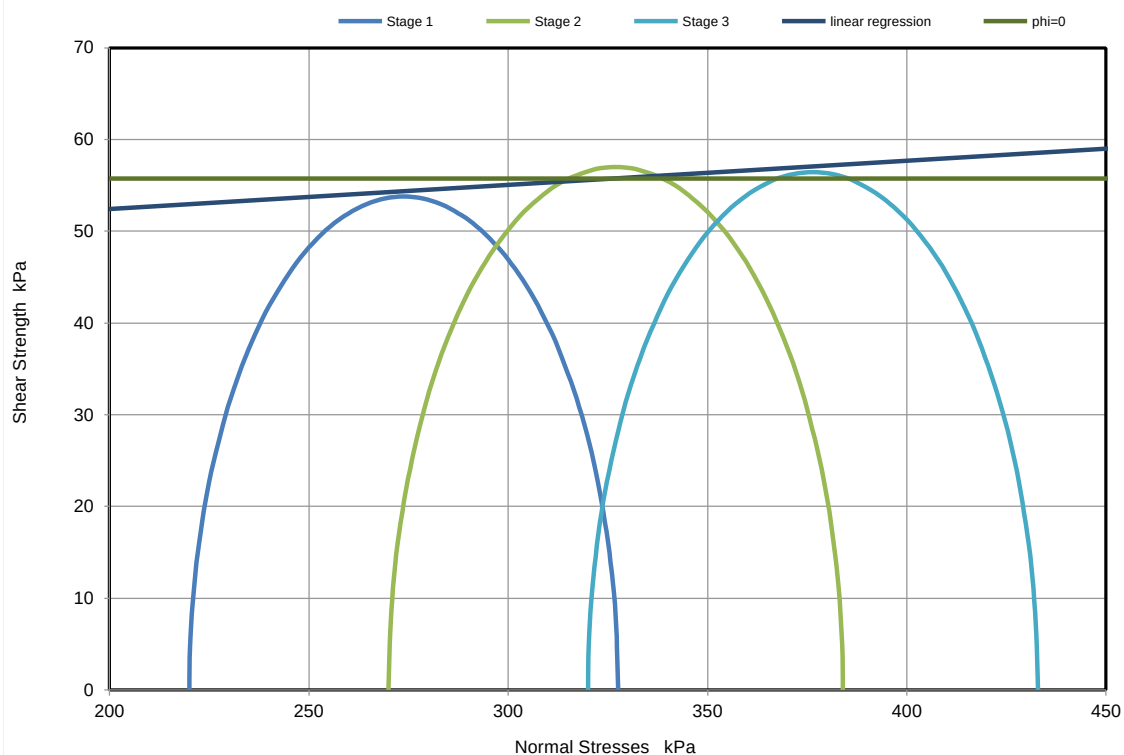
**Mohr Circles**

$\phi_u = 0$

Average  $c_u$  56 kPa

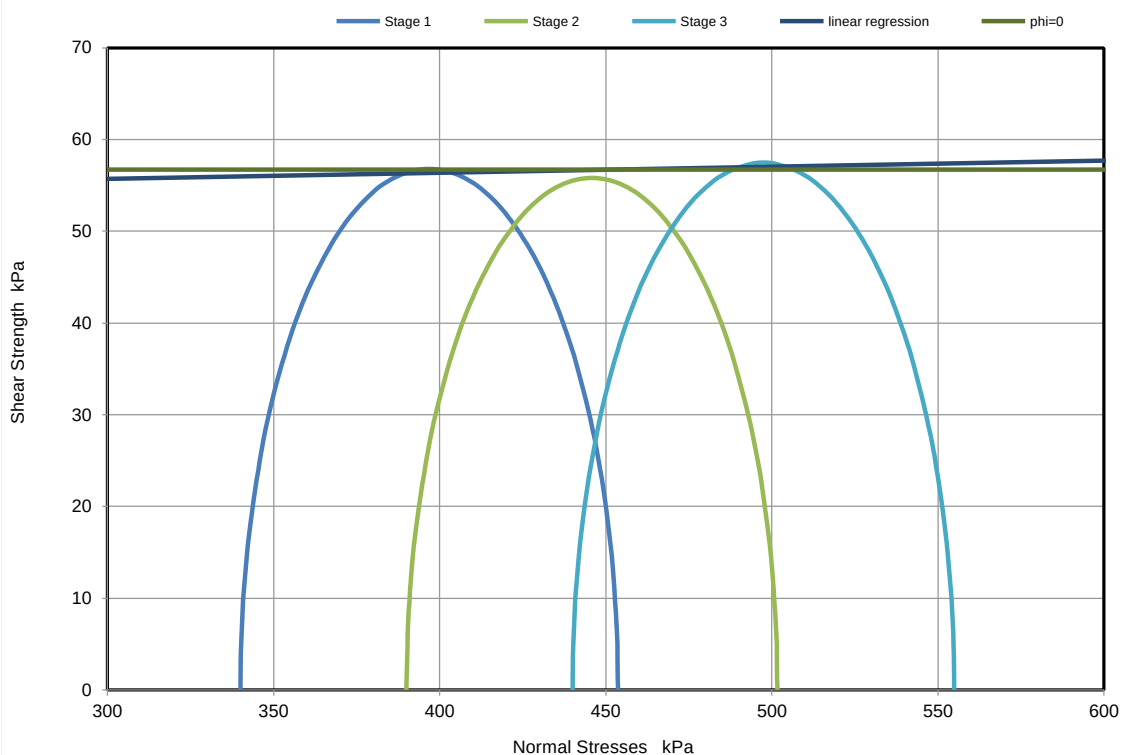
**Mohr Circles**

$\phi_u = 0$

Average  $c_u$  57 kPa
