**BELMONT CASTLE CARE/REST HOME, PORTSDOWN HILL ROAD, HAVANT,  
PO9 3JY**

**GROUND CONDITION ASSESSMENT**

**JUNE 2025**

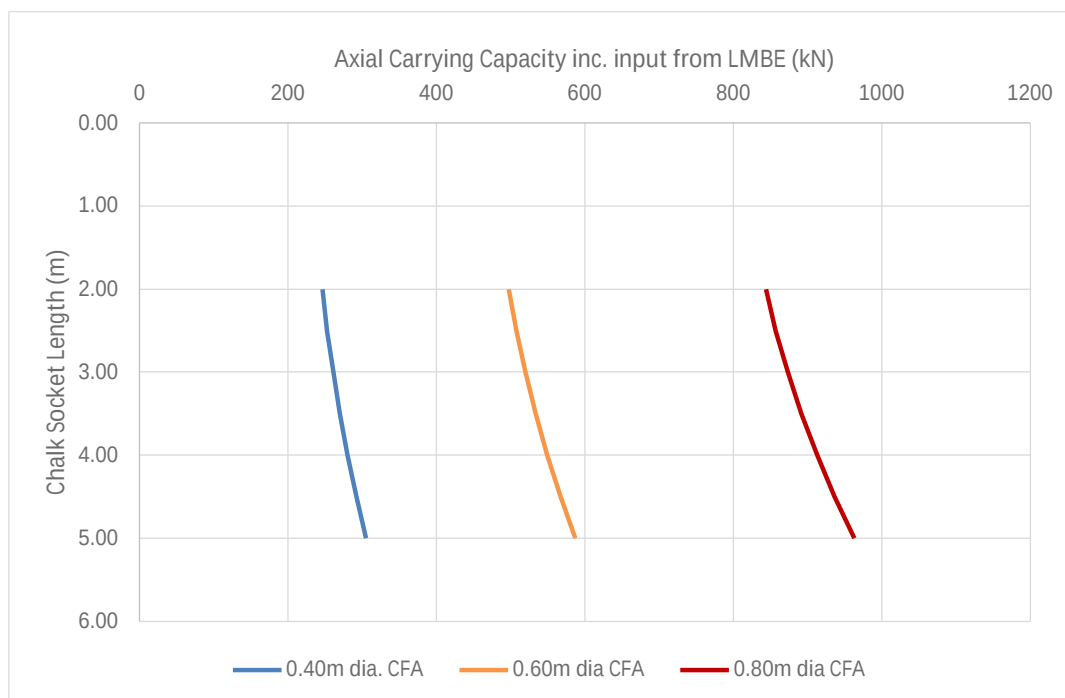
**Figure 9.1. Axial carrying capacity of piles socked into Chalk**

It must be stressed that the values presented in Table 9.3 are preliminary values and detailed calculations will be required once ground conditions are known to ca 18mbgl.

The full spreadsheet of results is presented within the pile design (Appendix 6) of this report. When determining the required pile length, it is considered appropriate to interpolate between graphed values if intermediate pile sizes are to be used. Applied loads should be factored in accordance with Design Approach 1 Combination 2.

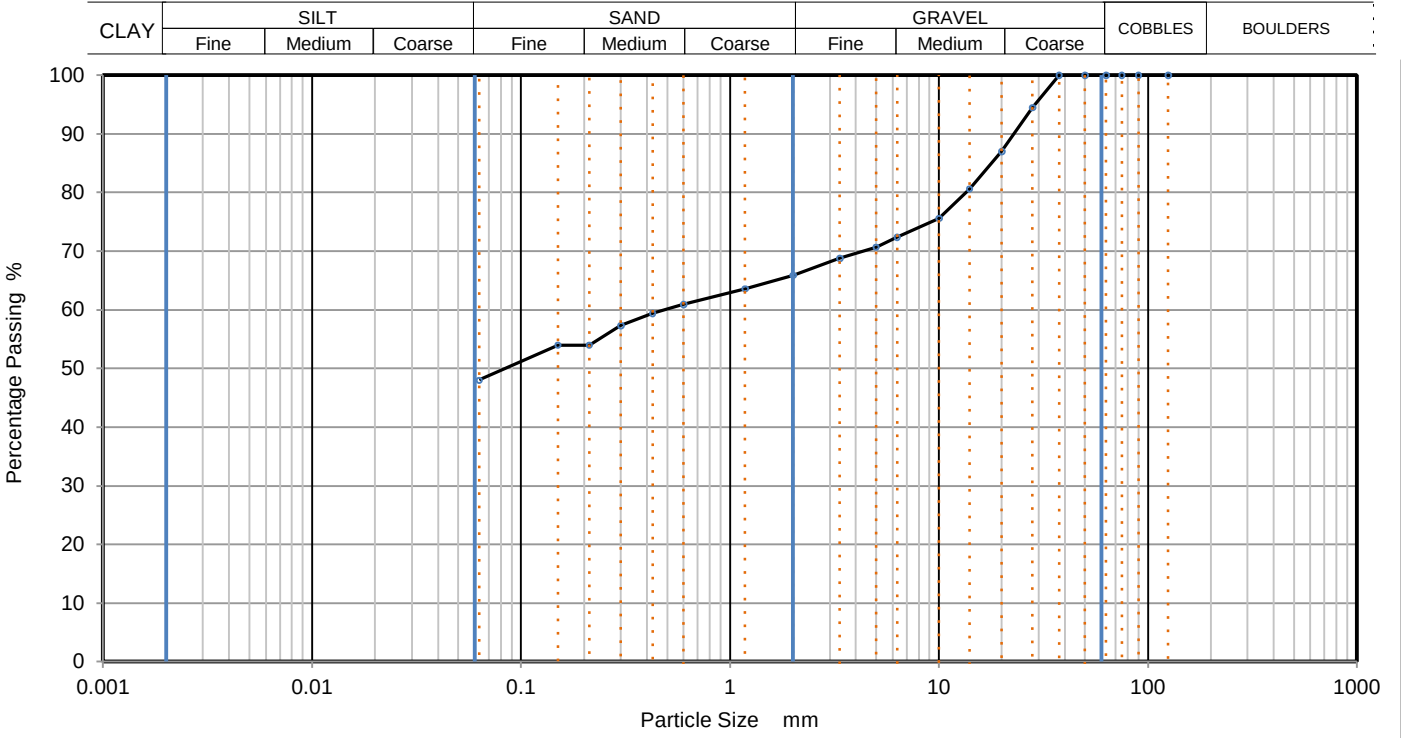
| Test Method | ISO 17892 -4, by sieving on pre-dried or dry sample | | | KeyLAB ID | TTLP2025060325 |

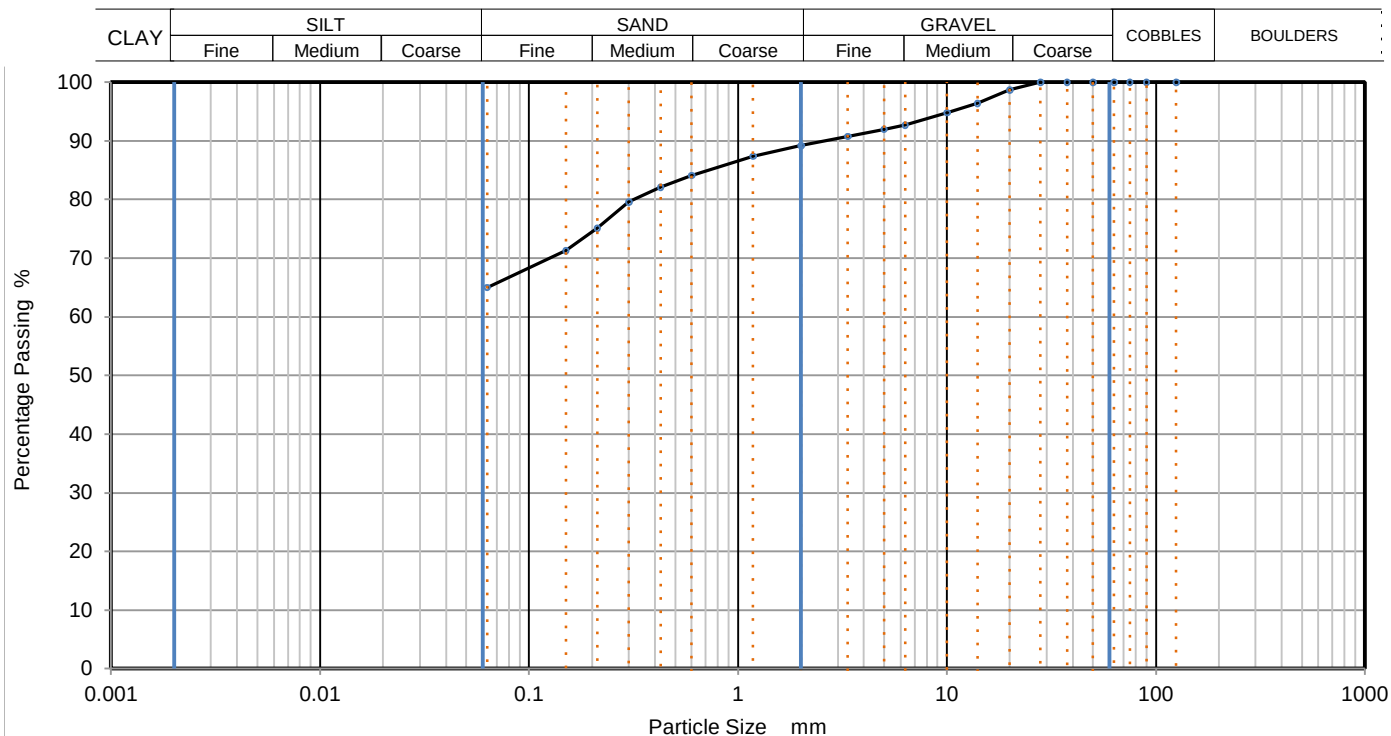
| Test Method | ISO 17892 -4, by sieving on pre-dried or dry sample | | | KeyLAB ID | TTLP2025060326 |

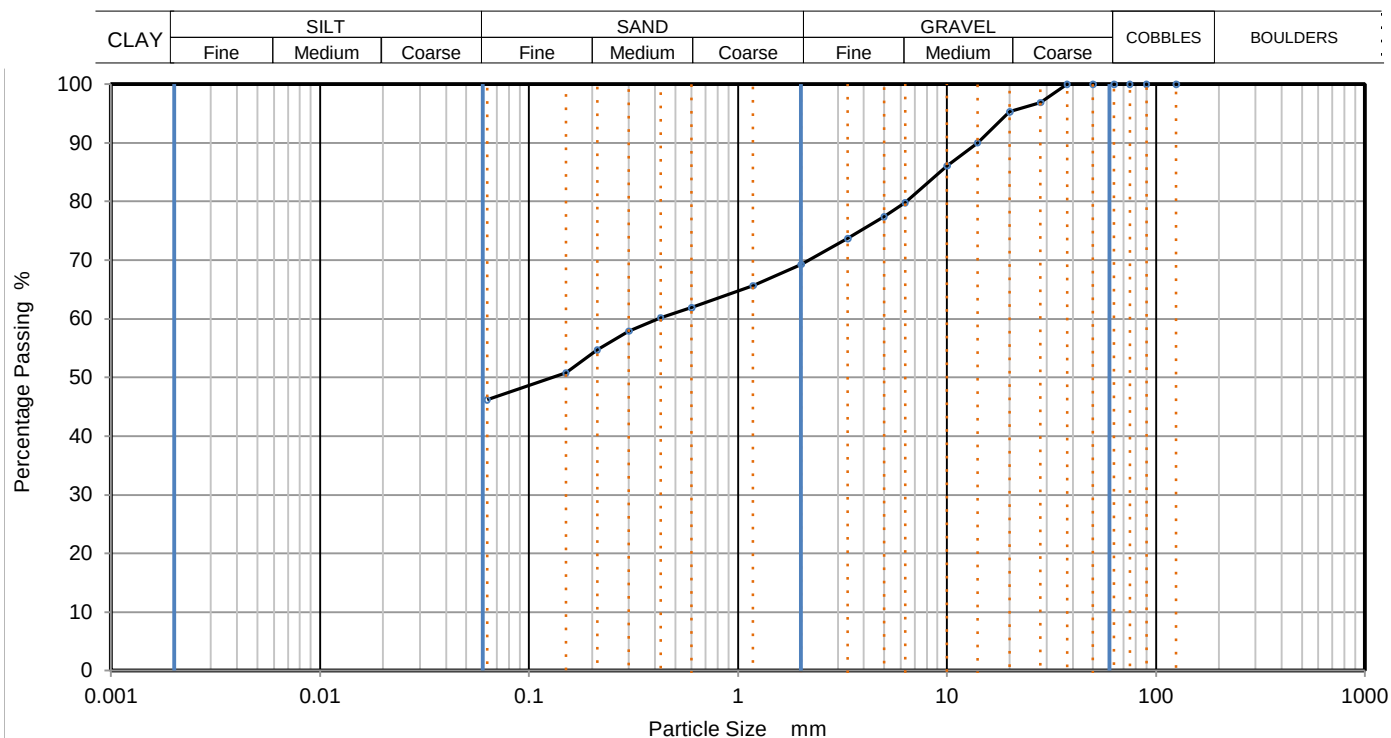
| Test Method | ISO 17892 -4, by sieving on pre-dried or dry sample | | | KeyLAB ID | TTLP2025060328 |

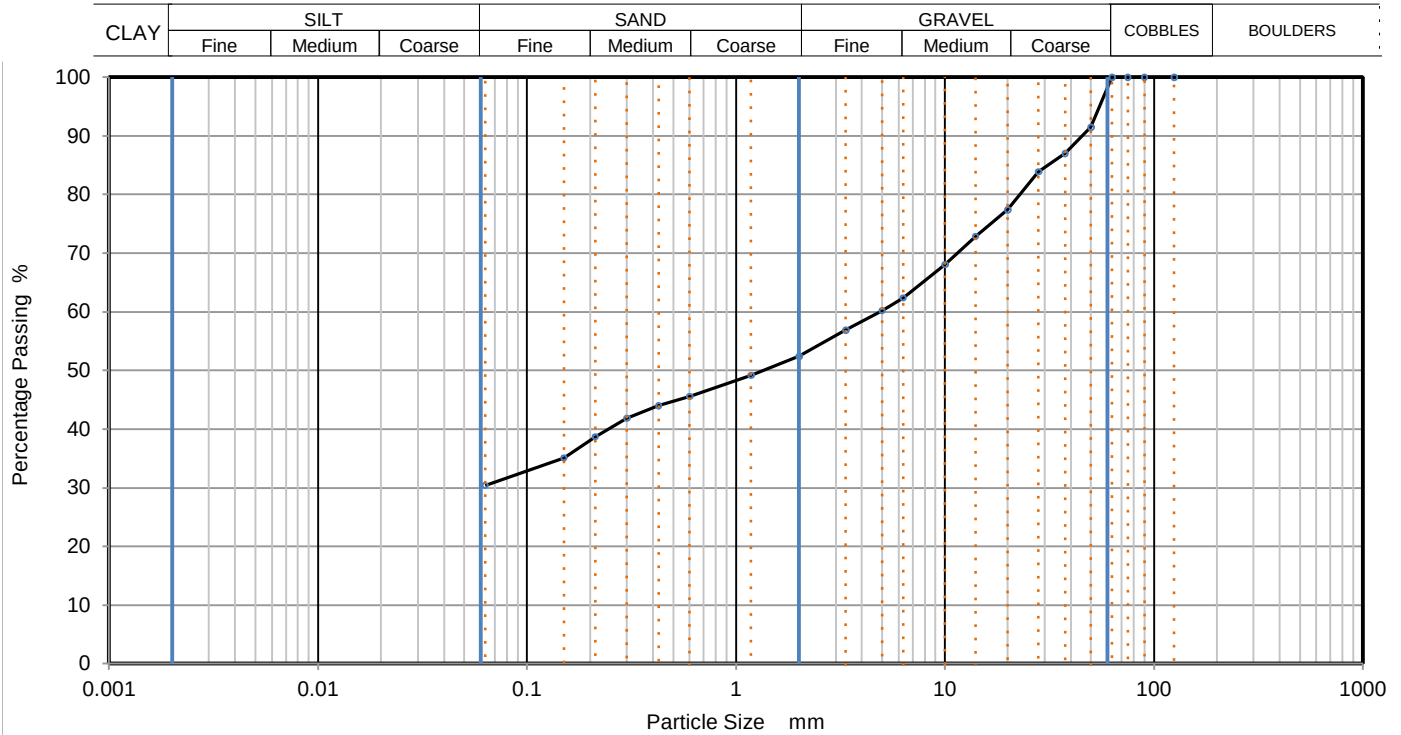
| Test Method | ISO 17892 -4, by sieving on pre-dried or dry sample | | | KeyLAB ID | TTLP2025060329 |
