Karl Iacobucci  
28 St Catherine's road  
Hayling Island  
Hampshire  
PO11 0HF07th April 2021  
Havant Borough Council's Arboriculture Team:

Please find following images and explanation to support application to fell No3 TPO 1123G.1 Austrian Pine that borders my property 28 St Catherine's Road, Hayling Island, Hampshire.

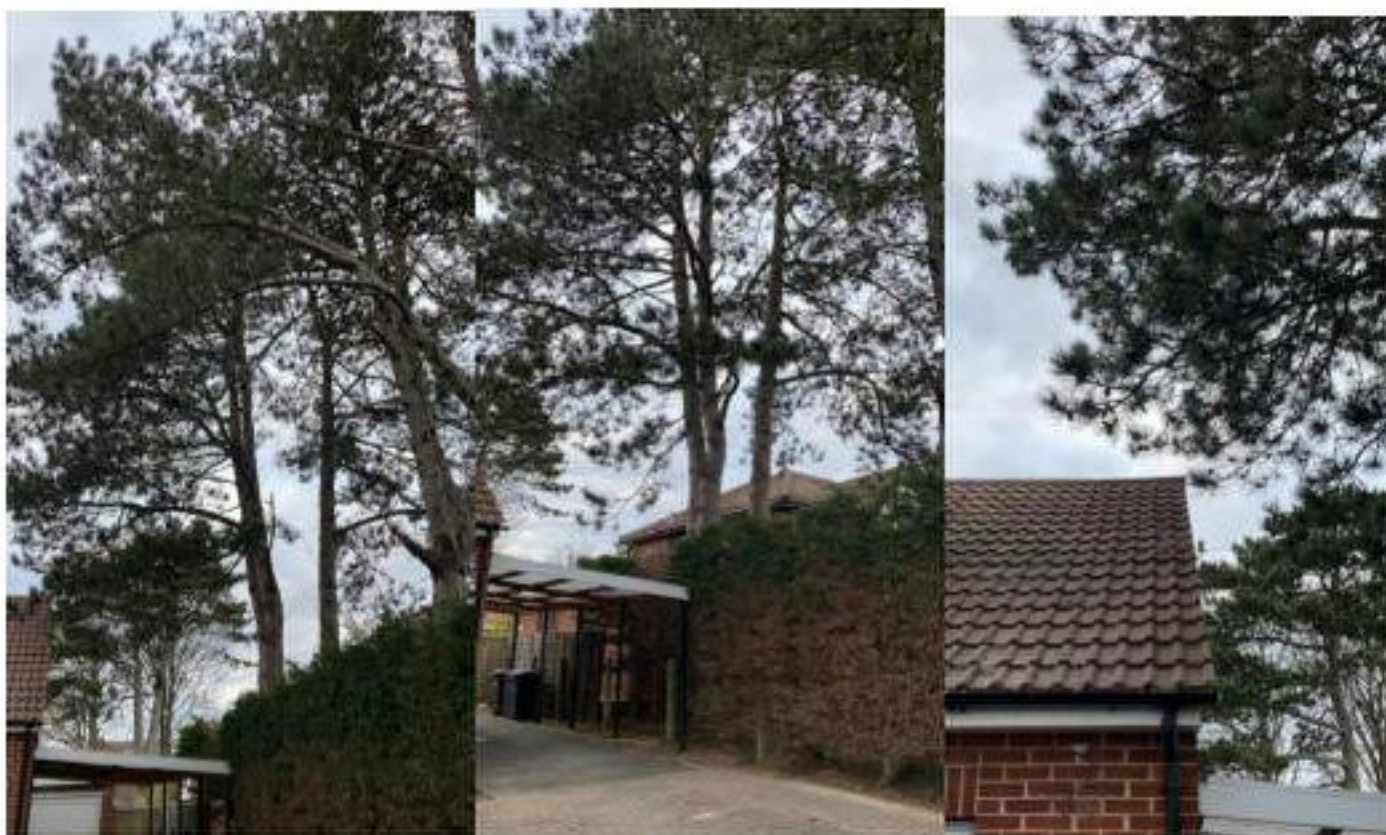
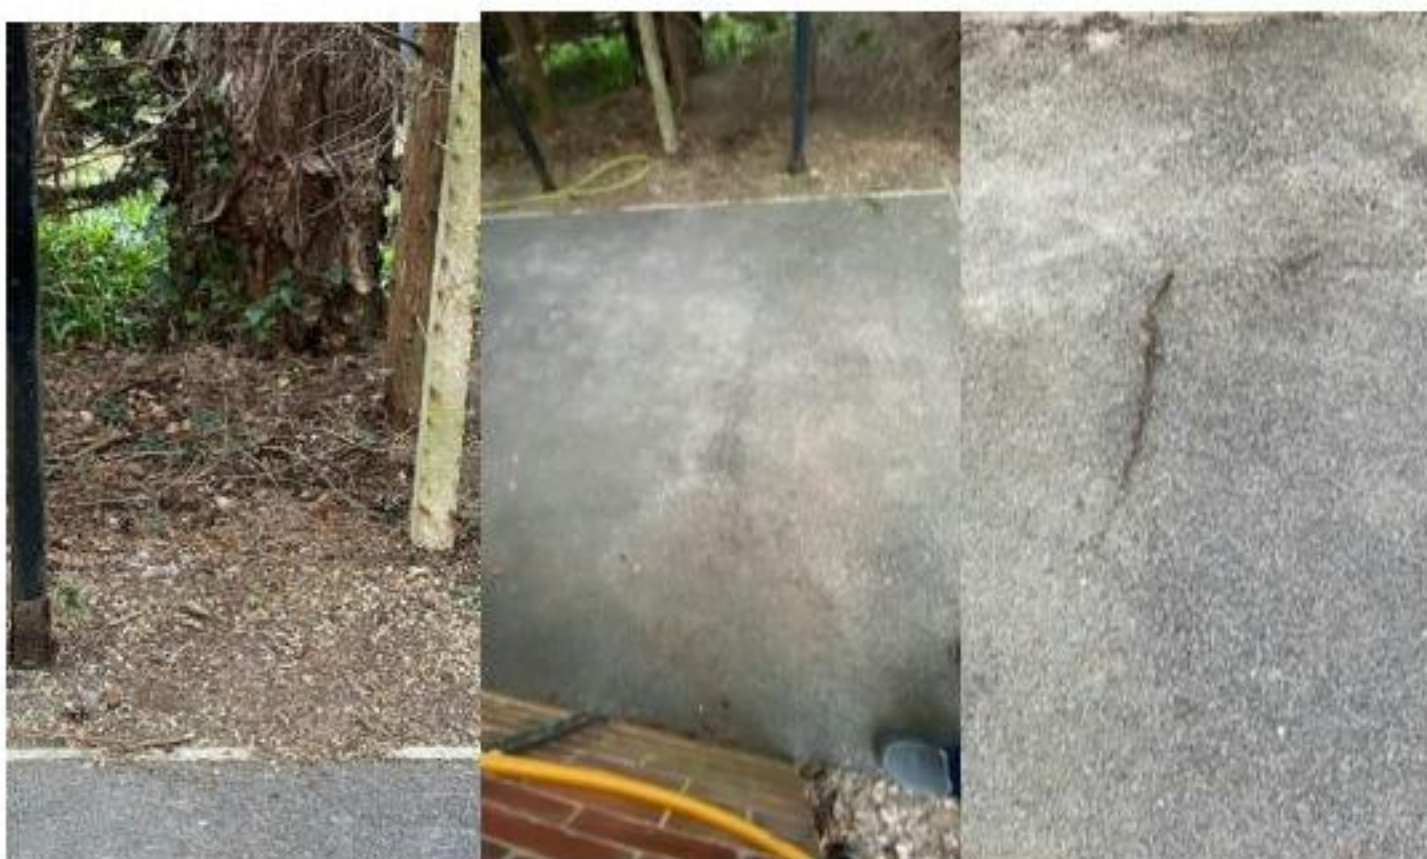
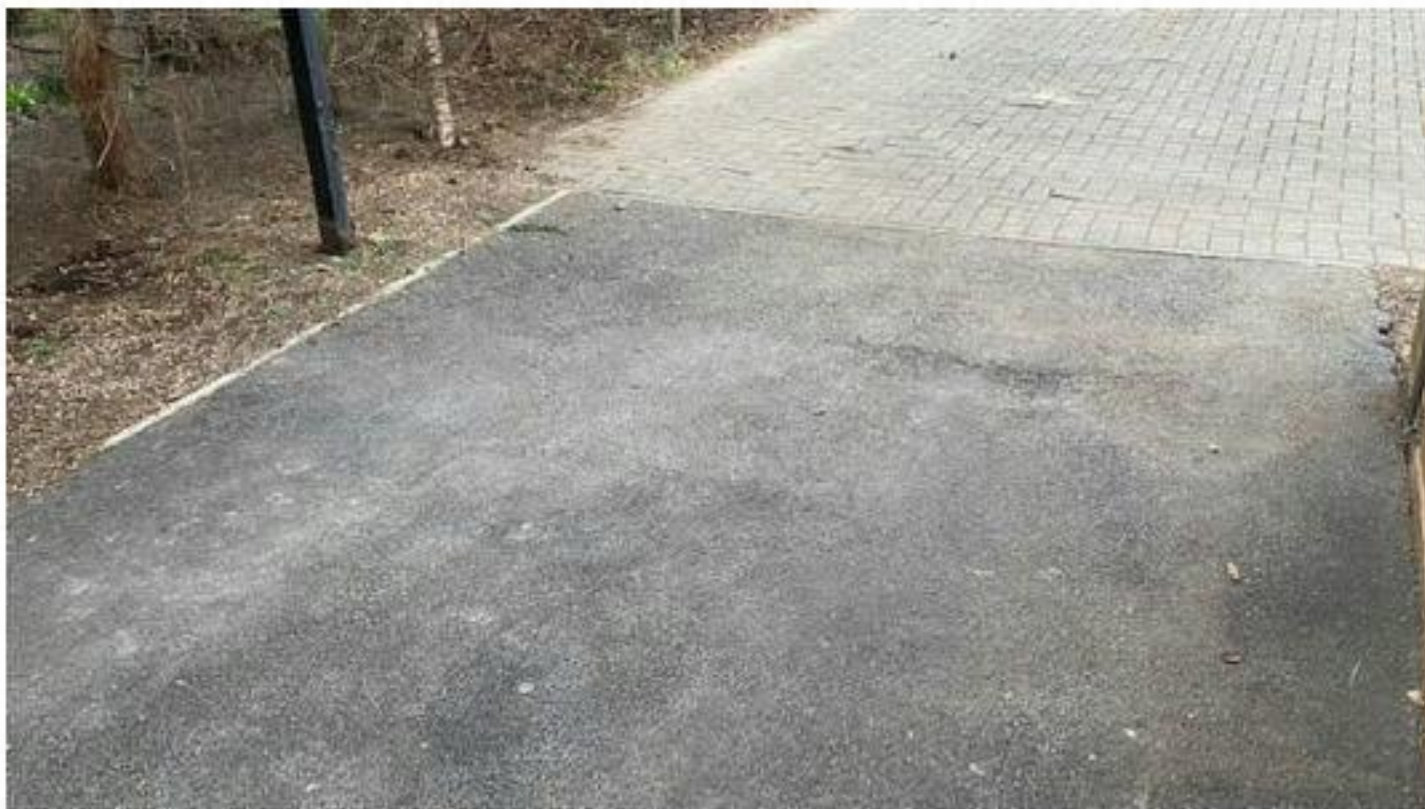
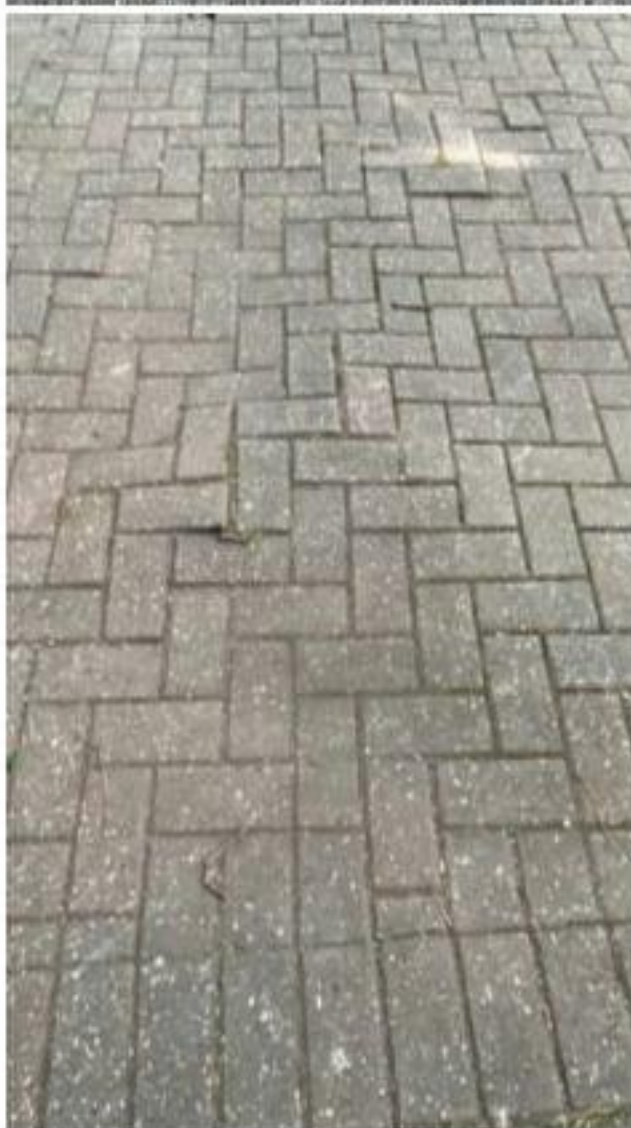
We are alarmed about the increase in damage to our driveway from the roots of No 3 Pine Tree as well as the branch's proximity to our roof. The tarmac area under our carport shows evidence of roots forcing up the surface, our bricked driveway has several areas of damage caused by the tree roots. I am concerned about the bricks as they represent a genuine trip hazard for any persons using my driveway to approach our property.

In high winds this tree sways considerably, I am concerned for the safety of my family as my young son's bedroom is directly under several branches that touch our roof.

I have attempted to capture the damage in the following images however my photographic skills leave room for improvement hence I welcome a visit from HBC to explain my concerns in person. Please also find attached JTS Civil Engineers report regarding the damaged mains water pipe.
