38105 Victoria Cottage Hospital, Emsworth  
**Design and Access Statement**

# 1. Introduction

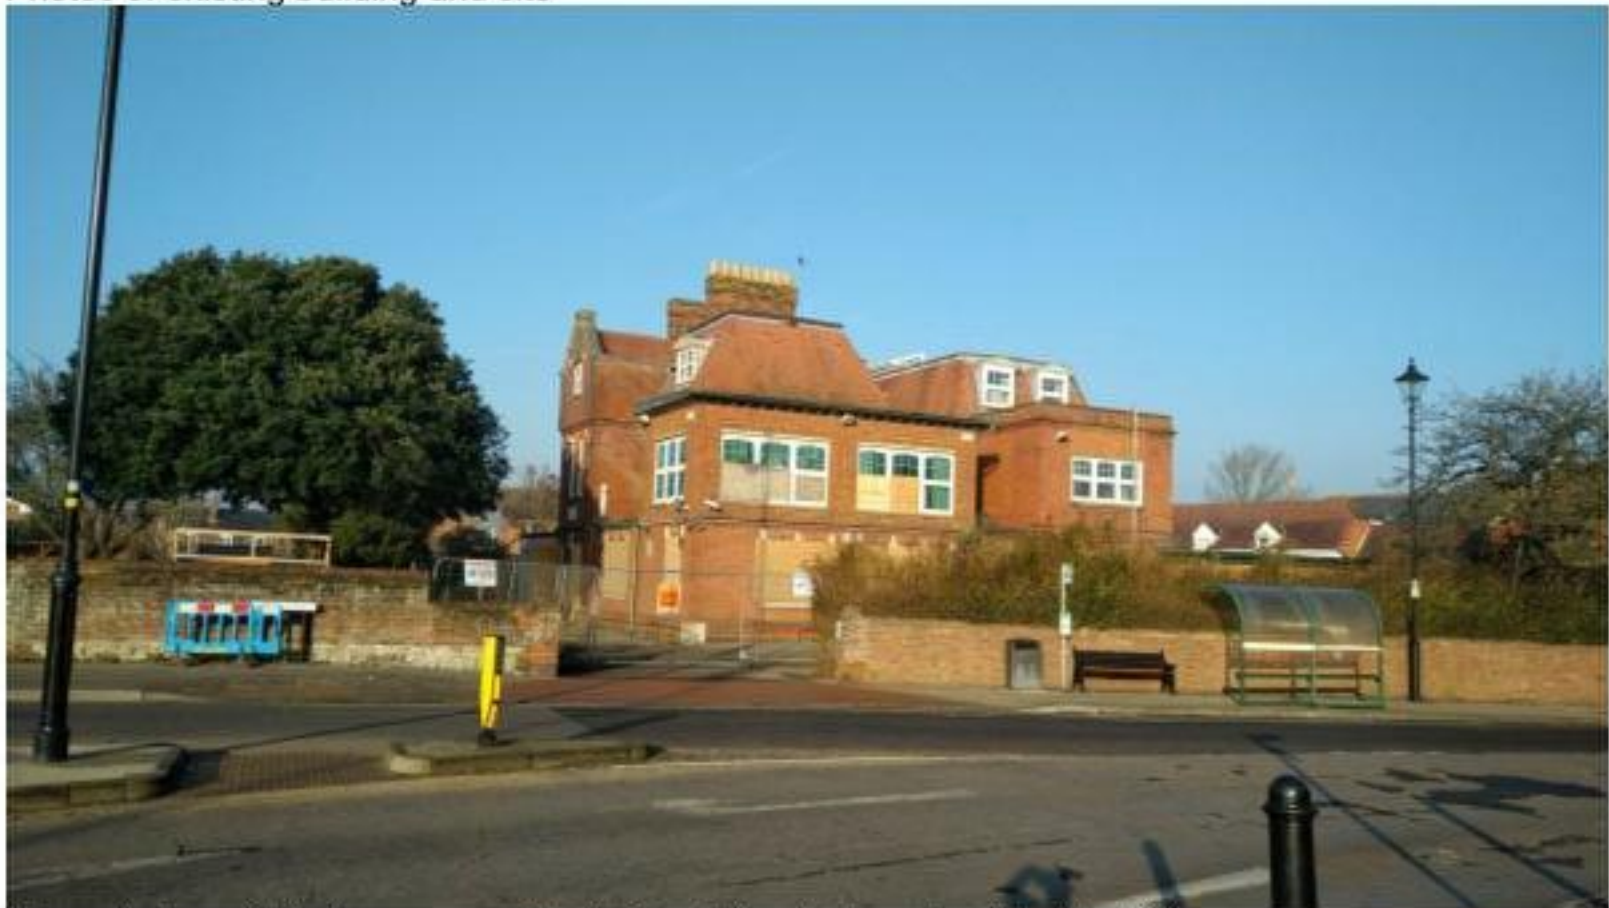
General view of site from across North Street (the LoF garden is to the left)

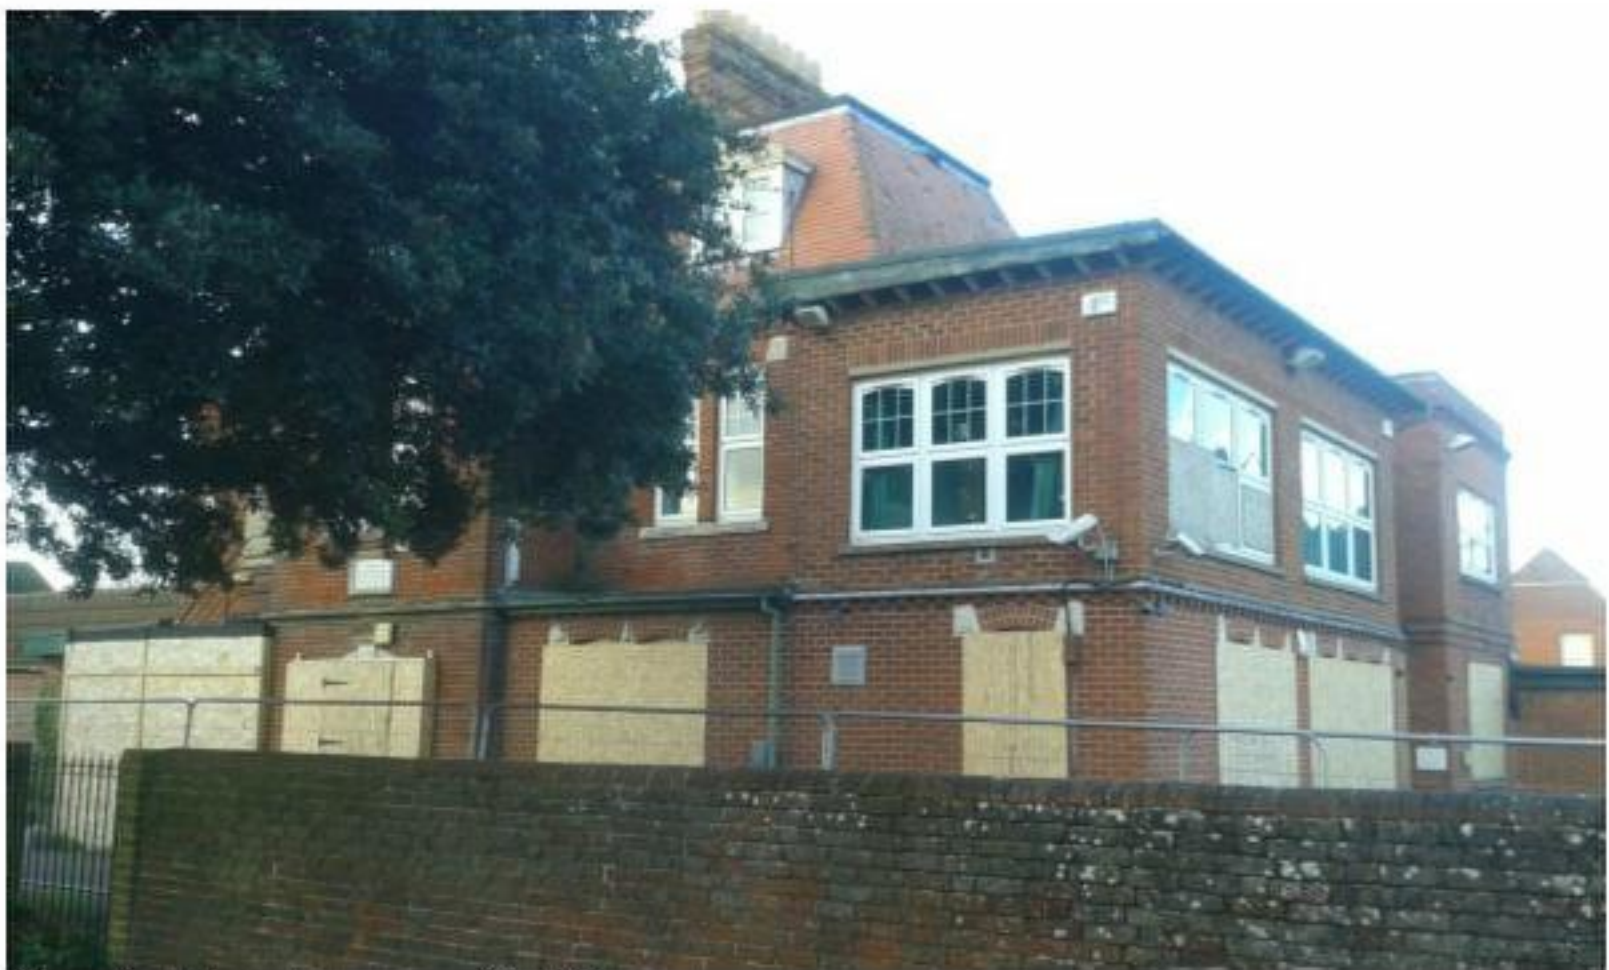
View of south-eastern corner of building

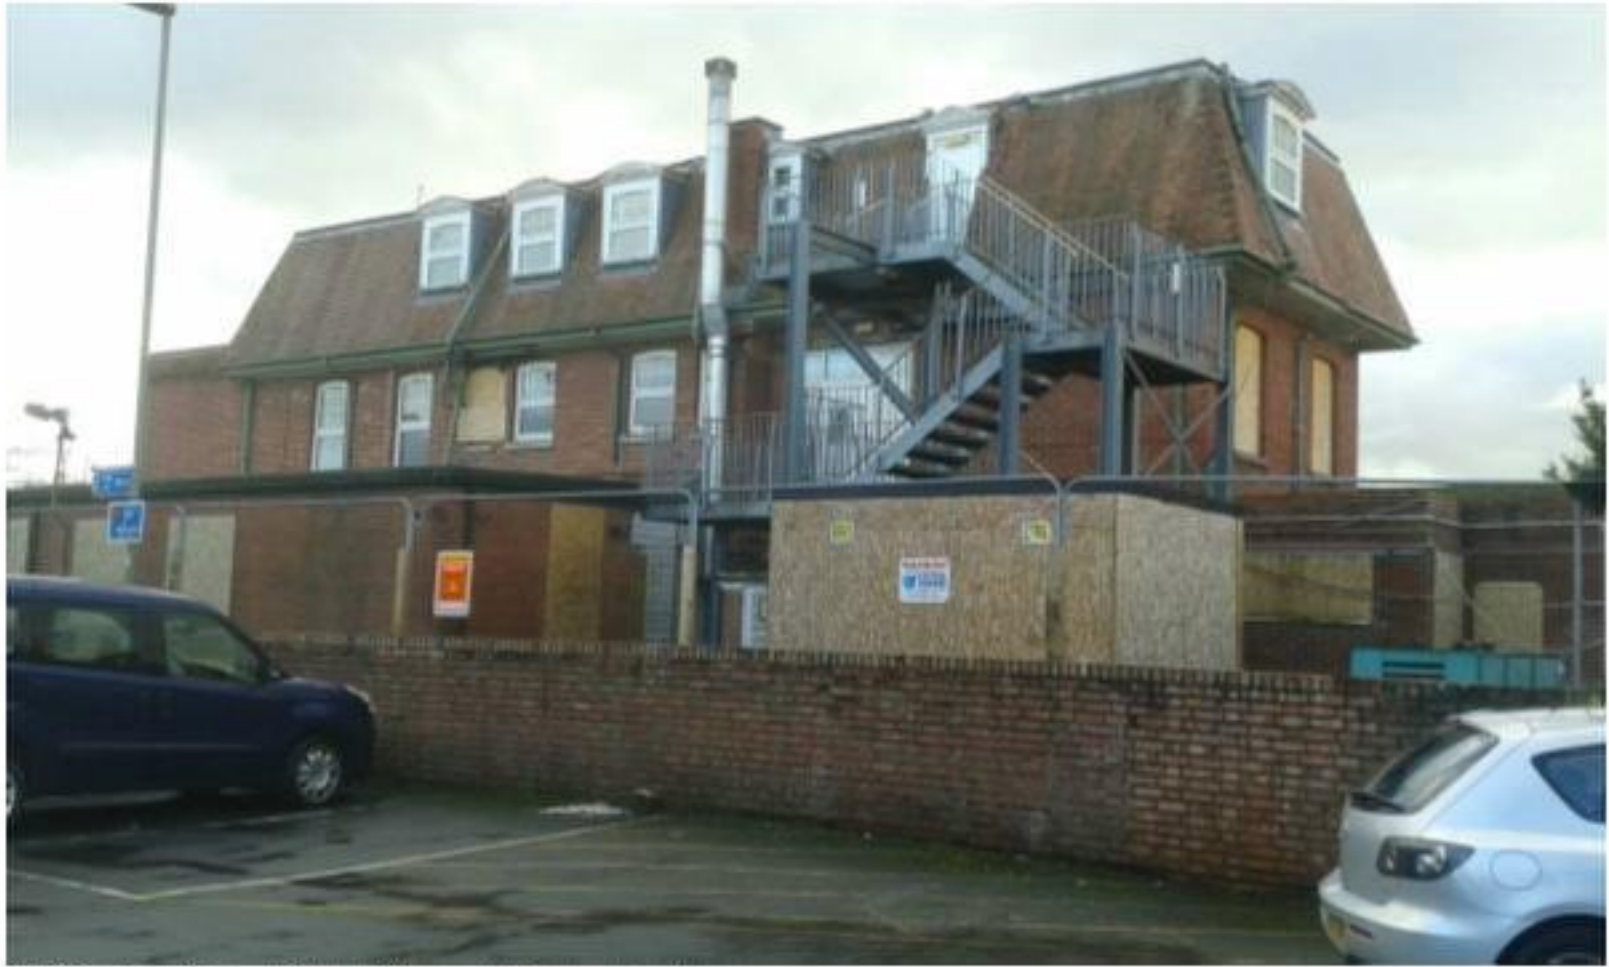
North elevation, viewed from public car park

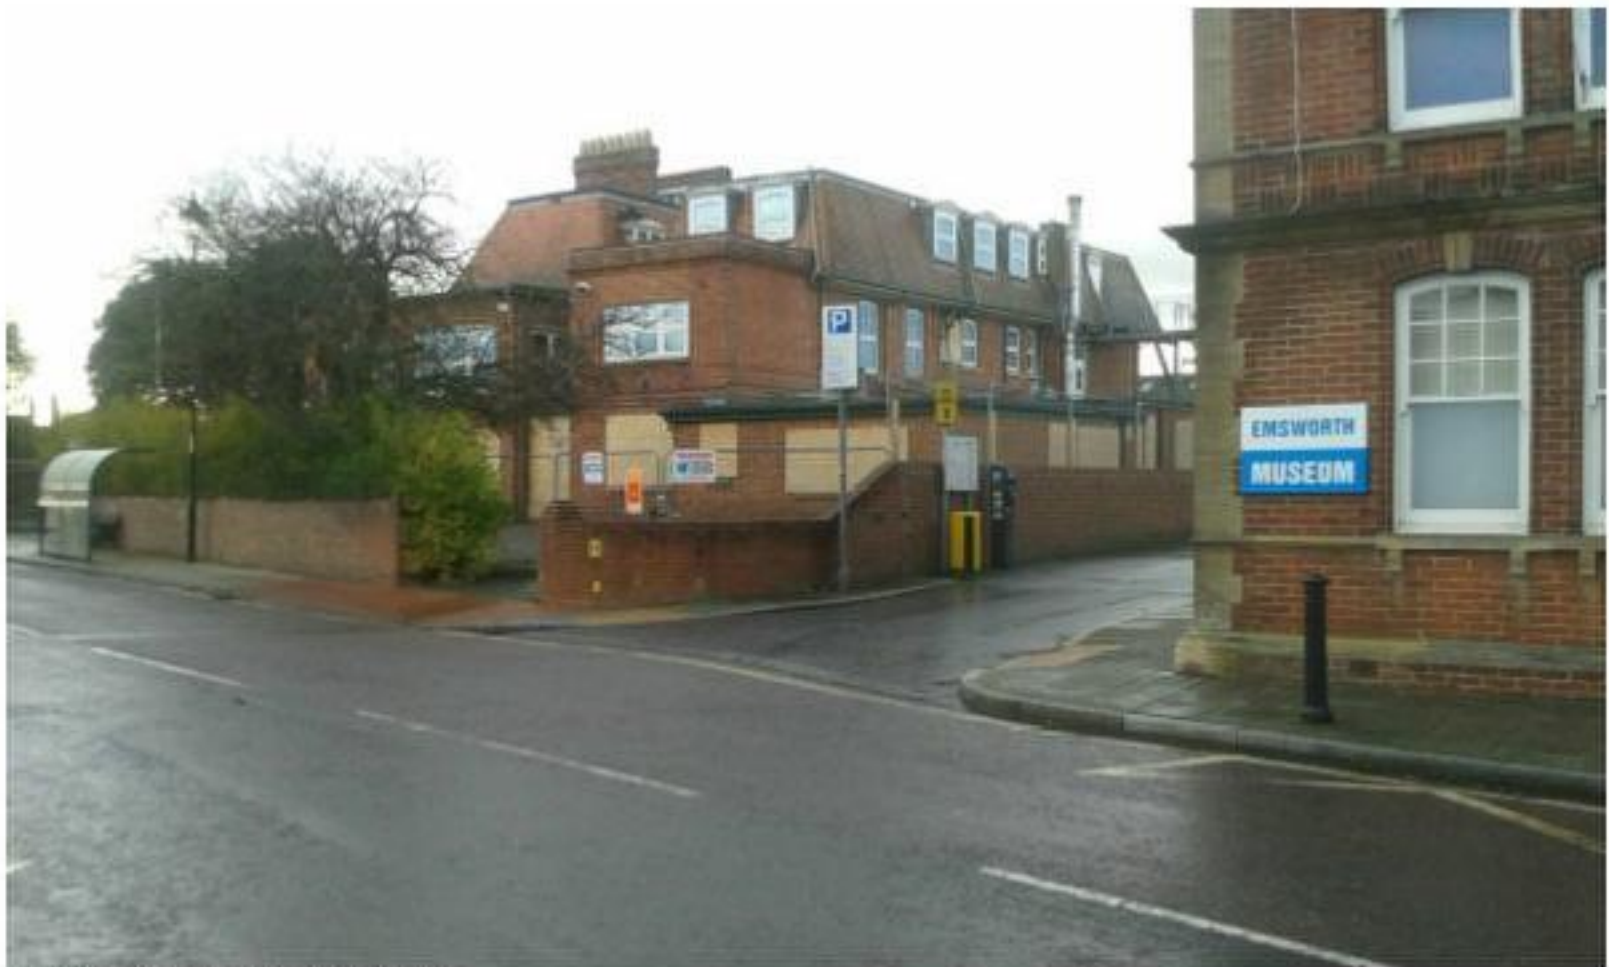
North-east corner of the site

Waste storage will be provided at the north-eastern corner of the site in a new purpose-built enclosure. The existing brick boundary wall in this corner will be built-up (it is currently lower in this area) to match

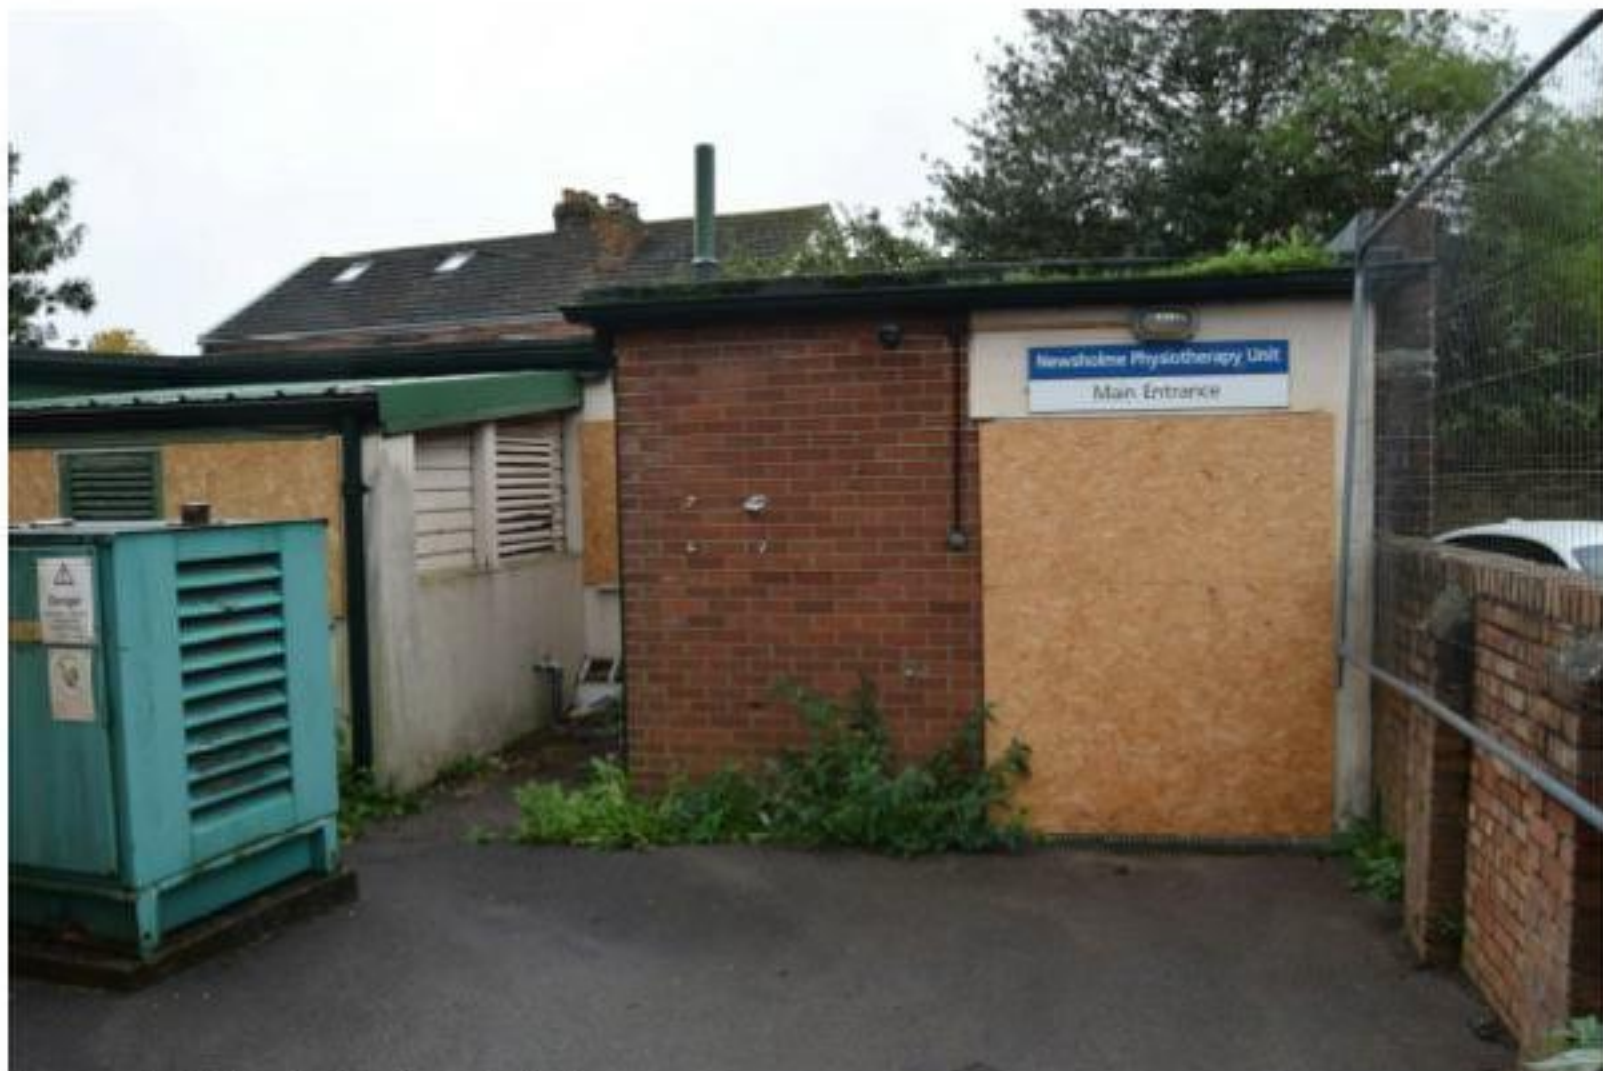
Rear outbuildings (to be demolished)

- Outbuildings to the rear
- External metal staircase
- Existing flat roof coverings and single-storey pitched roof element to the rear
- Internal finishes, doors, M&E services

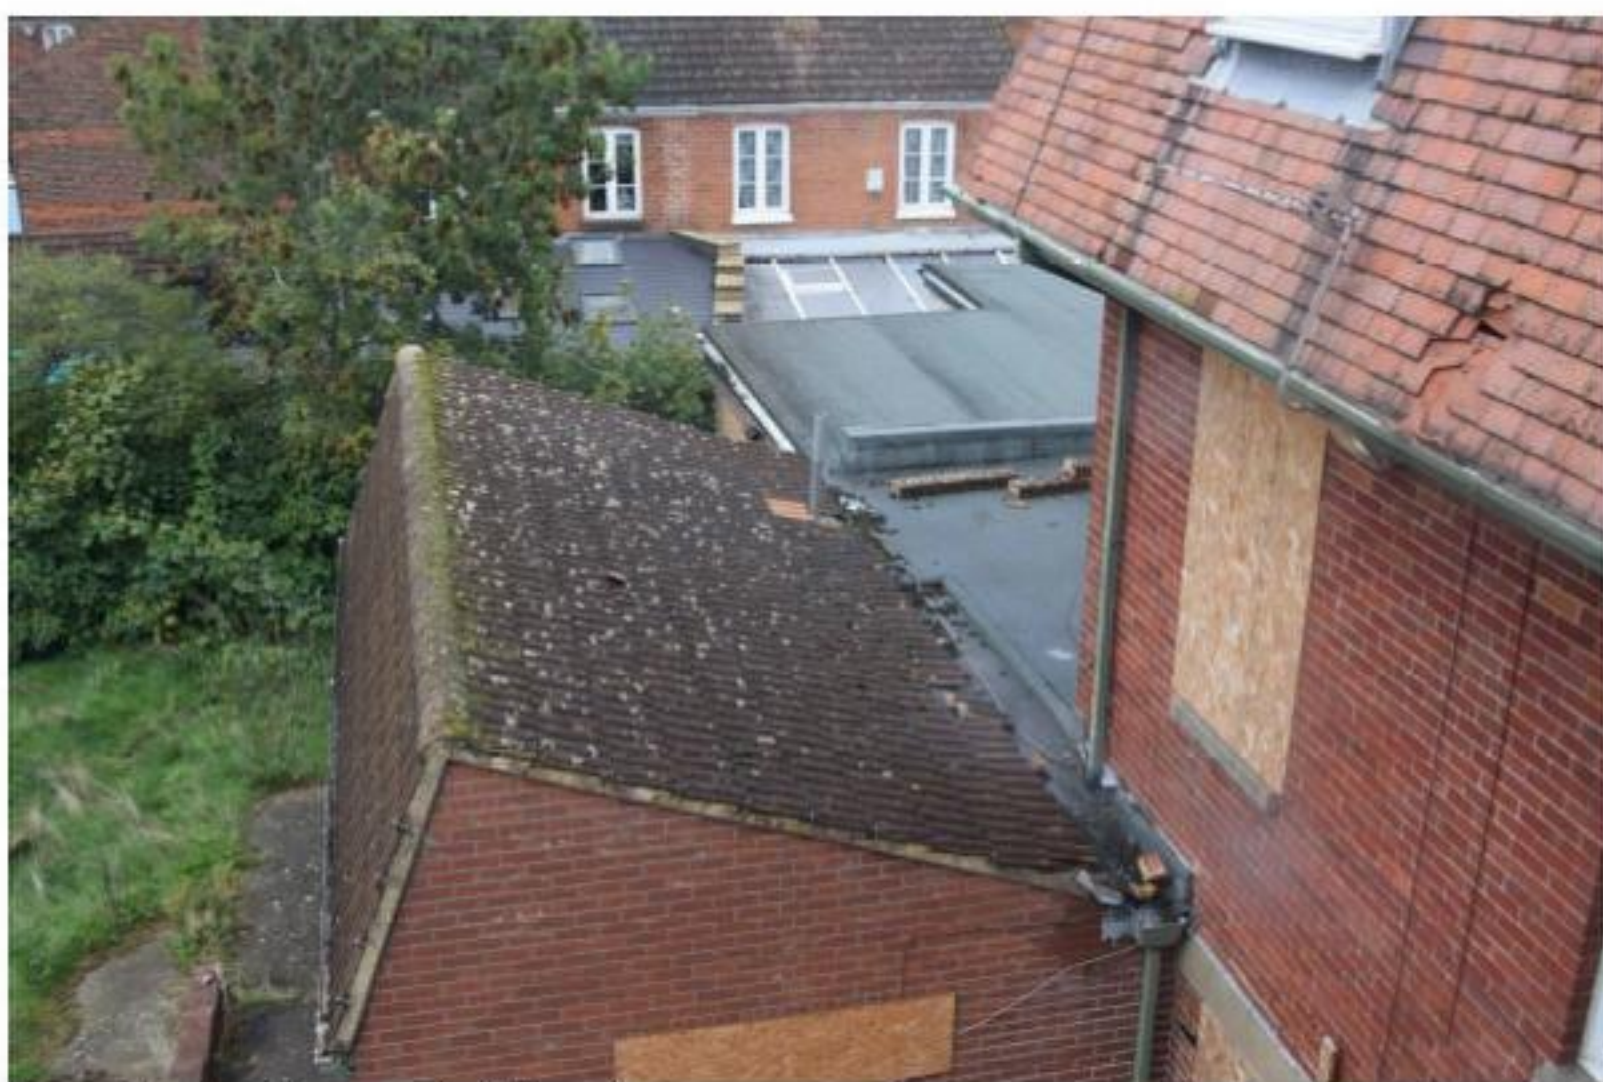
Rear extension with concrete tiled roof

External materials comprise a red brick, white upvc windows, a plain-tiled mansard roof with felt covering on top. A later extension to the rear added some asymmetric roofs with concrete interlocking tiles.

Structural alterations are required internally to suit this layout, and some re-building of the rear single-storey element is required to rationalise roofs. This element and the single-storey element to the north are identified as have the potential to accommodate future expansion at first floor level.
