Proposed industrial development  
Harts Farm Way  
Havant

## Ground Investigation Report

**Proposed industrial development  
off  
Harts Farm Way  
Hampshire  
PO9 1JU**

**GROUND INVESTIGATION REPORT**

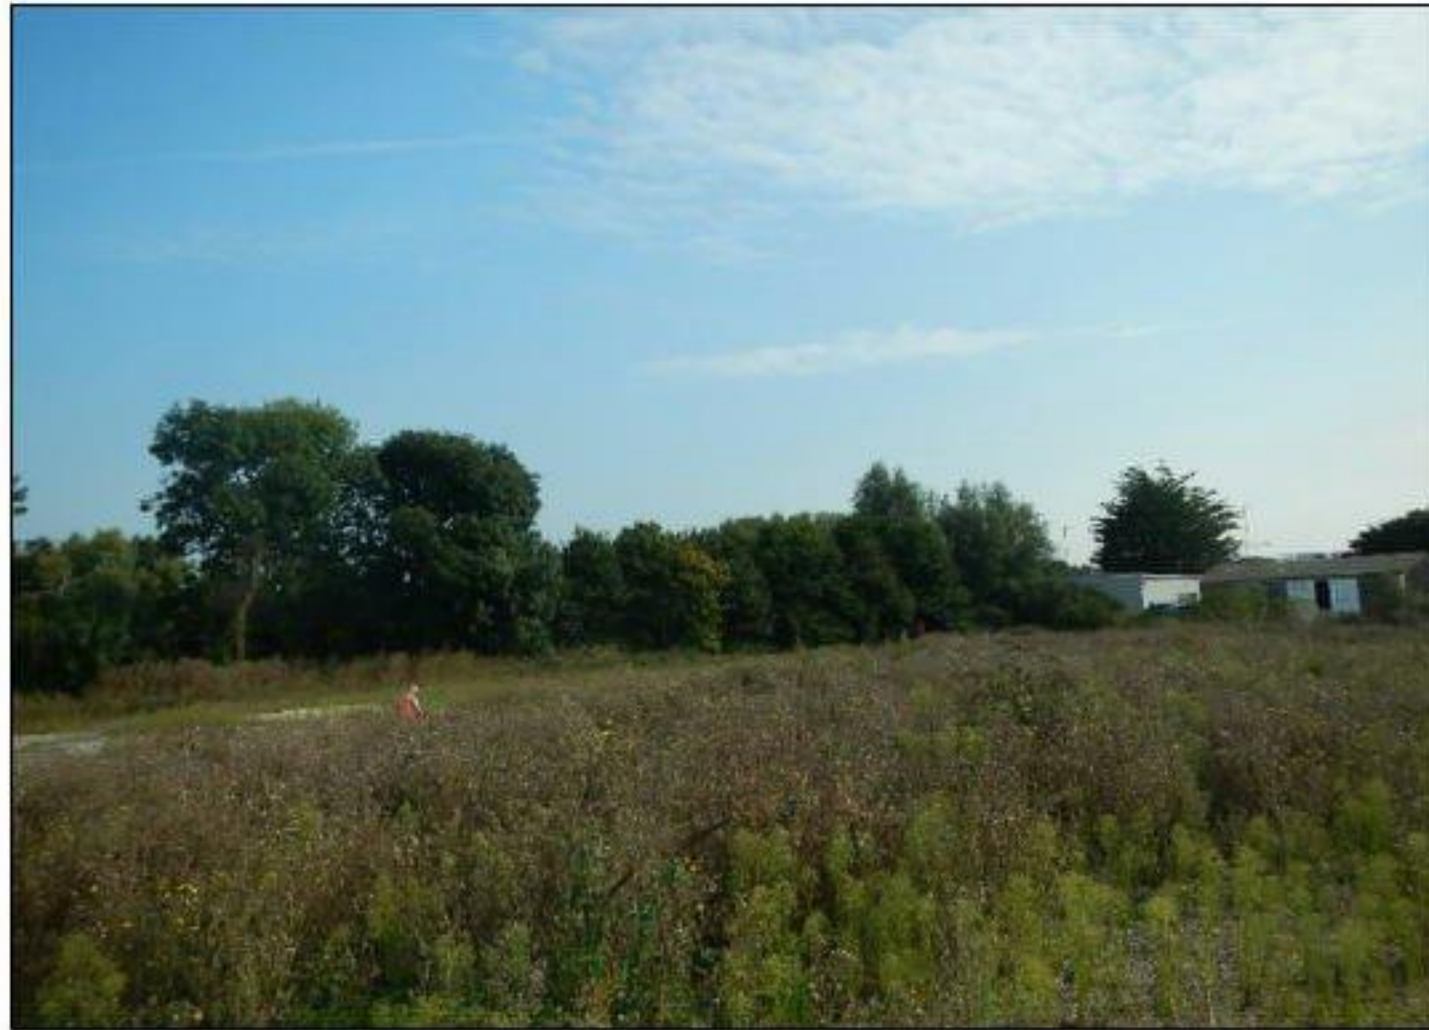
**Photograph 1**

Looking north-east at  
the eastern area  
adjacent to "Plot 4".

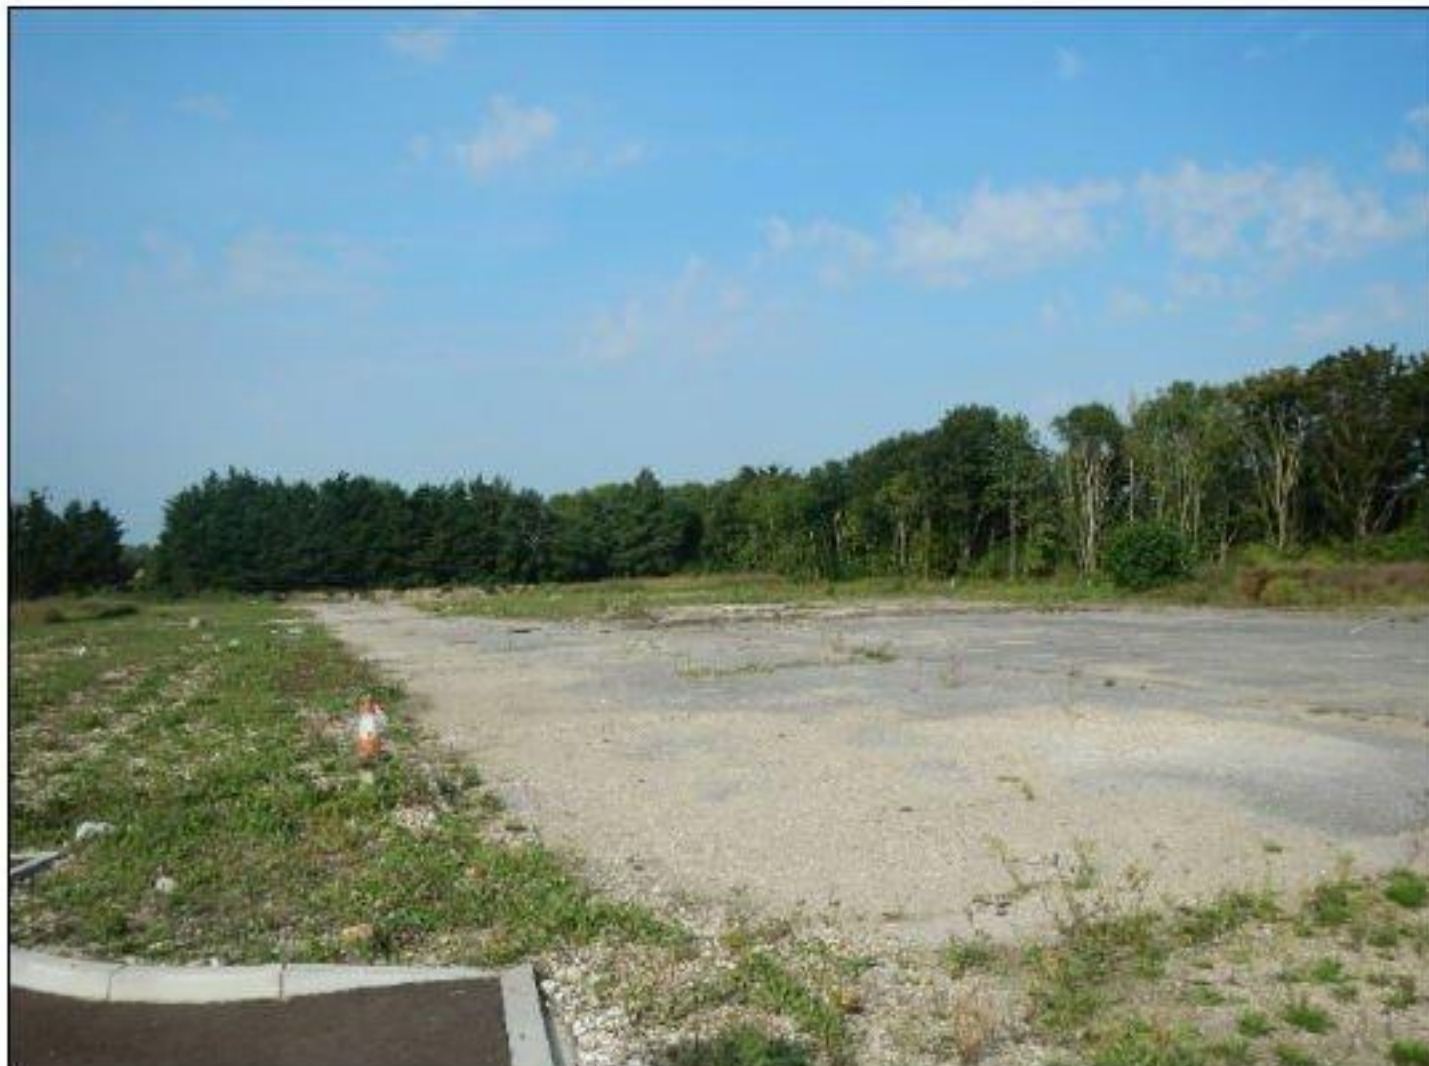
**Photograph 2**

Looking west, with  
"Plot 4" in the  
background.

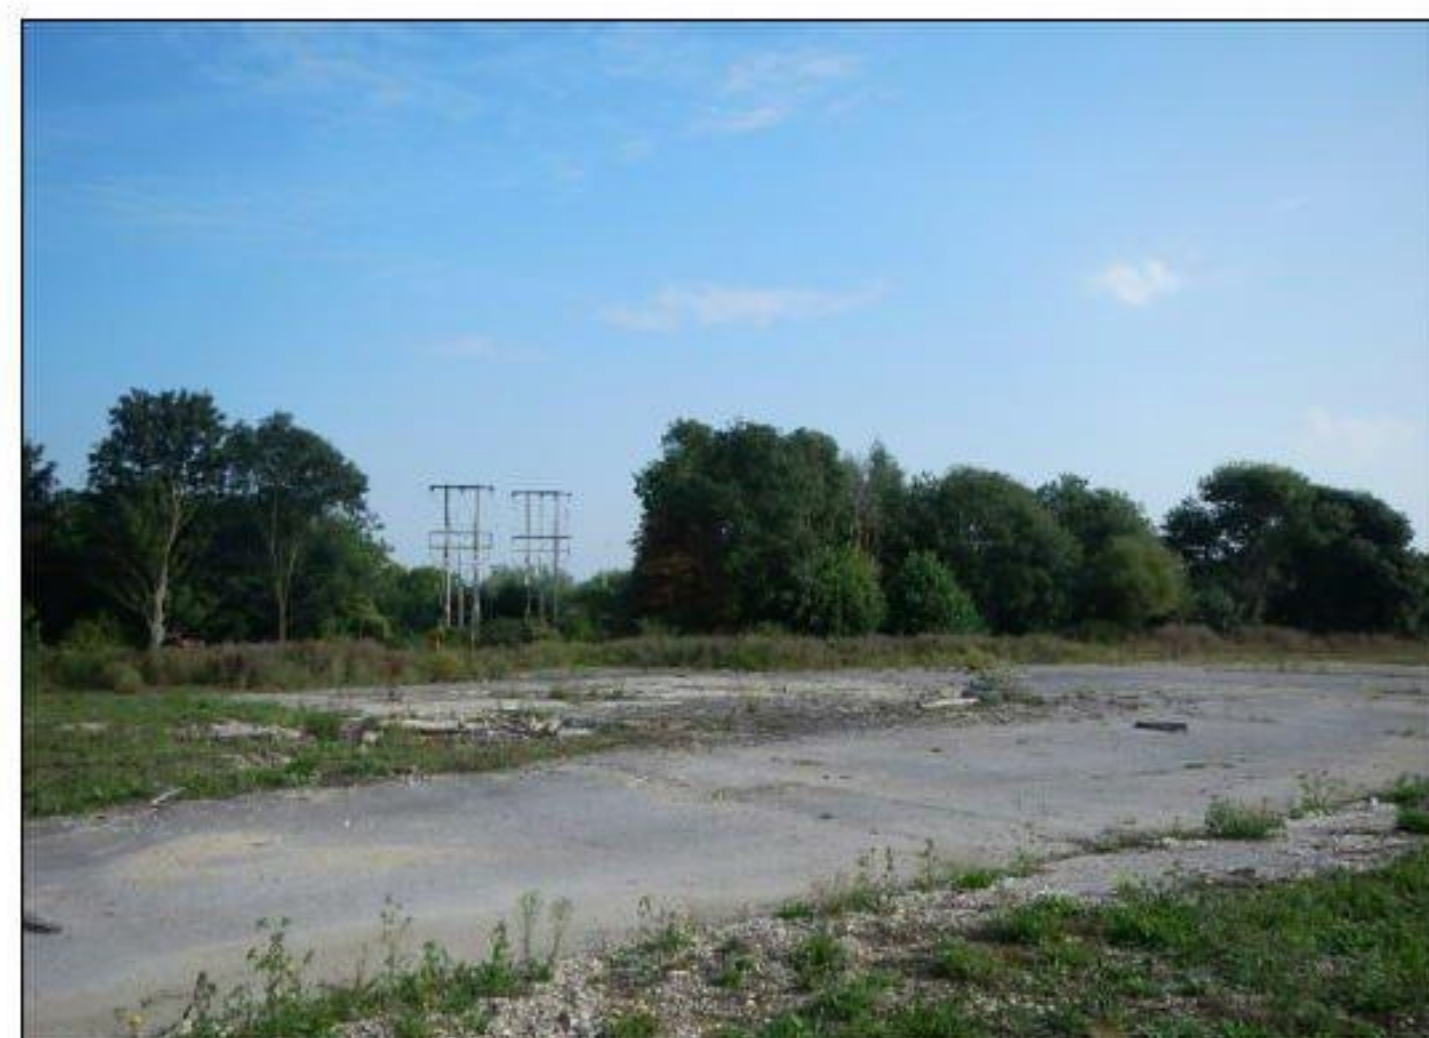
**Photograph 3**

Looking north, overhead  
electricity poles in  
background.

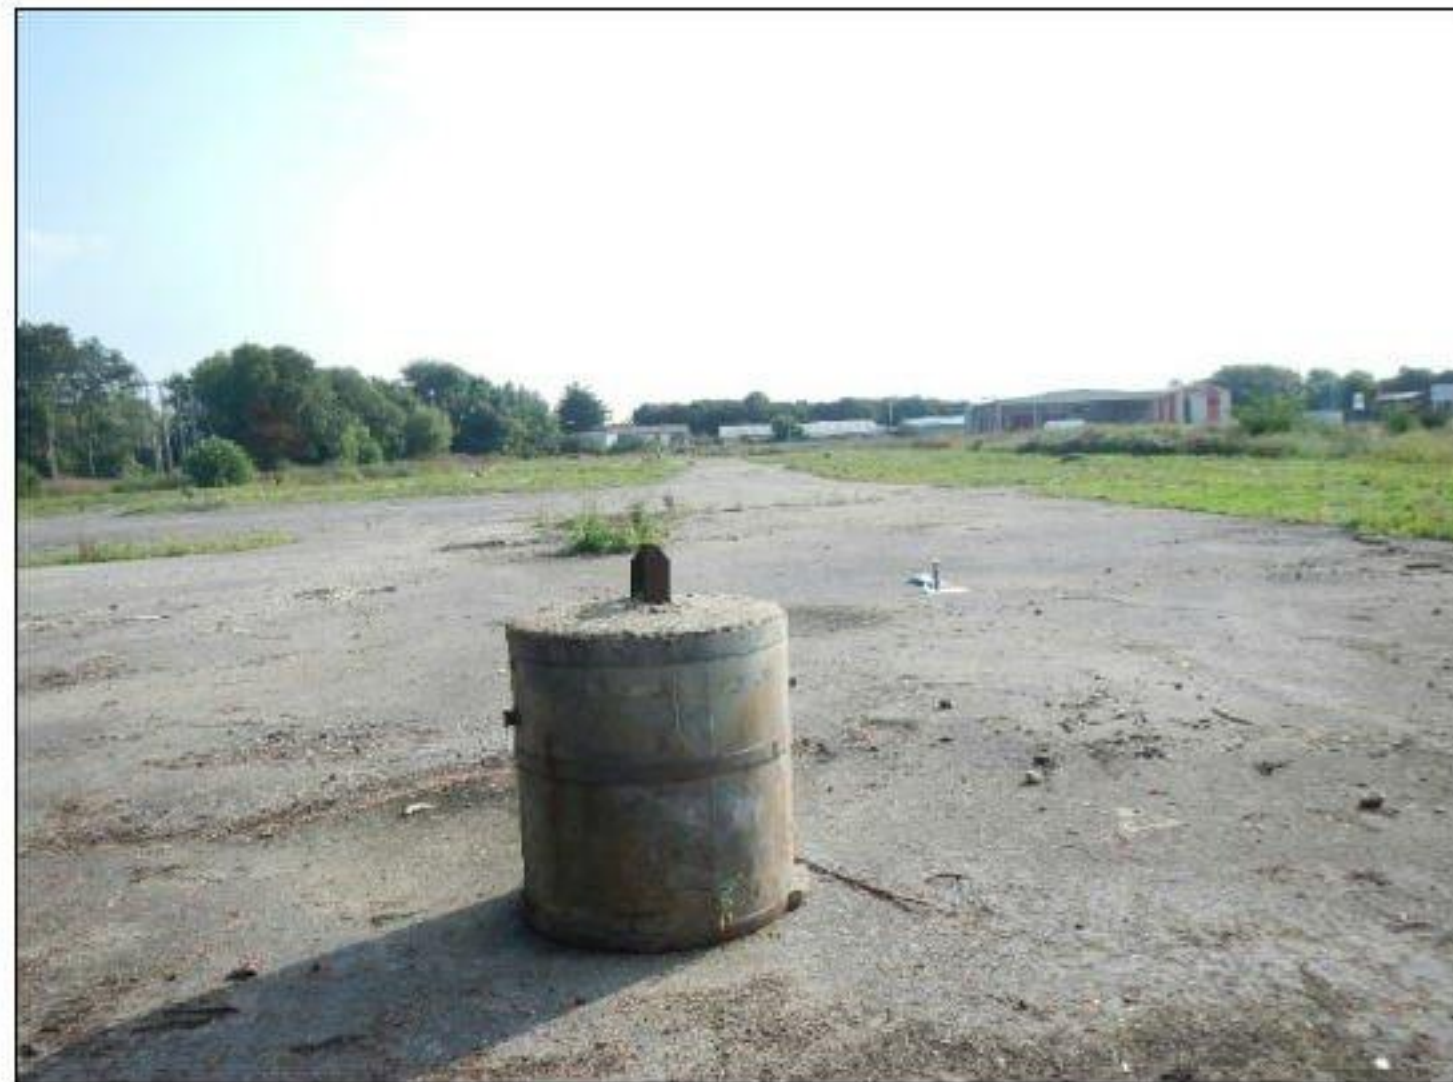
**Photograph 4**

Looking east, across "Plot 4", cylindrical concrete feature in foreground.

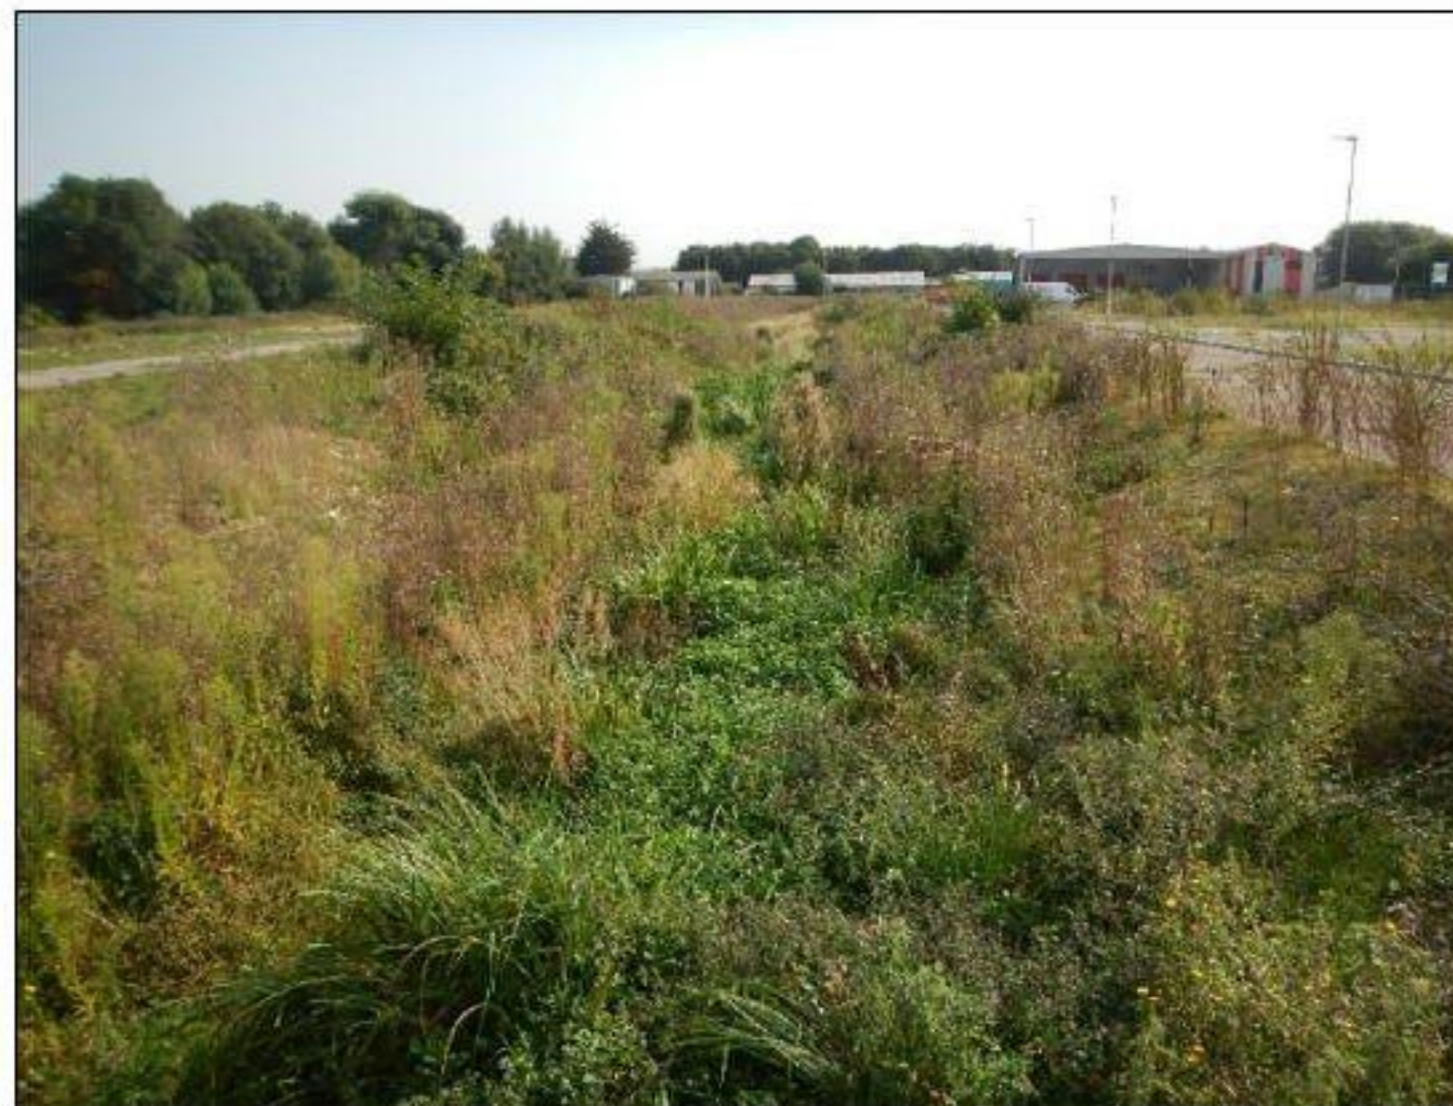
**Photograph 5**

Looking east, along the southern site boundary, showing the newly diverted Brockhampton stream covered in vegetation.

- 3.6.4 In addition, it should be noted that the course of Brockhampton stream has been recently altered as it is presented in Drawing 02. We have considered this as infilled land which extents alongside the southern boundary of the site.

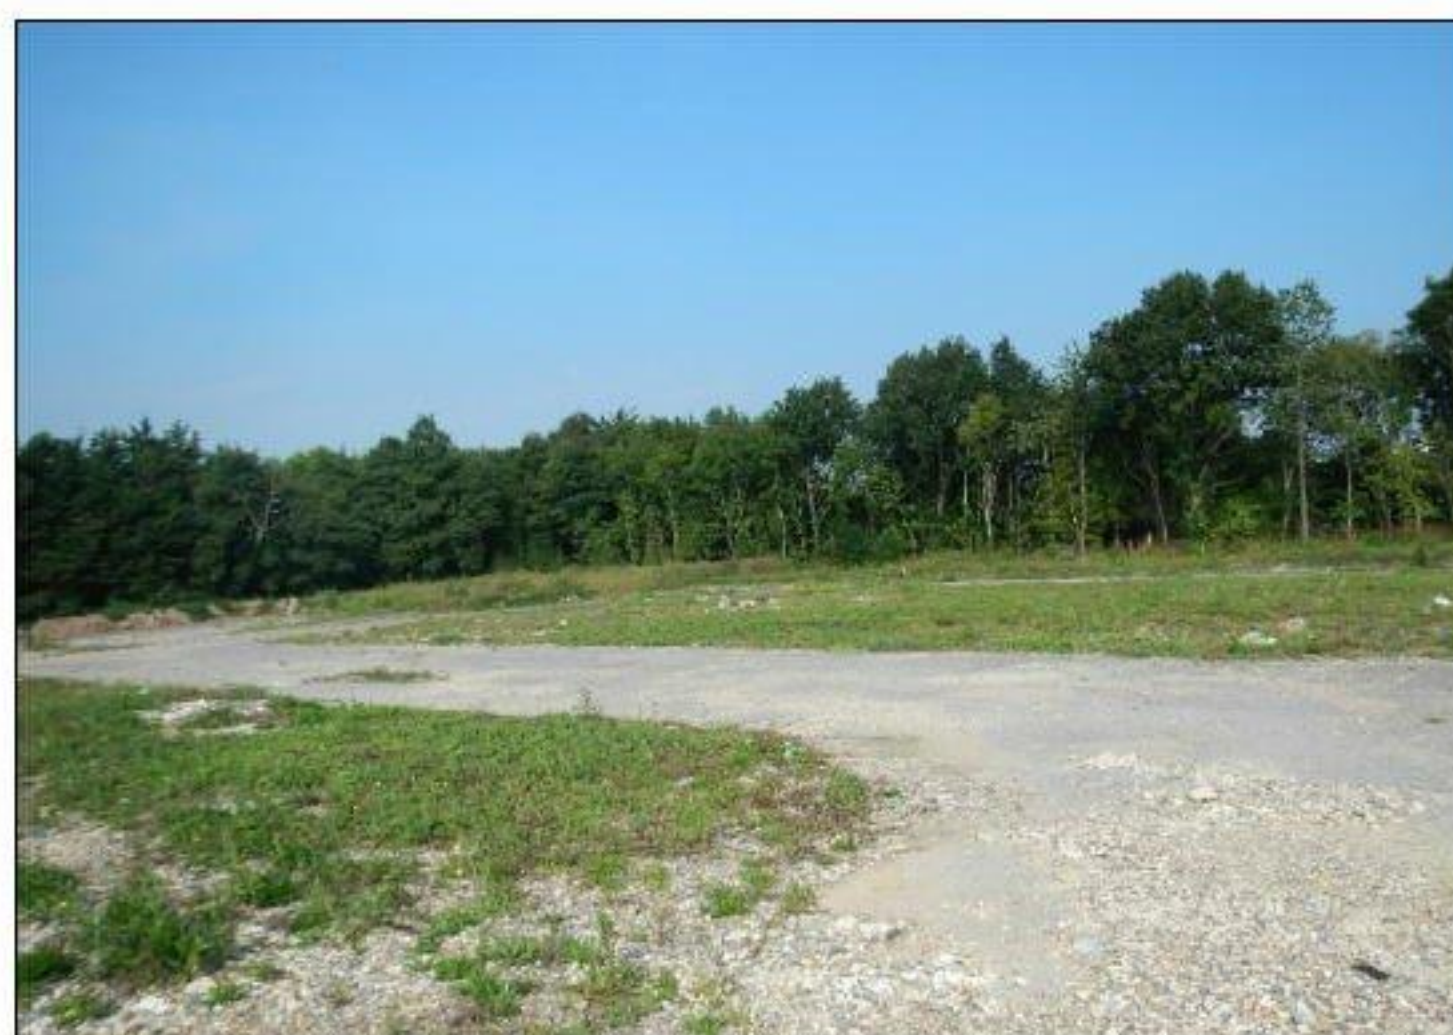
**Photograph 6**

The site looking north-east, across "Plot 4"
