# Design, Access & Heritage Report: Phase V

## Replacement Cottage

59 & 61 Langstone Road, Havant, Hampshire, PO9 1RB

November 2019 Issue

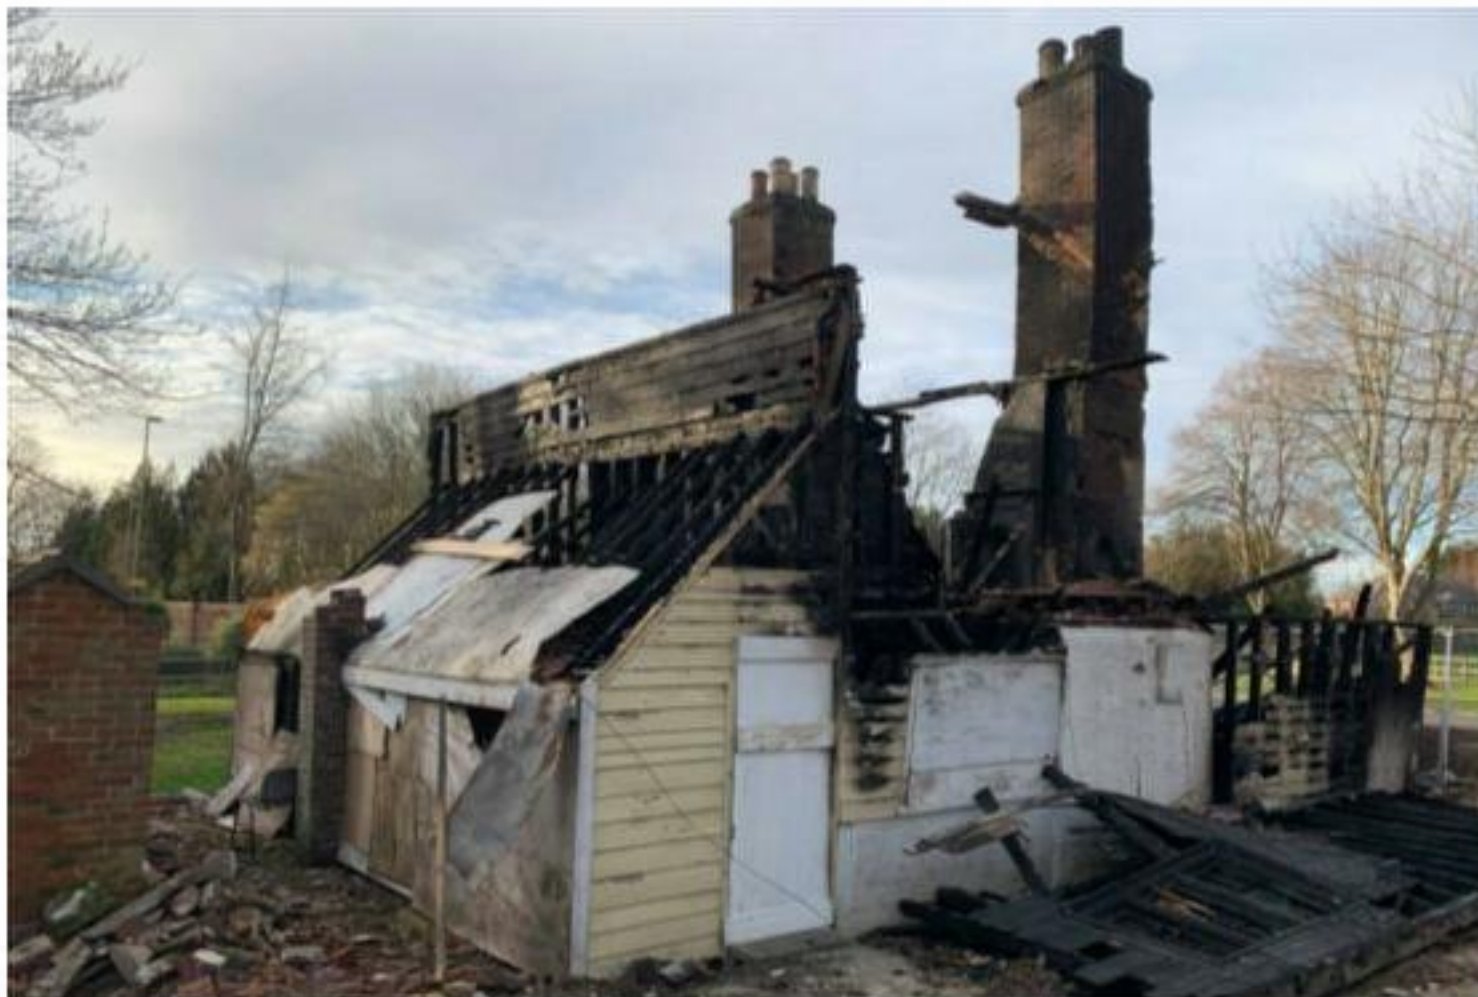
Figure 3: Post-Fire Damage (Jan 2019)

- 5.2 As shown in Figure 3 above, there is very little structure remaining of the Listed cottages. Almost none of the remaining structure is able to be retained. The fire service have confirmed the bricks will not be able to be re-used within the replacement cottage.
- 5.3 Structural scaffolding (Phase I) has been erected to support the chimney stacks, as they were unstable in their post fire condition. See below:

- 5.1 The Listed cottages were significantly damaged in the devastating fire in December 2018. See below:

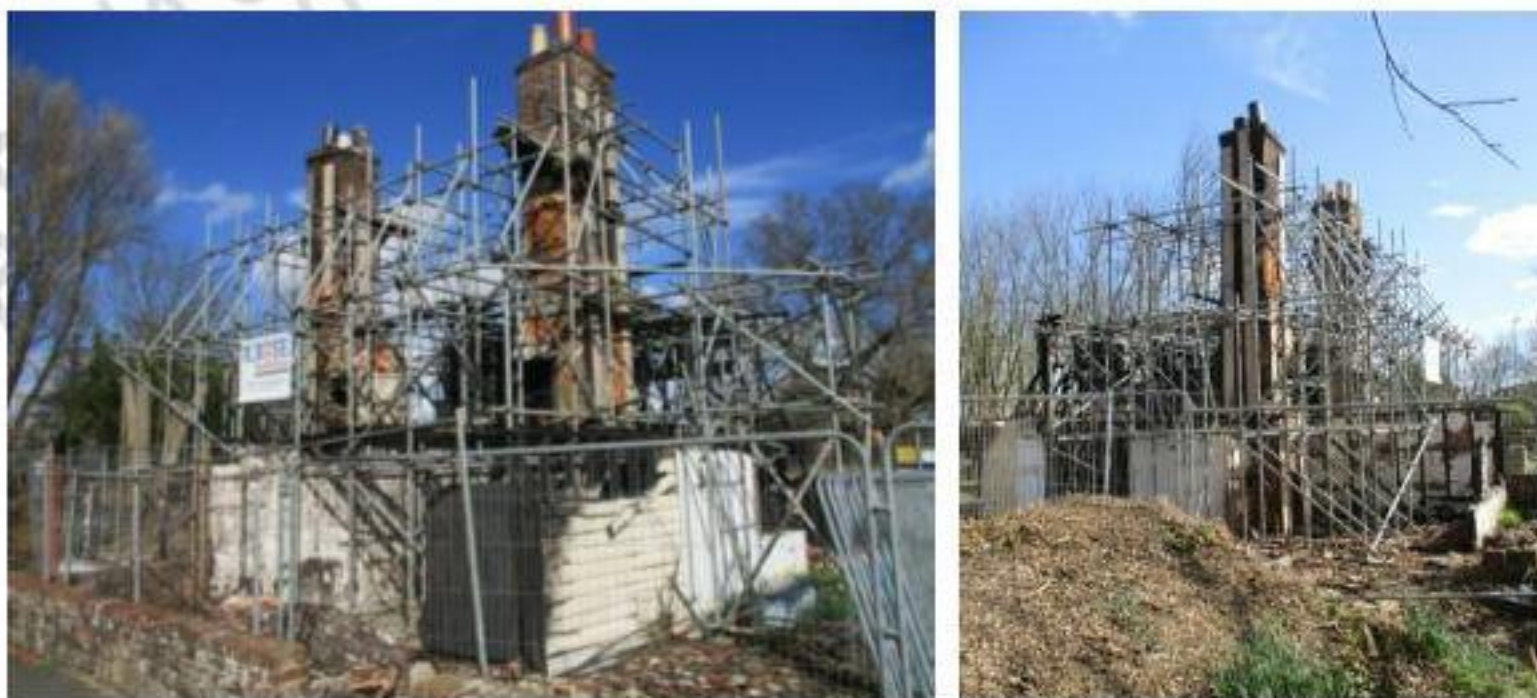
Figure 4 & 5 : Structural Scaffolding (March 2019)

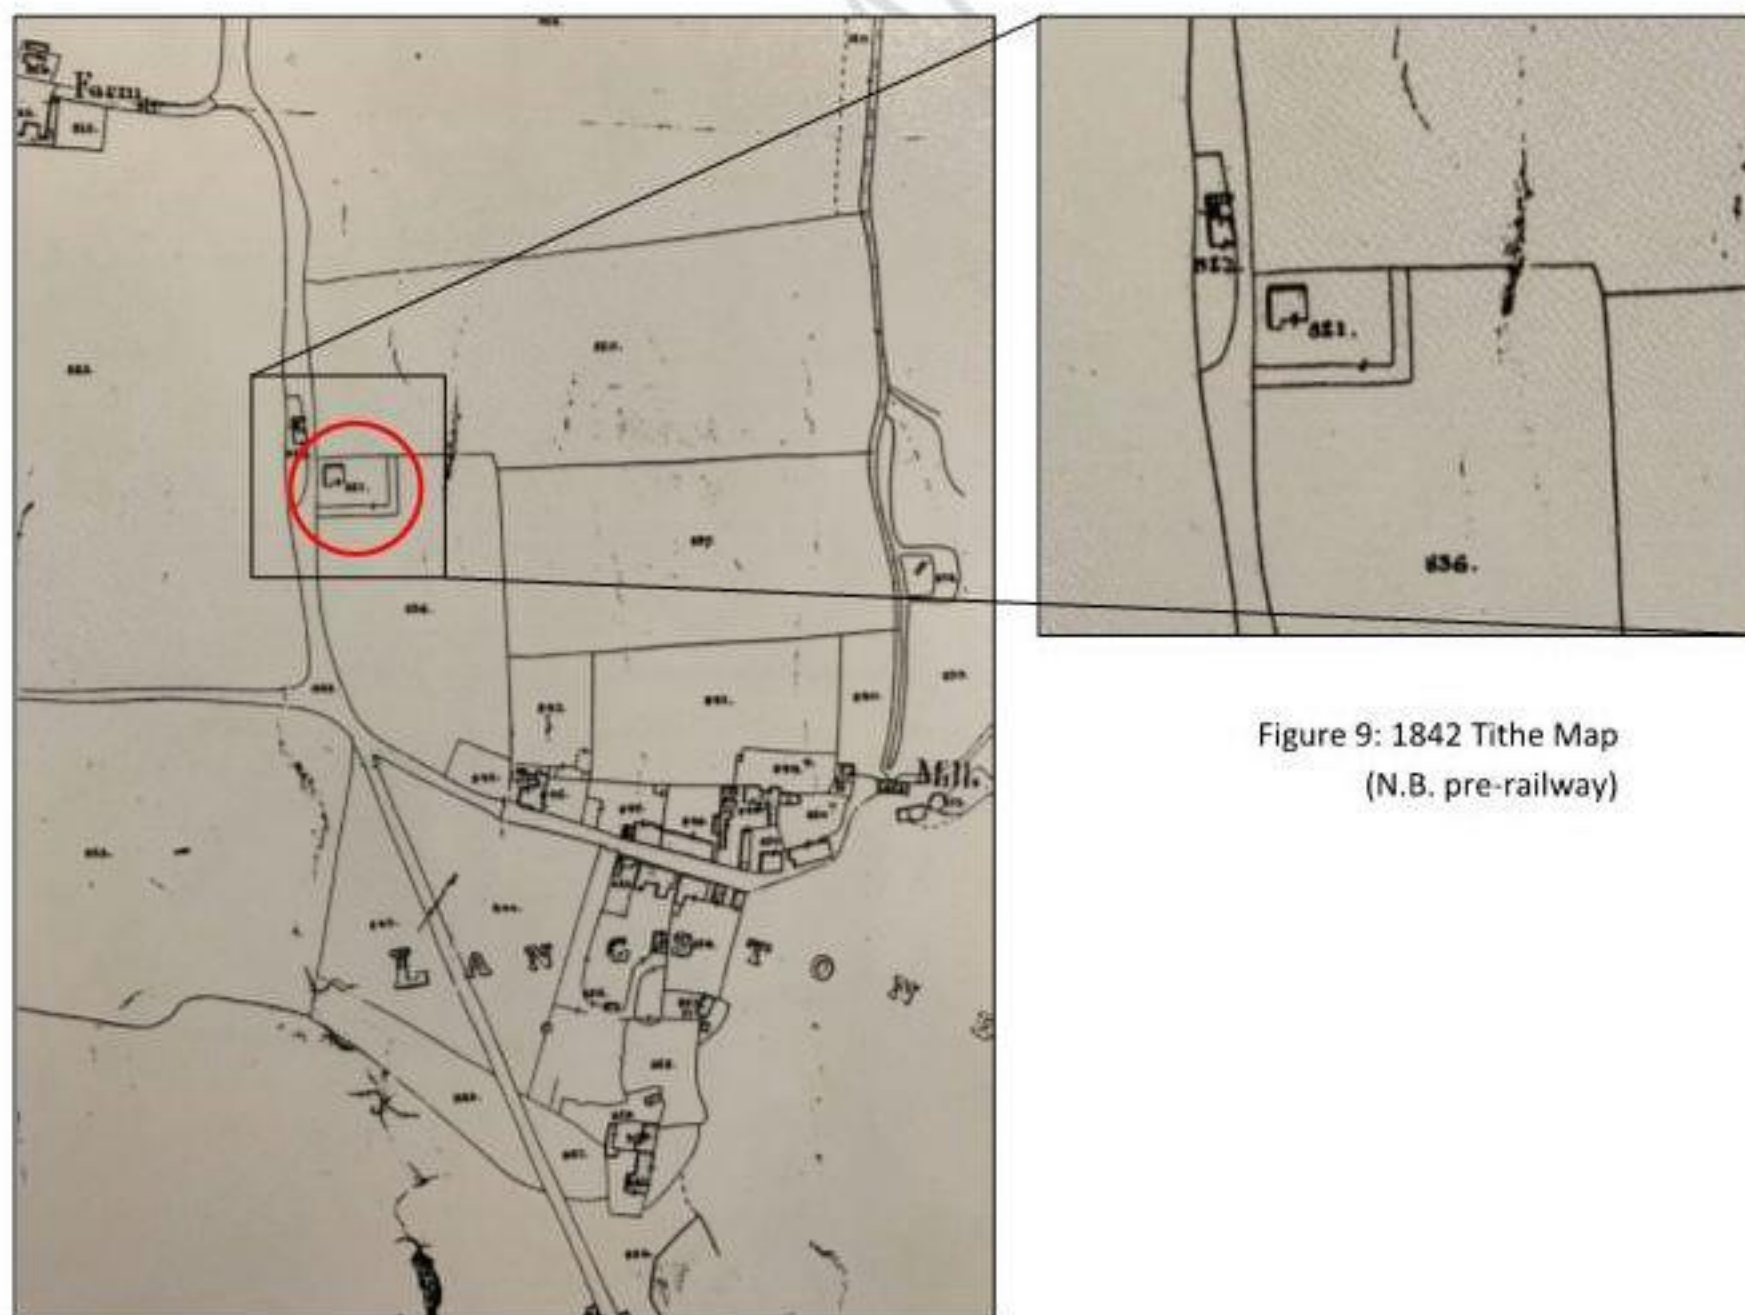
Figure 9: 1842 Tithe Map  
(N.B. pre-railway)

- 6.8 Figure 9 above shows the subject site as Field parcel number 821. This shows the subject building in more detail, with features (such as the southern porch) that can be related to what you could see in November 2018, prior to the destructing fire.
- 6.9 As explained in 5.8 above, the written Schedule that accompanies the map lists the details of the site at the time. The ownership details are as follows:

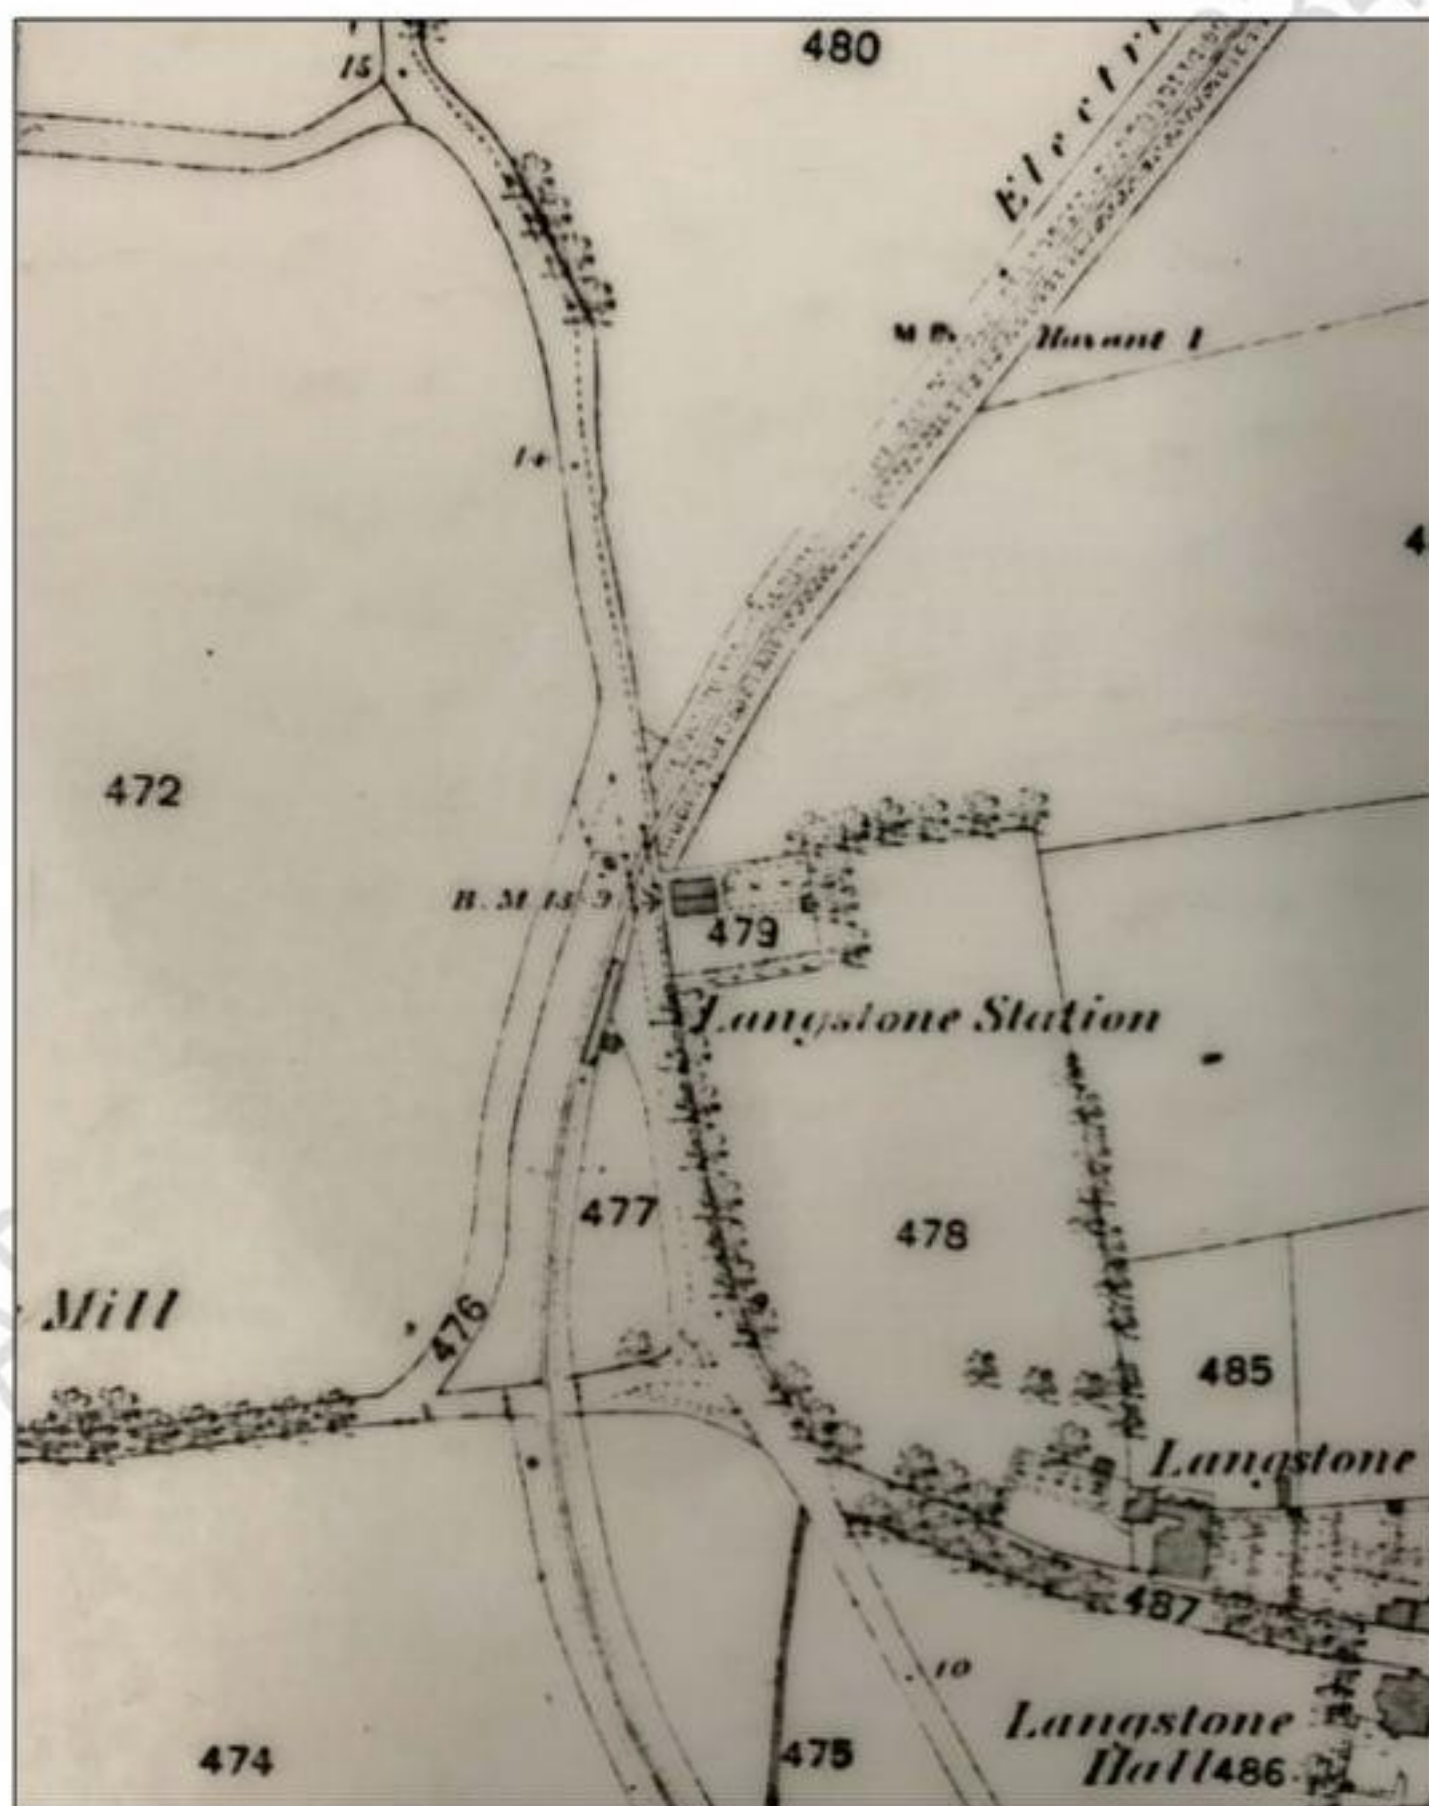
Figure 12: 1873 Map of Langstone Halt/Station

- 6.13 As shown in Figure 12, the subject site and cottages are labelled as Field parcel number 479. The Hayling Railway sits tightly to the northern boundary of the subject site. The lines drawn on Langstone Road to the west indicate the Langstone level crossing (which was actually unauthorised for the entirety of its use until the railway closed in 1963 (Cousins, 2017)). 'Langston' Halt/Station. Ralph Cousins (2017) describes the crossing:

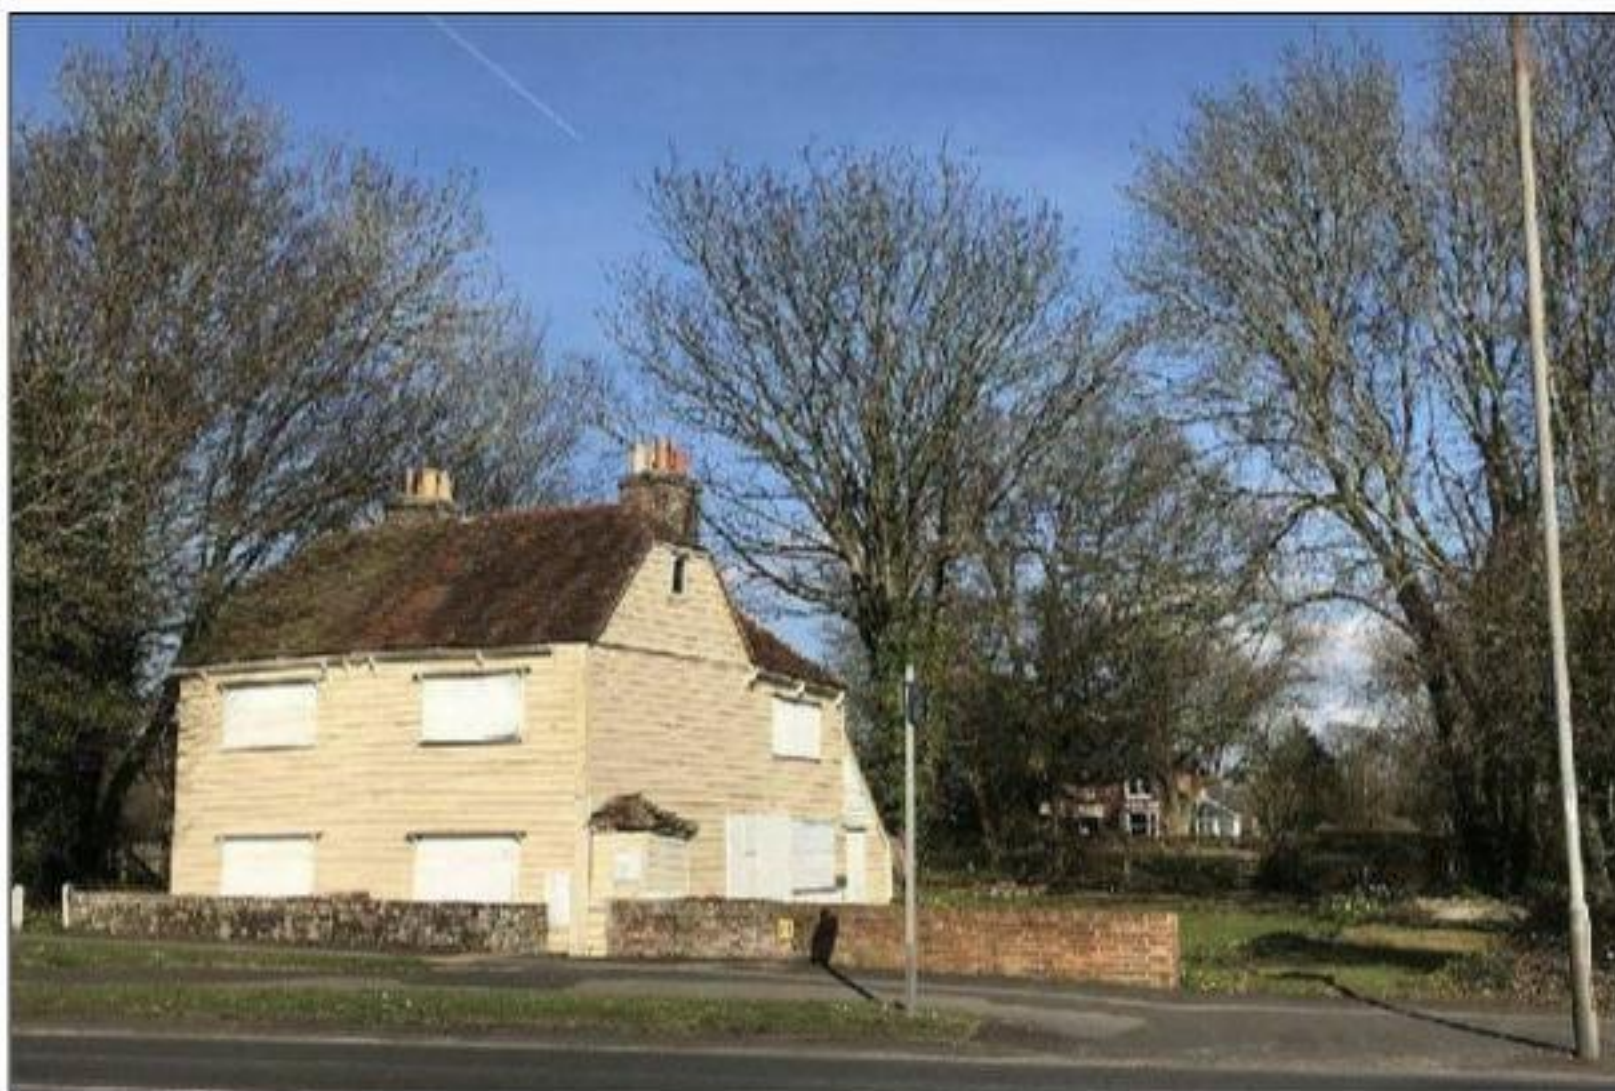
Figure 20: 59 & 61 Langstone Road. Vacant with boarded up windows. (The News, 2019)

- 6.16 59 & 61 Langstone Road fell in to disrepair in prior to 2000, with pressing need for upkeep and maintenance. In approximately 2015/2016 the cottages became empty and the windows were later boarded up. See figure 20 below:

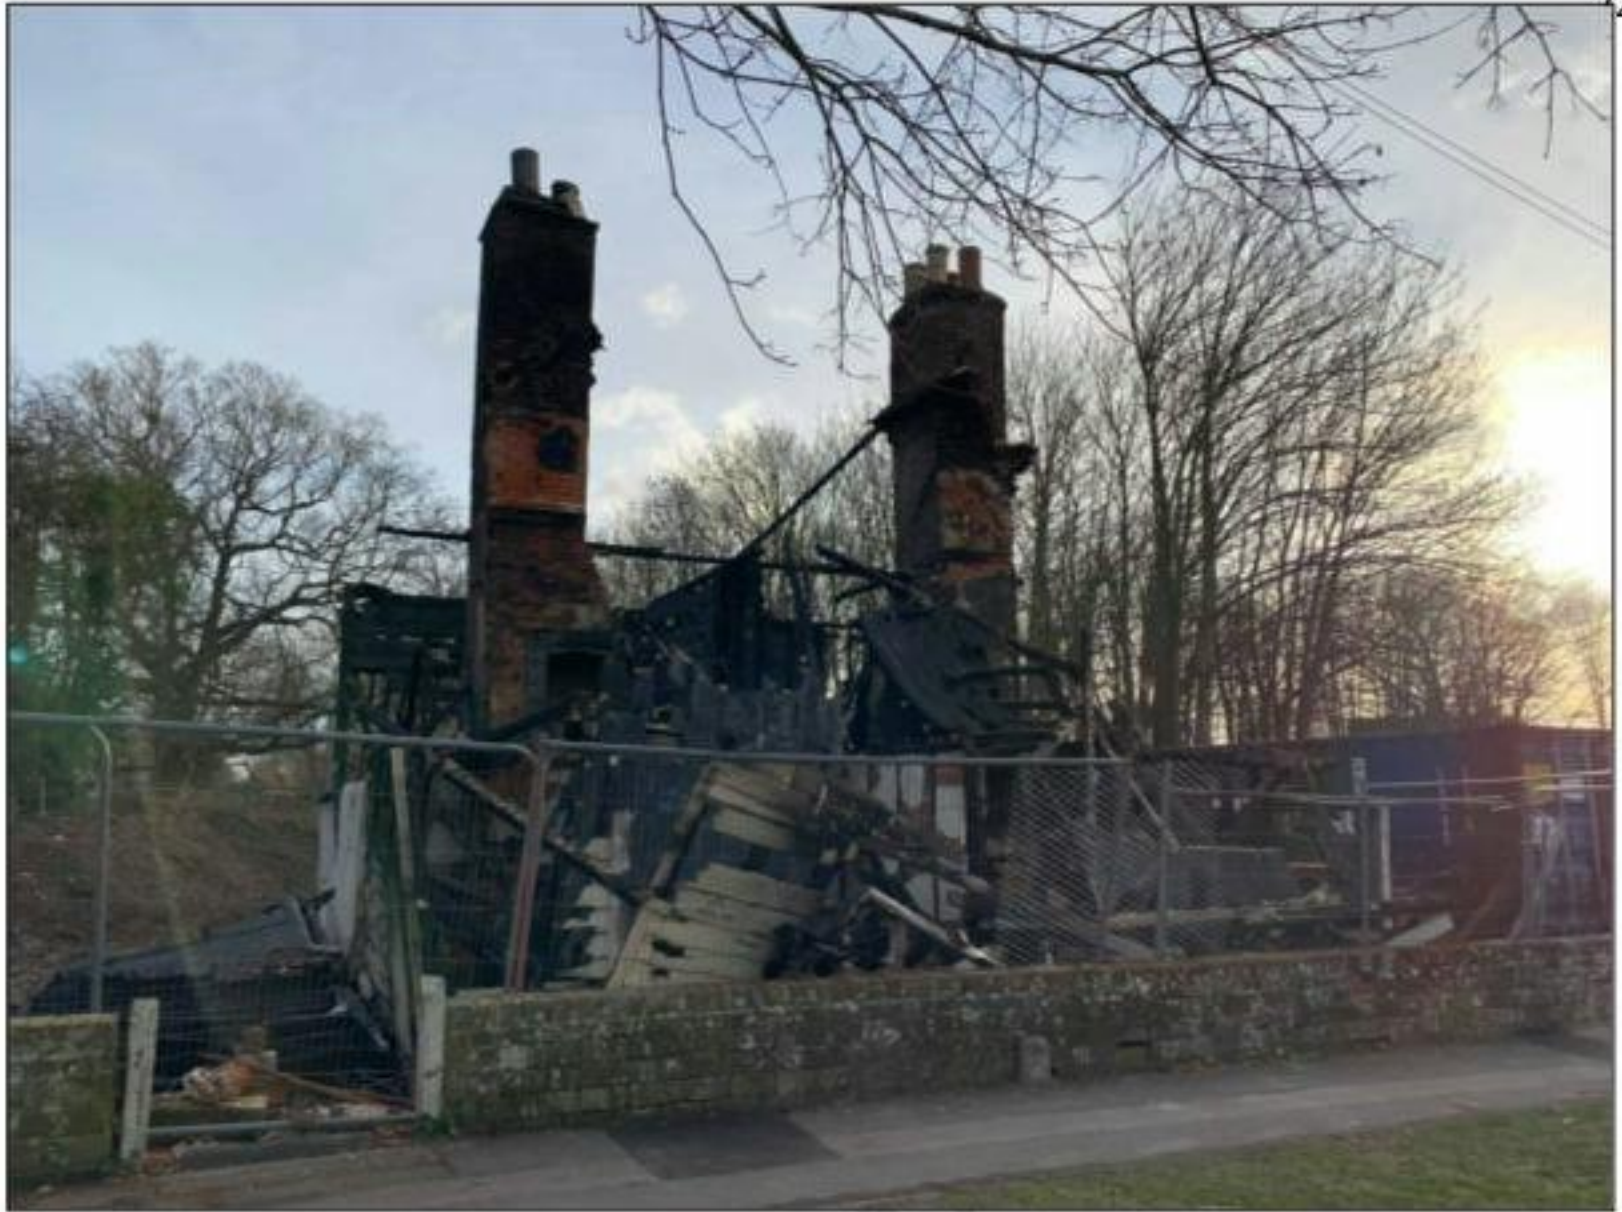
Figure 22: The cottages after the devastating fire (Jan, 2019)

- 6.23 Critchley Architecture And Design Ltd were appointed in January 2019 to manage the surveying, Planning and re-building of the cottages, which were completely destroyed. See figure 22-24 below:

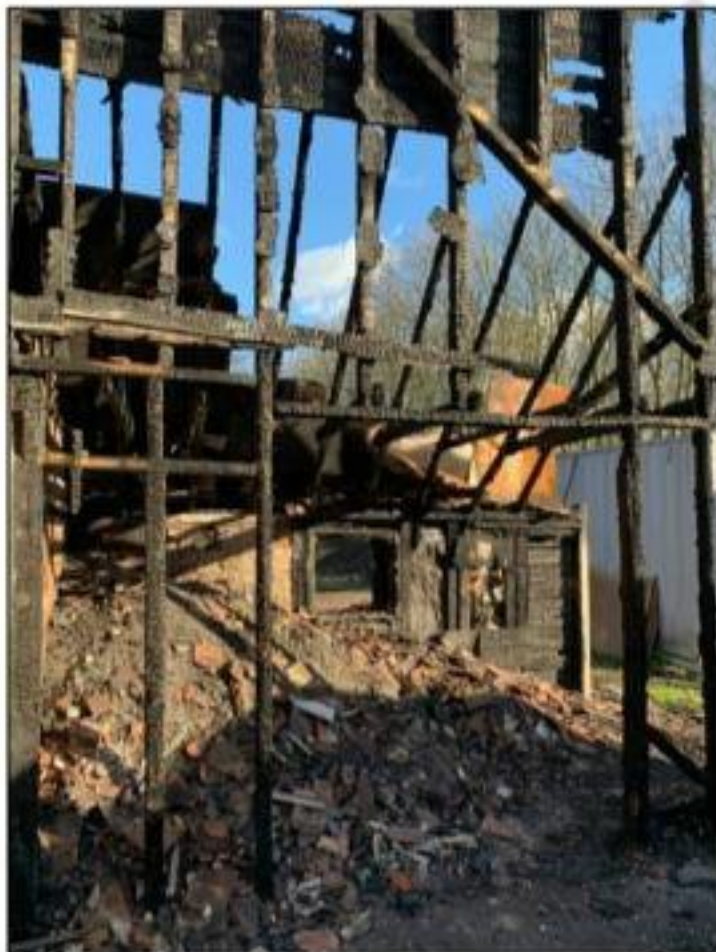
Figure 23: The cottages after the devastating fire (Jan, 2019)

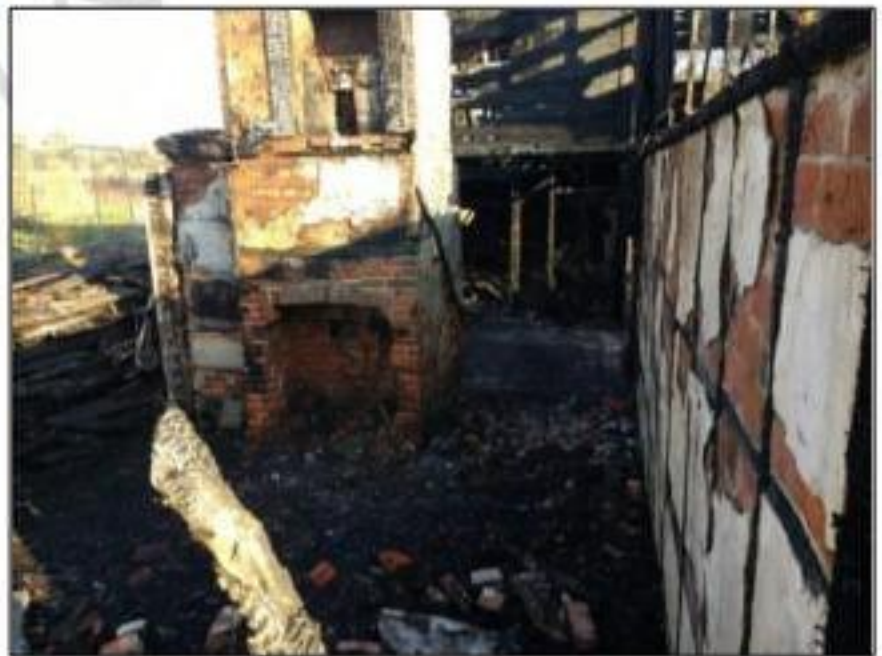
Figure 24: The cottages after the devastating fire (Jan, 2019)
