## **Arboricultural Method Statement**

### **Premier Inn Hotels**

Premier Inn Portsmouth (Havant),  
65 Bedhampton Hill,  
Havant,  
PO9 3JN.

22 October 2024

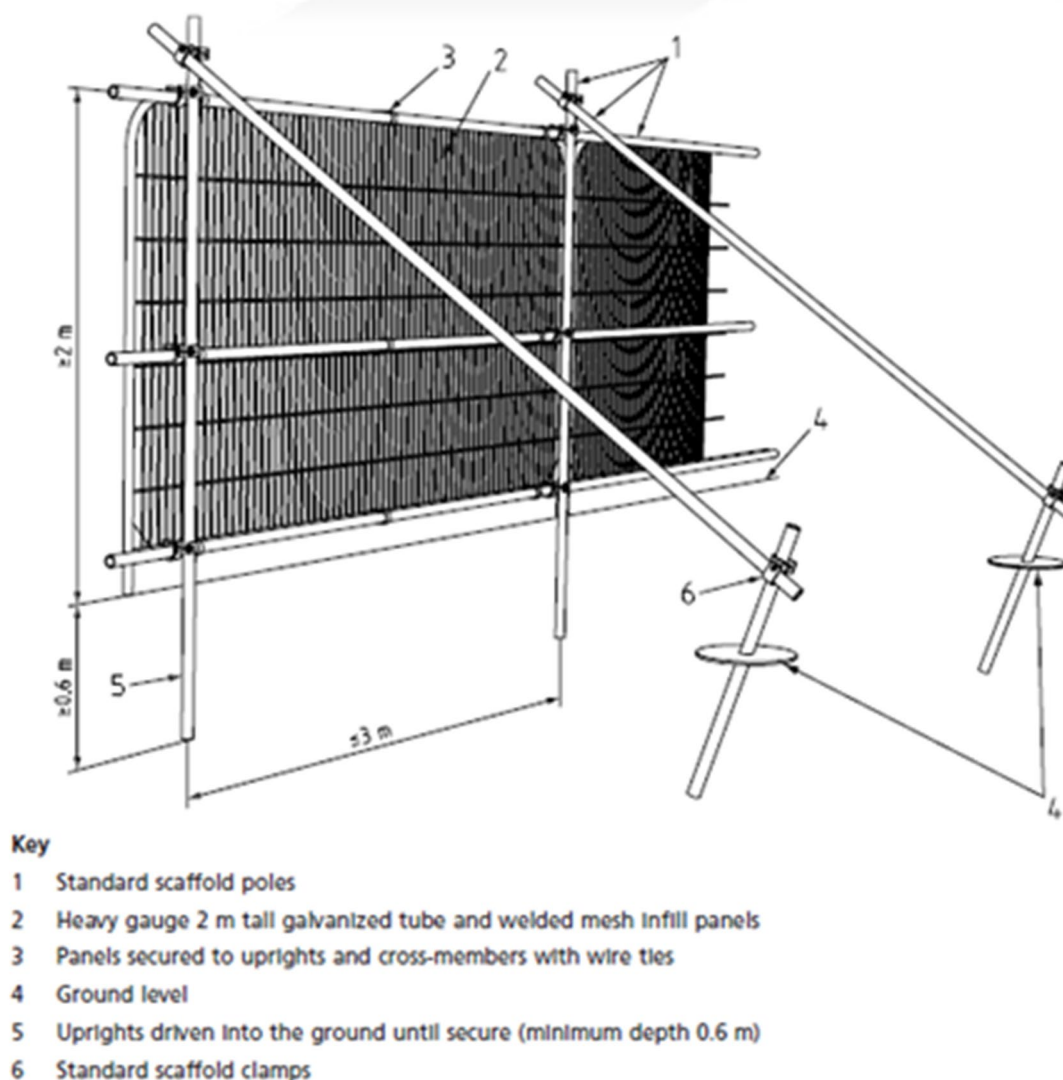
Figure 2: BS5837:2012 - Figure 2, Default specification for protective barriers.

Default specification: To comprise either 2.4m wooden site hoarding; or a 2.3m high scaffold framework, well braced to resist impacts, with uprights to be spaced at a maximum of 3.0m intervals and driven into the ground by a minimum of 600mm. On to this, standard anti-climb welded mesh panels are to be securely fixed to each other with at least two scaffold clamps and to the scaffold frame work with wire.

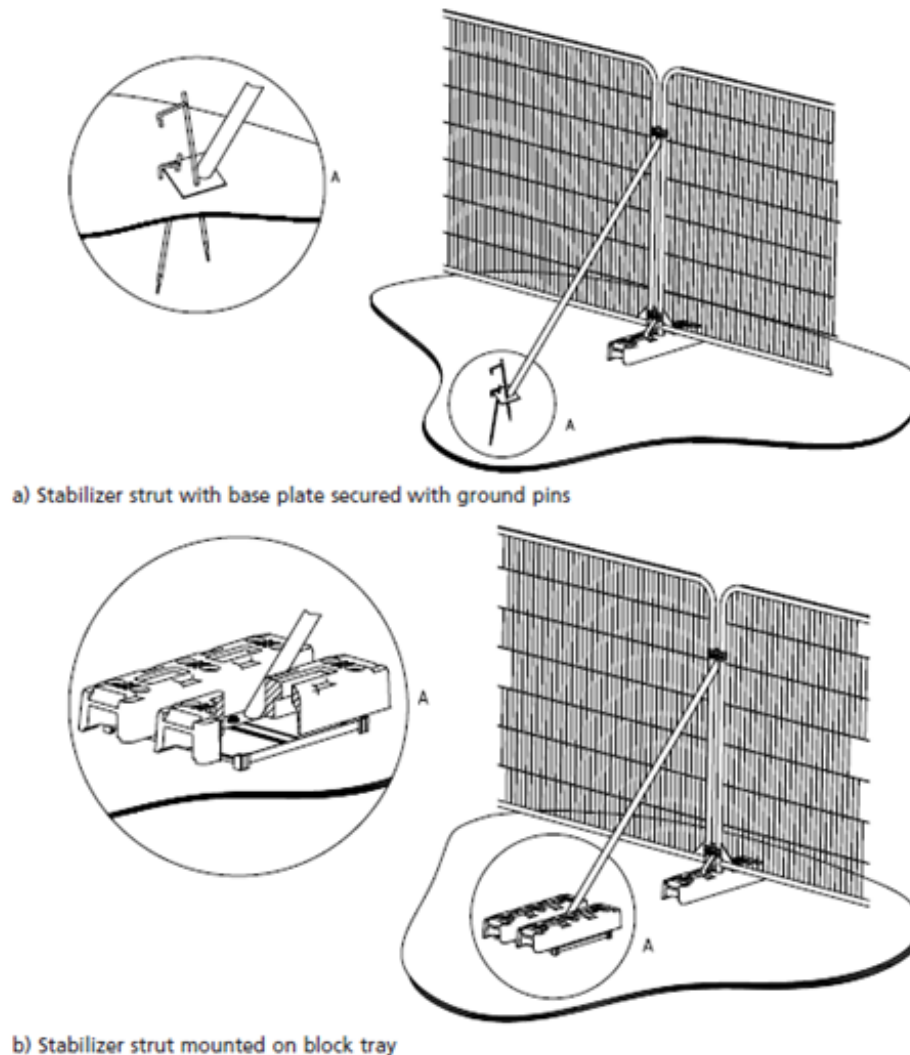
Figure 3: BS5837:2012 - Figure 3, Examples of above-ground stabilising systems.

**Secondary specification:** To comprise of 2m tall, welded mesh panels on rubber or concrete feet. Panels are to be joined together using a minimum of two anti-tamper couplers, installed so that they can only be removed from inside the fence. The panels should be supported on the inner side by stabiliser struts, which should be attached to a base plate and secured with ground pins.

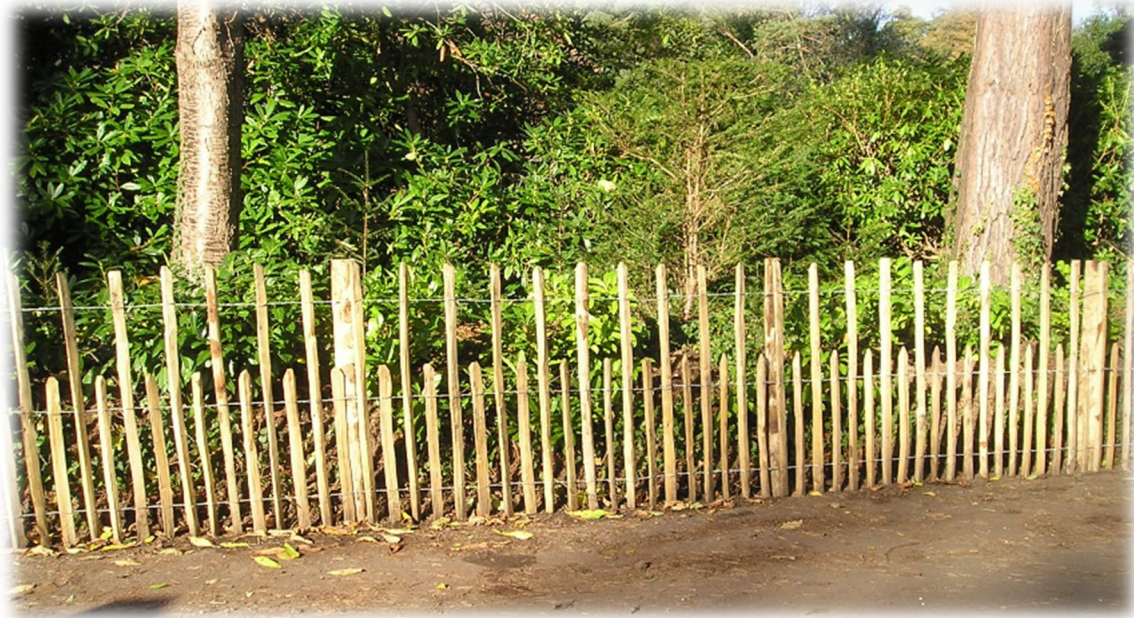
Figure 4: Cleft chestnut paling fencing

To comprise of 100mm driven round timber stakes set at 5m spacing's with a top 'straining' wire, with 1.2m to 1.4m tall cleft chestnut paling fencing affixed to the posts and straining wire.
