# **ARBORICULTURAL IMPACT ASSESSMENT AND TREE PROTECTION PLAN**

**FOR THE SITE OF  
48 Park Lane, Cowplain, Waterloooville  
PO8 8BB**

**Date – 18<sup>th</sup> March 2026**

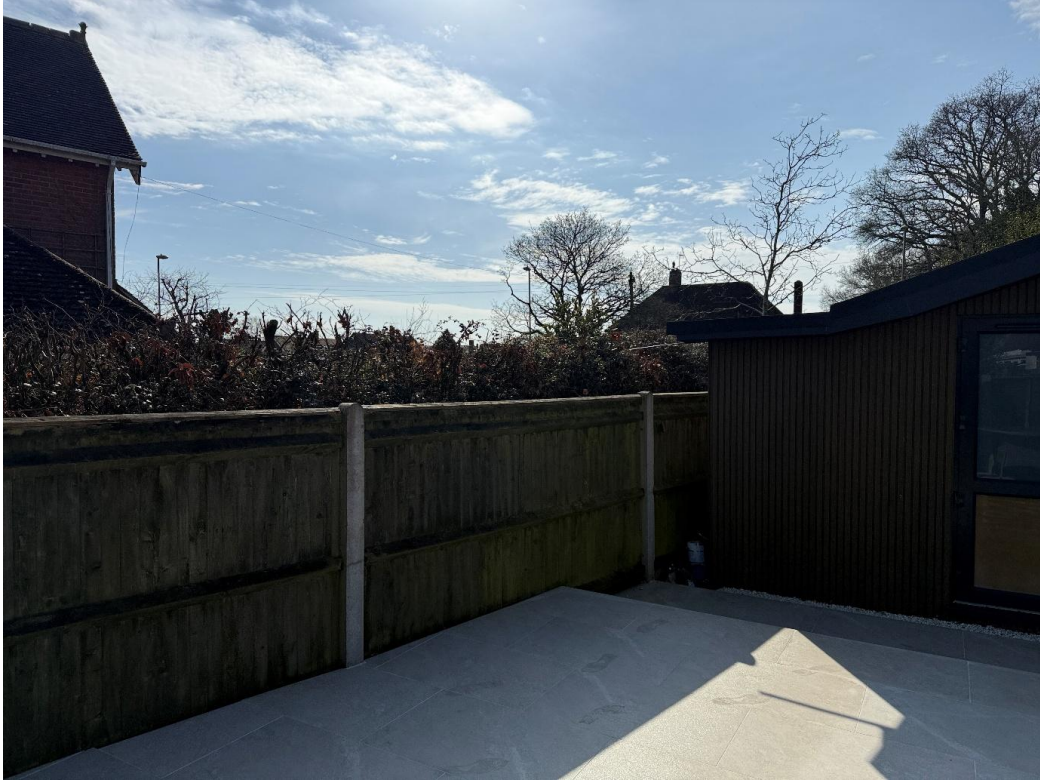
**Photograph 1:** Showing the absence of the Oak from the rear garden, looking southeast

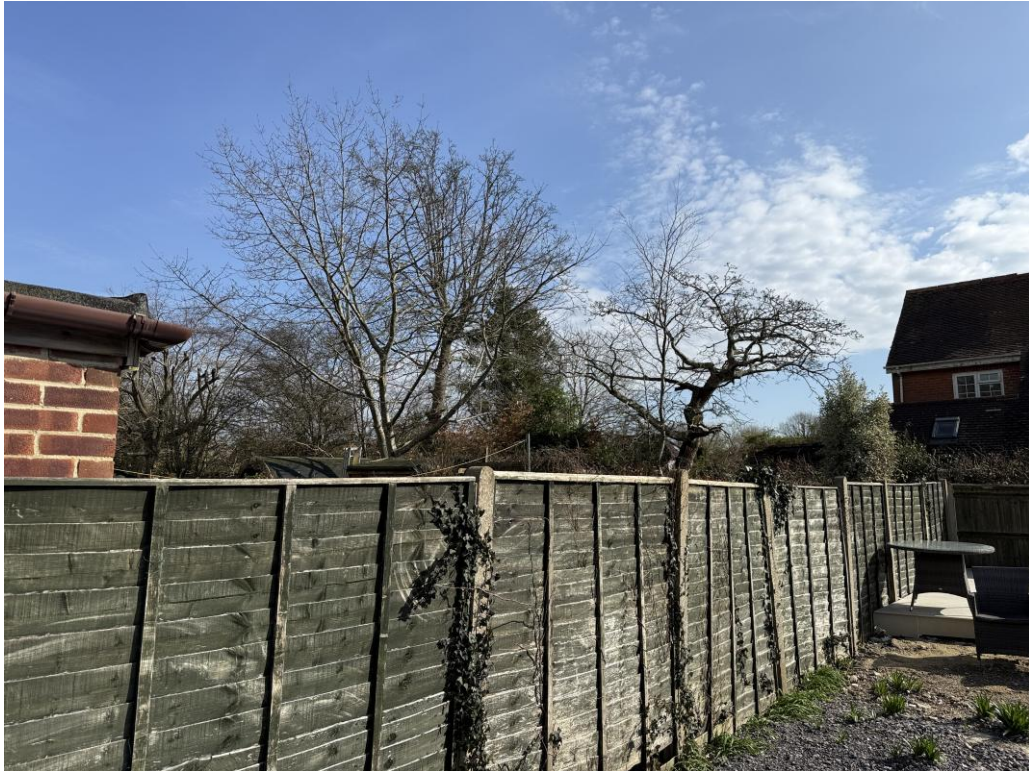
**Photograph 2:** Showing the relationship of the offsite trees from the rear garden, looking northeast

4.2 There is no potential damage that can occur to the significant trees beyond the site boundary as they are far enough away from the site boundary not to impact on the site.

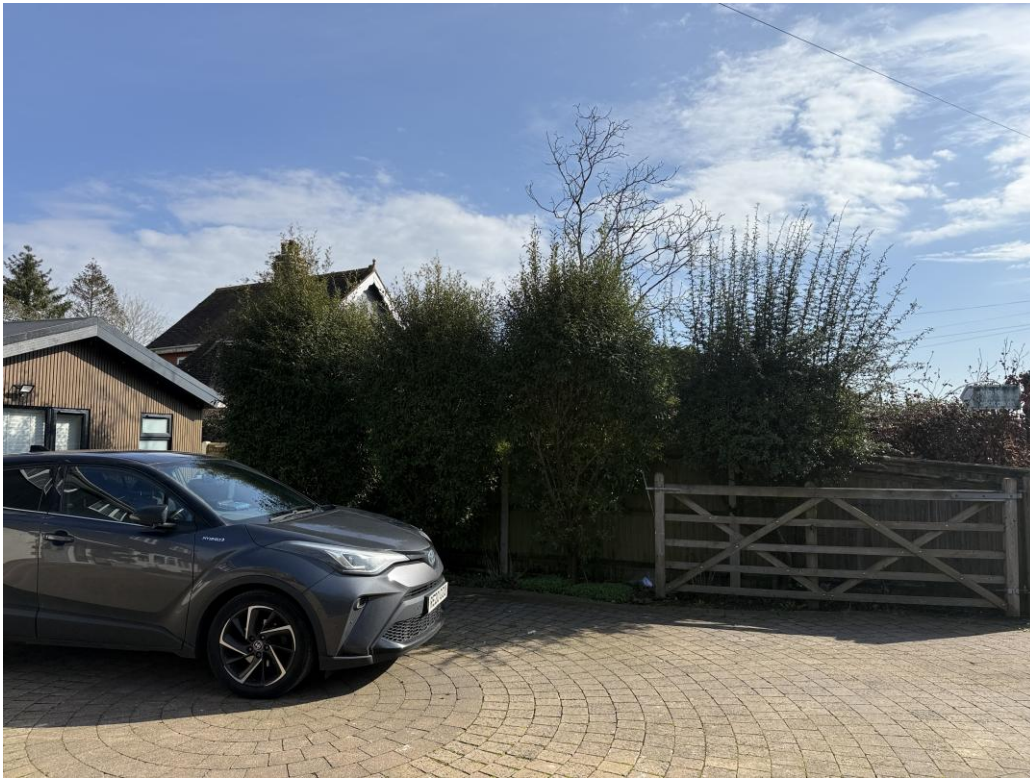
**Photograph 3:** Showing the only group of trees onsite large enough to survey and the absence of the Oak from the front garden, looking east

4.3 The potential for damage to the group of trees on site comes from the delivery and storage of materials and contractor parking where soft ground is damaged through compaction or through the leaching of chemicals into the ground.

4.5 Contractors will utilise the existing driveway area and areas outside of and away from the rooting area of the group for material storage and mixing.
