ref: A12342-1/250428/L2

**RE: Goodwillie's Timber Yard, 154 London Road, Purbrook, Waterlooville, Portsmouth, PO7 5SR – Winter Groundwater Monitoring**

| Project Number: A12342-1 | | | | | | |
|---|---|---|---|---|---|--|
| <br>Geo-<br>Environmental | Winter Groundwater Monitoring Report | | | | | |

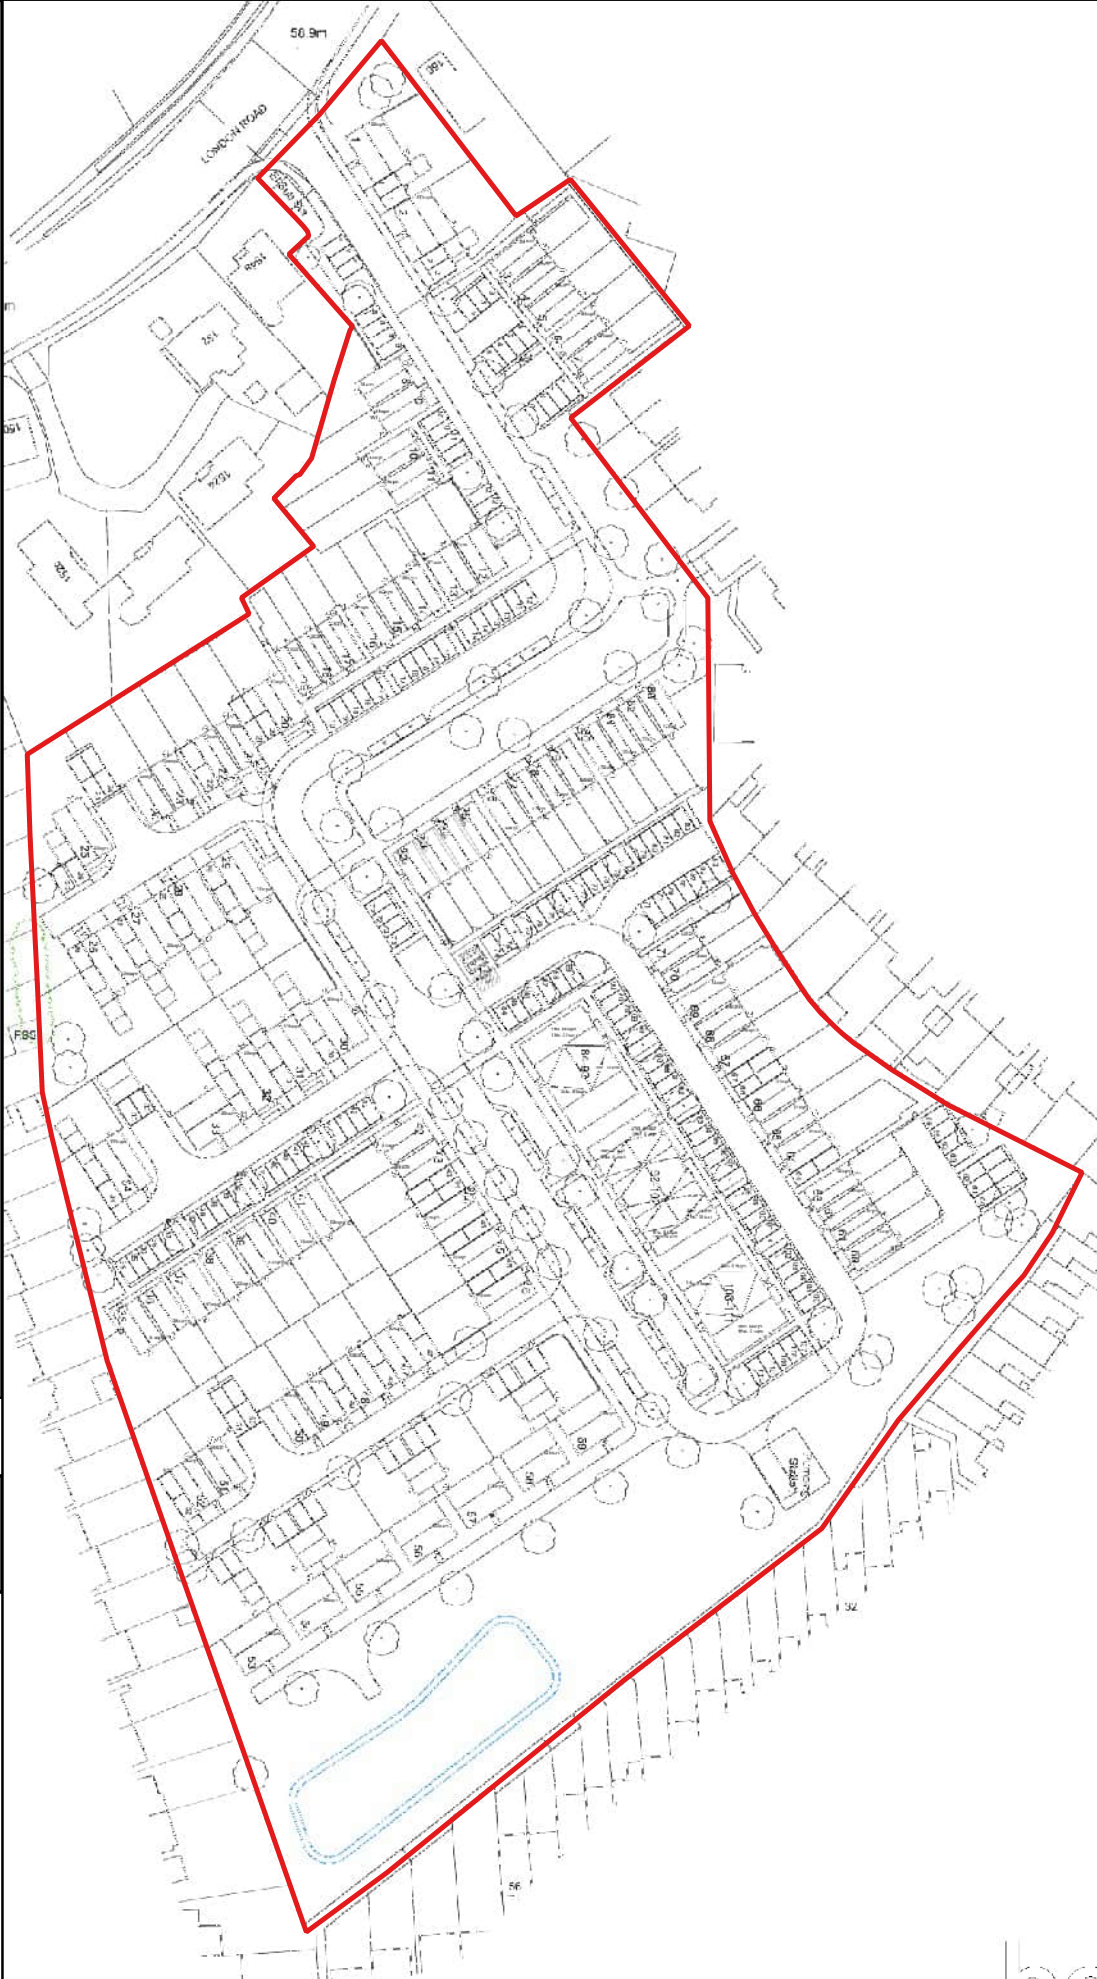
| Project Number:<br>A12342-1 | Client:<br>Foreman Homes | Drawn By:<br>H. Spurling | Drawing Title:<br><br>Figure 2.0<br>Proposed Development<br>Plan |

A site location plan, proposed development plan and intrusive location plan are presented as Figure 1.0, Figure 2.0 and Figure 3.0 respectively within Appendix II.
