| Location Name | Forty Acre Farm, Havant |
| Report Reference | As Built Level Check – Forty Acre Farm |

**Summary**

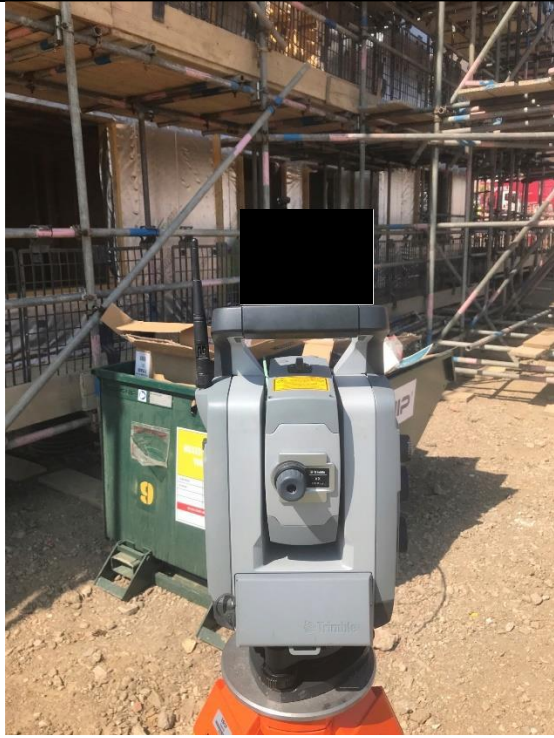
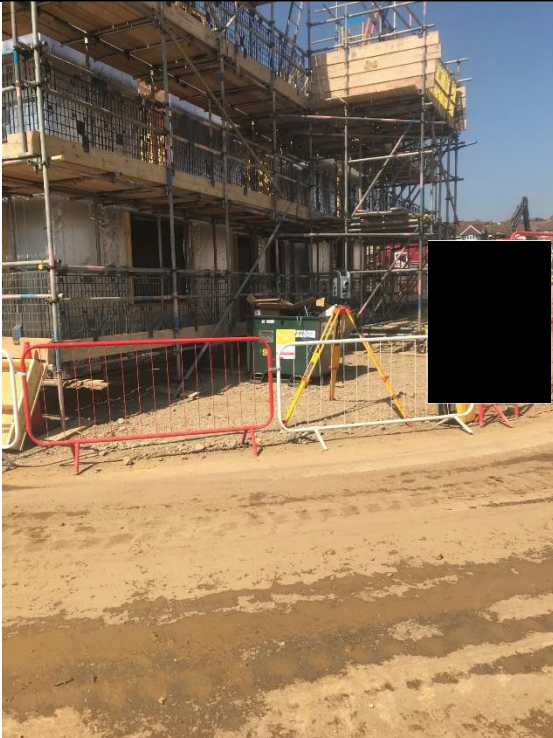
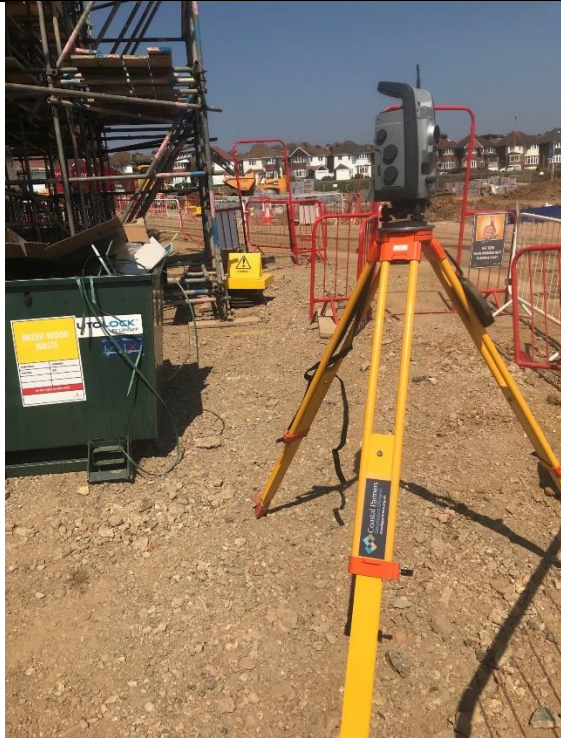
| Site Photo 1 | Site Photo 2 | Site Photo 3 |

When we arrived and viewed the site, we found that housing plots 1 to 4 had been built up to finished floor level, leaving plots 5 to 8 at Structural Slab Level. Coastal Partners have made the decision to compare our updated levels to the Approved FFL level stated in brackets in column four, of the table above for plots 1 to 4. For plots 5 and 6, we have been able to compare like for like against As-Built Levels, as the construction was in the same phase. Plots 7 and 8 had no previous As- Built levels to check independently.
