# Dunsbury Park, Plot 100

## Phase 2 Ground Investigation Report

Prepared for:  
Portsmouth City Council

Project/File:  
01960-STN-XX-XX-RP-GE-1011

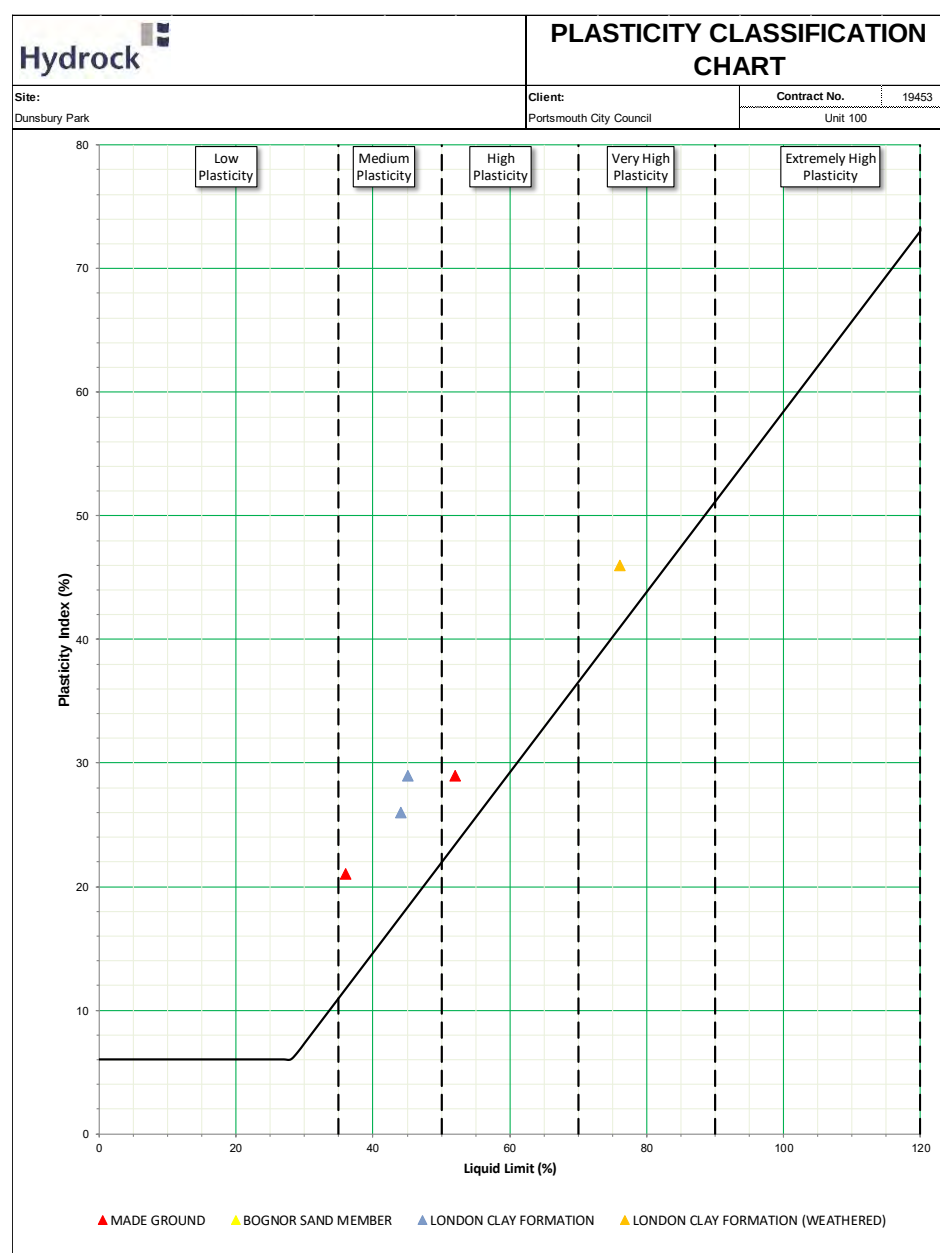
Figure 5.1: Plasticity Chart

Plasticity charts for each unit are presented in Figure 5.1 below.

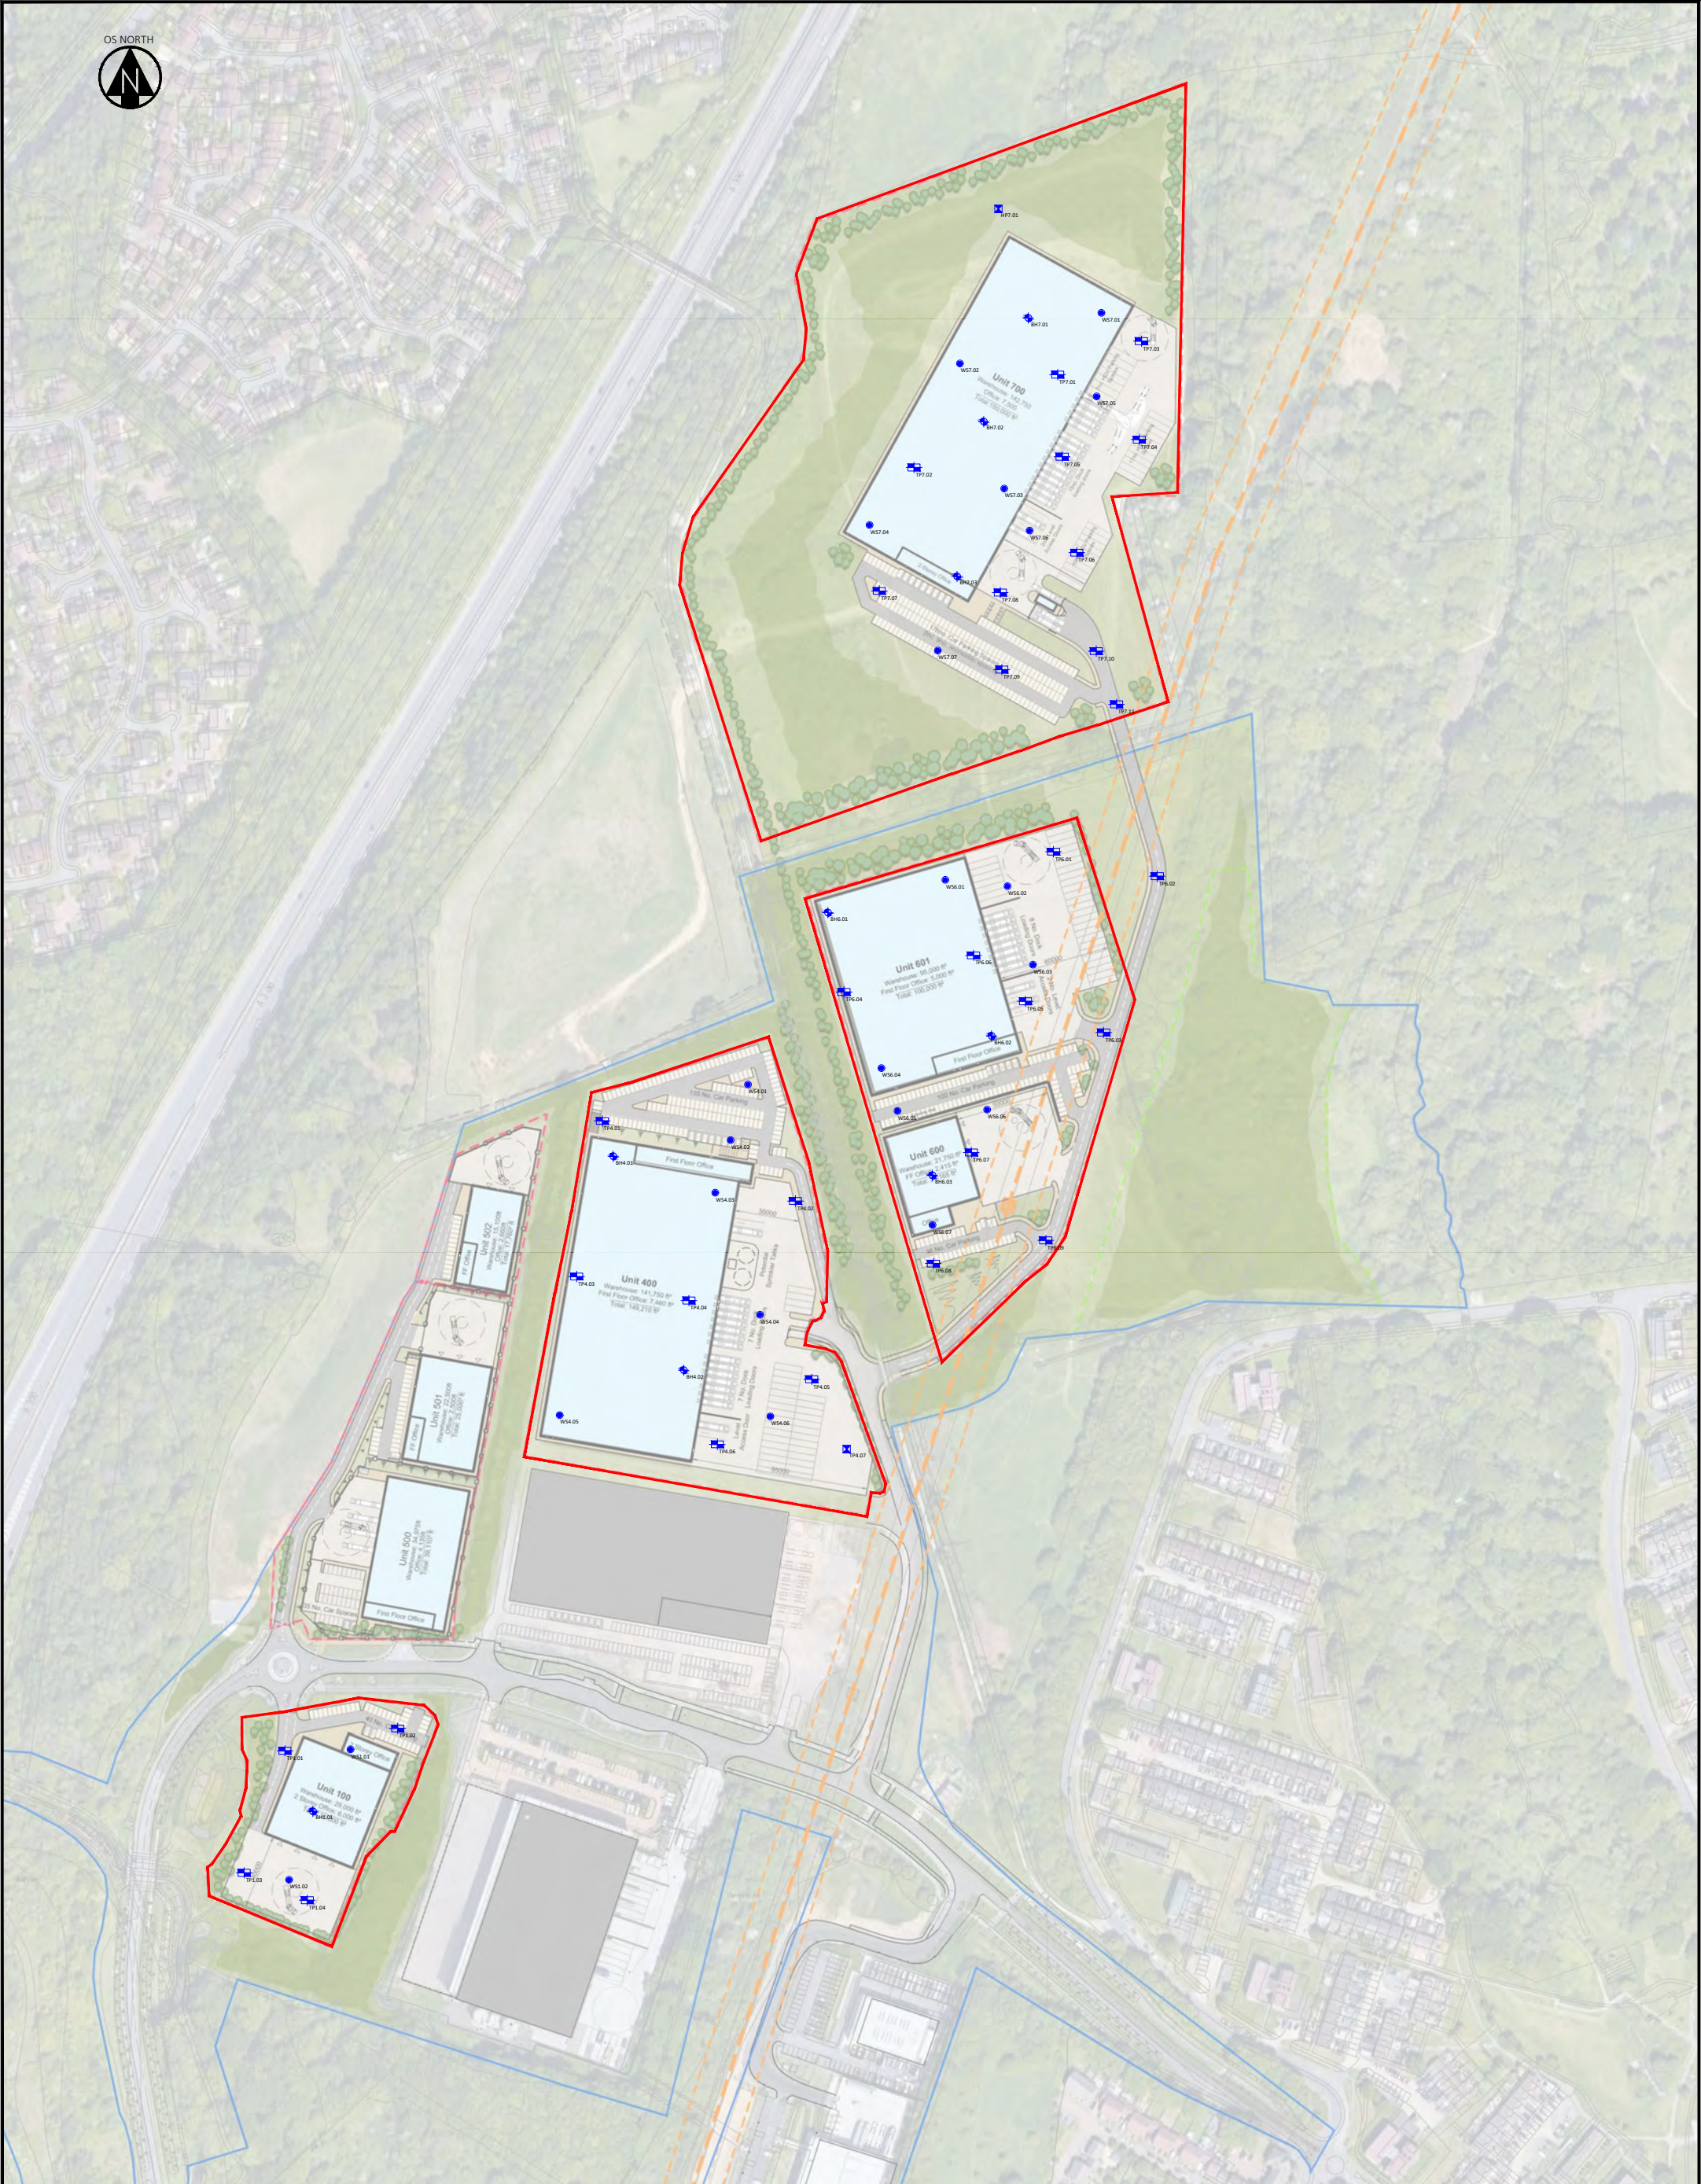
| KEY | | NOTES | | | | Hydrock | | TITLE | |
|---|--|---|--|--|--|---|--|---|--|
| <div>Key:</div> <div><div><div></div><div>BH##</div></div><div><div></div><div>Windowless sampler borehole</div></div><div><div></div><div>TP##</div></div><div><div></div><div>TP##</div></div></div> | | | | | | CLIENT | | EXPLORARY HOLE LOCATION PLAN -<br>Plots 100, 400, 600 and 700 | |

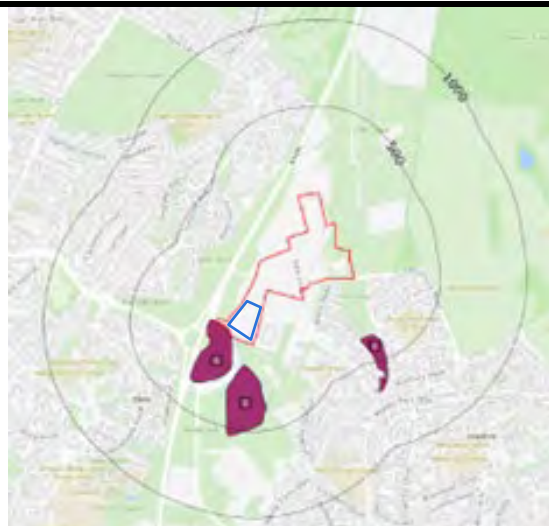
*Figure 2-4: Artificial Made Ground (Reproduced with permission from Groundsure)*

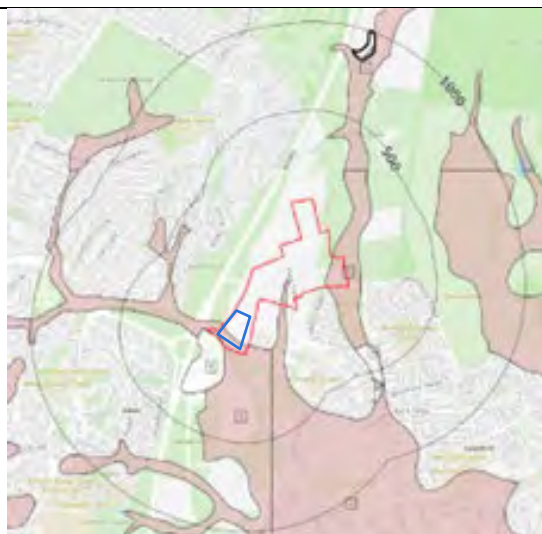
*Figure 2-5: Superficial Deposits. (Reproduced with permission from Groundsure)*

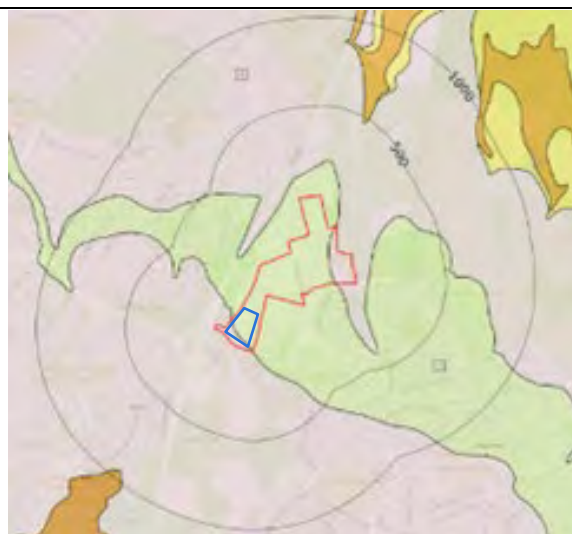
*Figure 2-6: Solid geology (Reproduced with permission from Groundsure)*

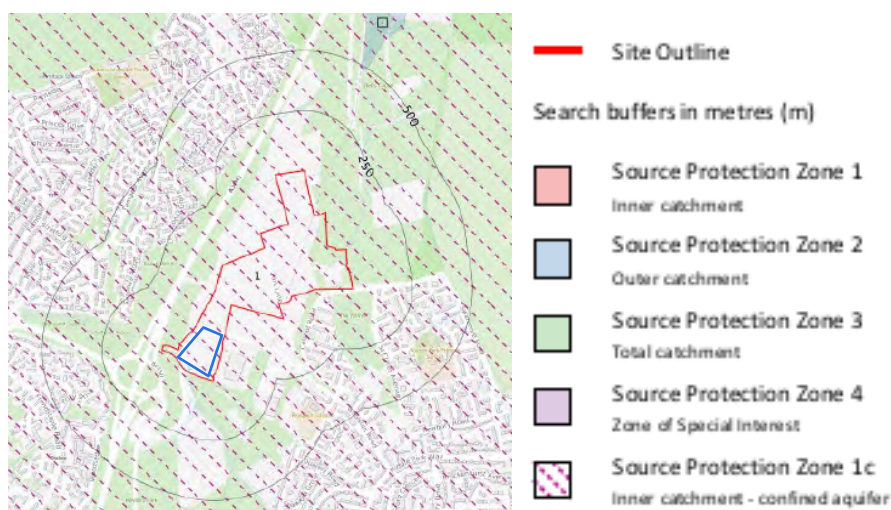
Figure 2-7: Abstractions and source protection zones

There is one record of Zone 2 Source Protection Zone (SPZ2 – outer catchment) located at 486m NE of the site boundary.

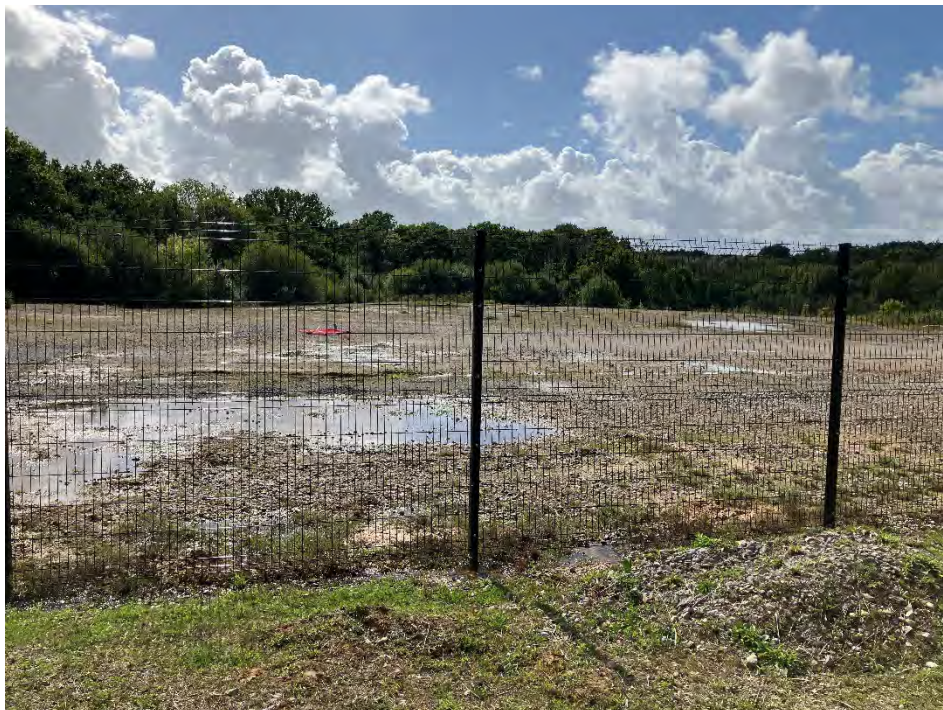
Figure 2: Looking S across unoccupied plot. Note gravel surface
