**BELMONT CASTLE CARE/REST HOME, PORTSDOWN HILL ROAD, HAVANT,  
PO9 3JY**

**GROUND CONDITION ASSESSMENT**

**JUNE 2025**

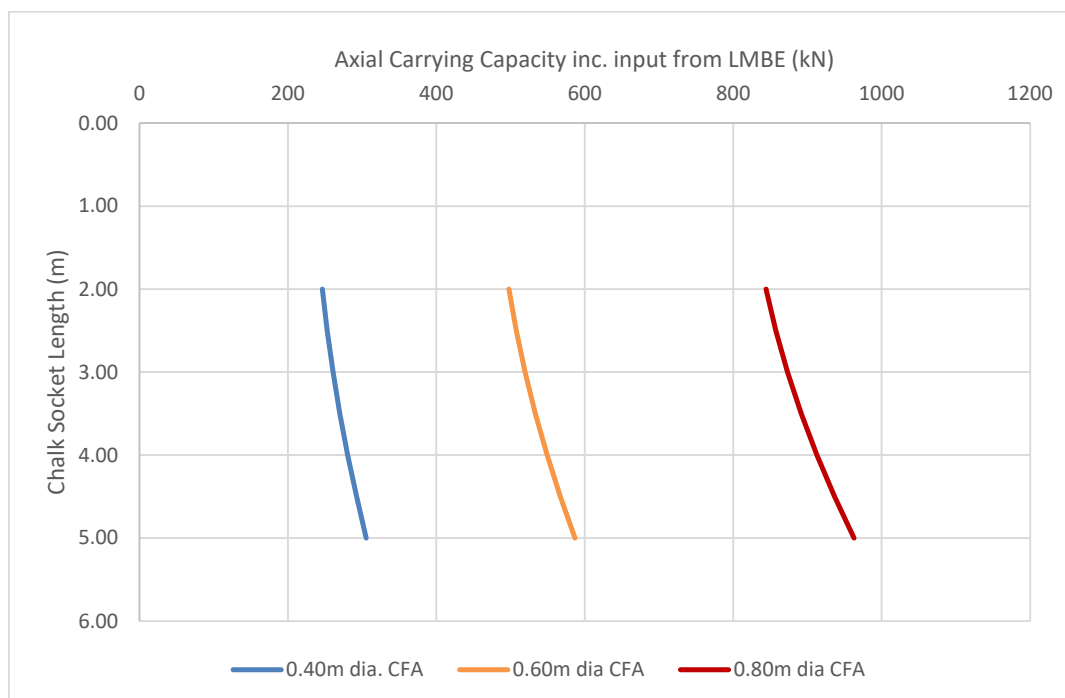
**Figure 9.1. Axial carrying capacity of piles socked into Chalk**

It must be stressed that the values presented in Table 9.3 are preliminary values and detailed calculations will be required once ground conditions are known to ca 18mbgl.

The full spreadsheet of results is presented within the pile design (Appendix 6) of this report. When determining the required pile length, it is considered appropriate to interpolate between graphed values if intermediate pile sizes are to be used. Applied loads should be factored in accordance with Design Approach 1 Combination 2.

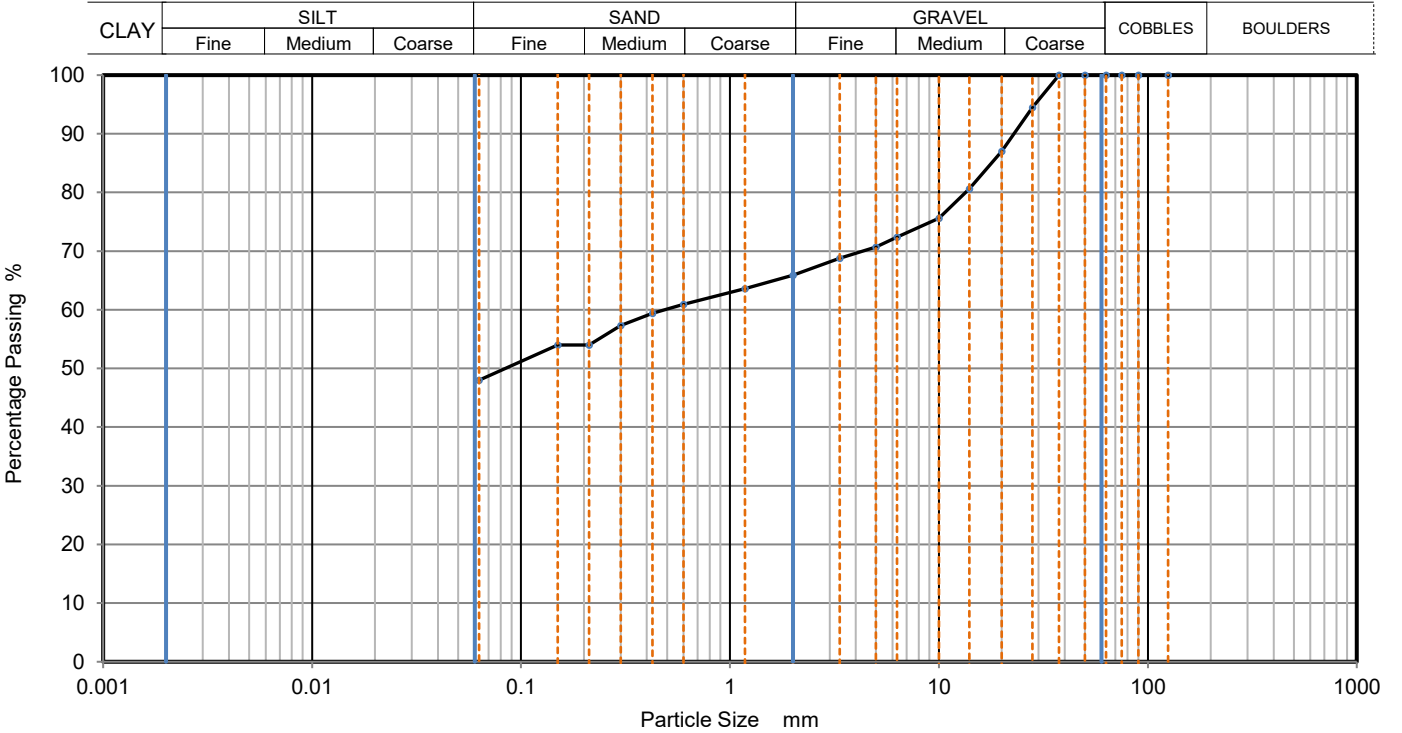
| Test Method | ISO 17892 -4, by sieving on pre-dried or dry sample | | | KeyLAB ID | TTLP2025060325 |

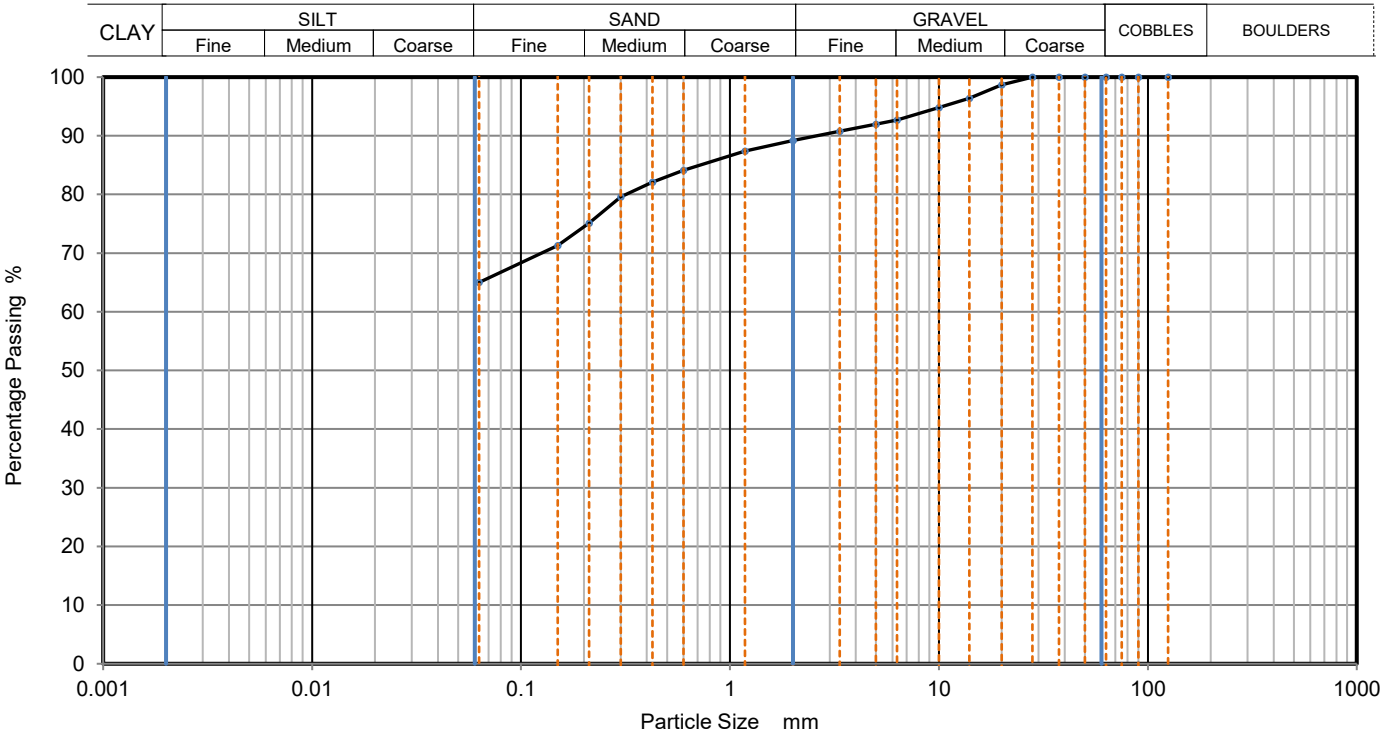
| Test Method | ISO 17892 -4, by sieving on pre-dried or dry sample | | | KeyLAB ID | TTLP2025060326 |

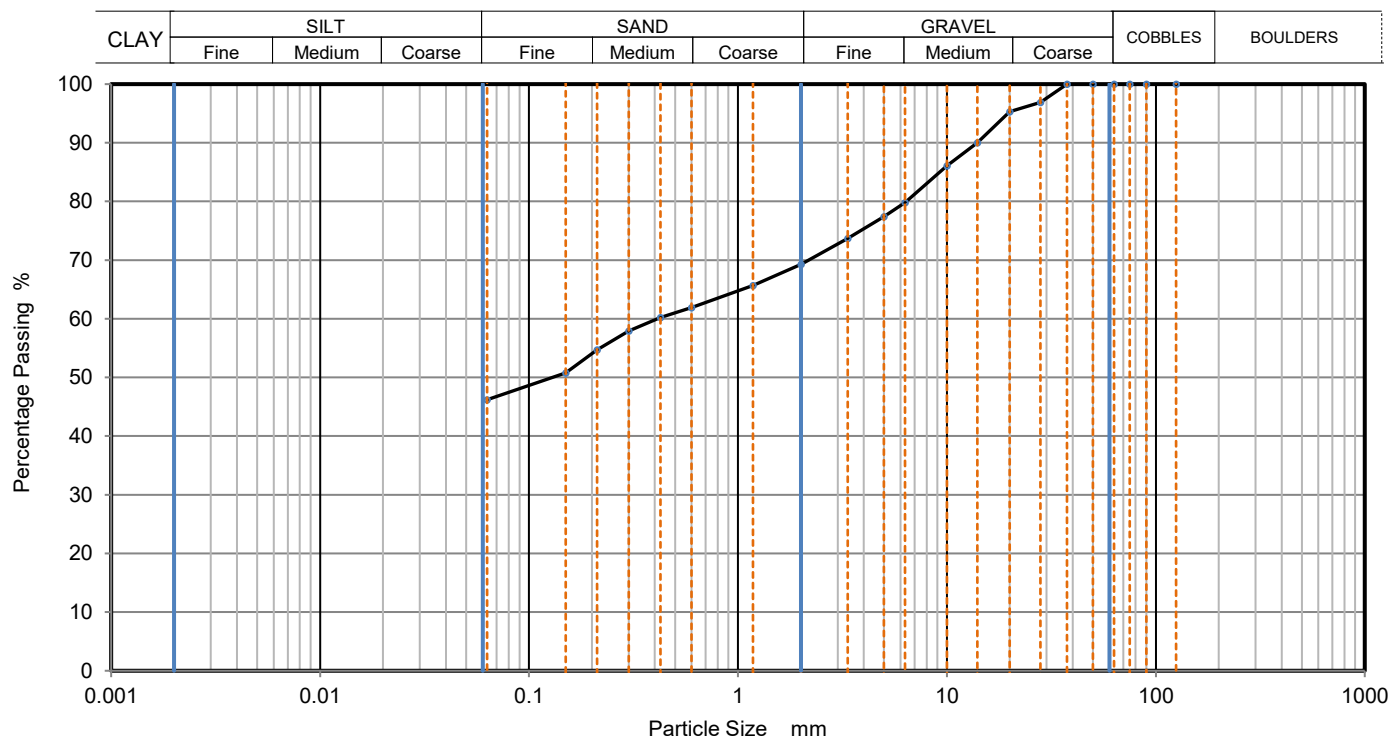
| Test Method | ISO 17892 -4, by sieving on pre-dried or dry sample | | | KeyLAB ID | TTLP2025060328 |

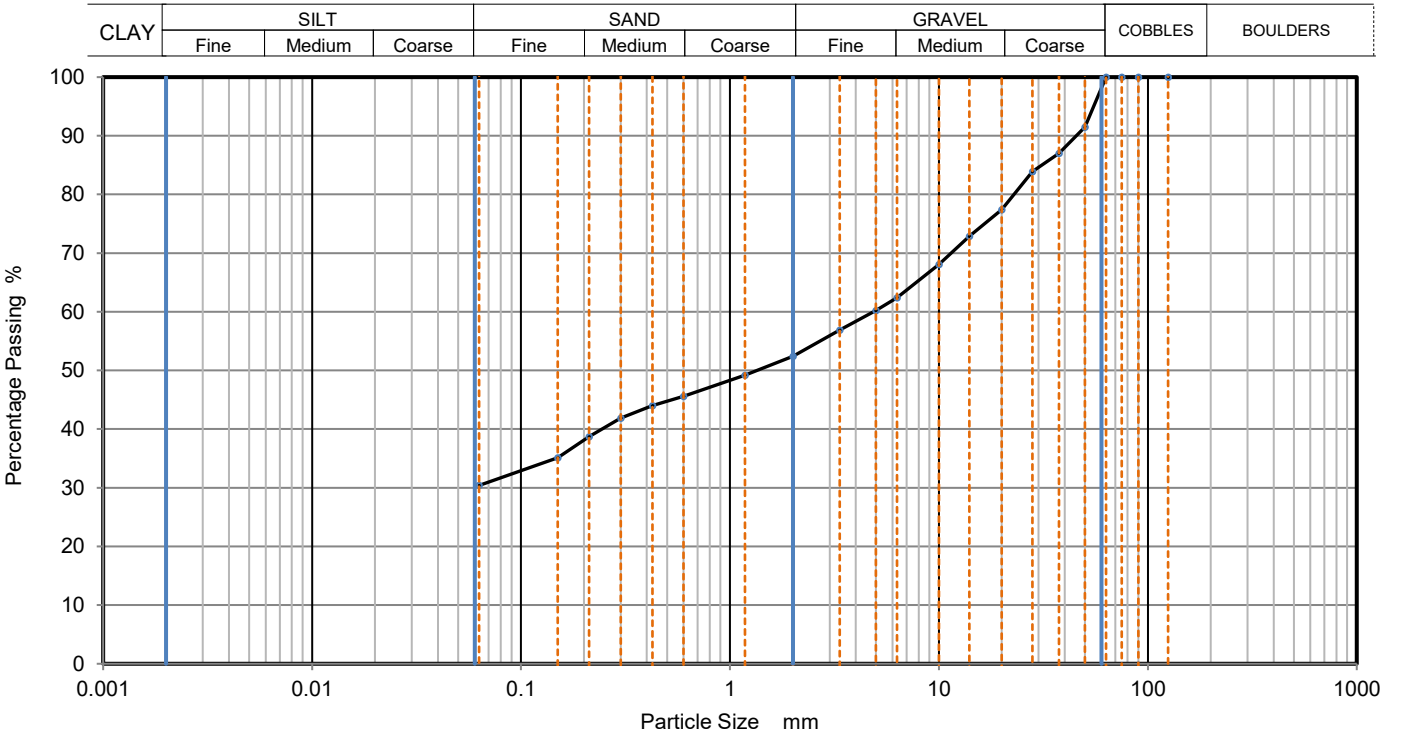
| Test Method | ISO 17892 -4, by sieving on pre-dried or dry sample | | | KeyLAB ID | TTLP2025060329 |

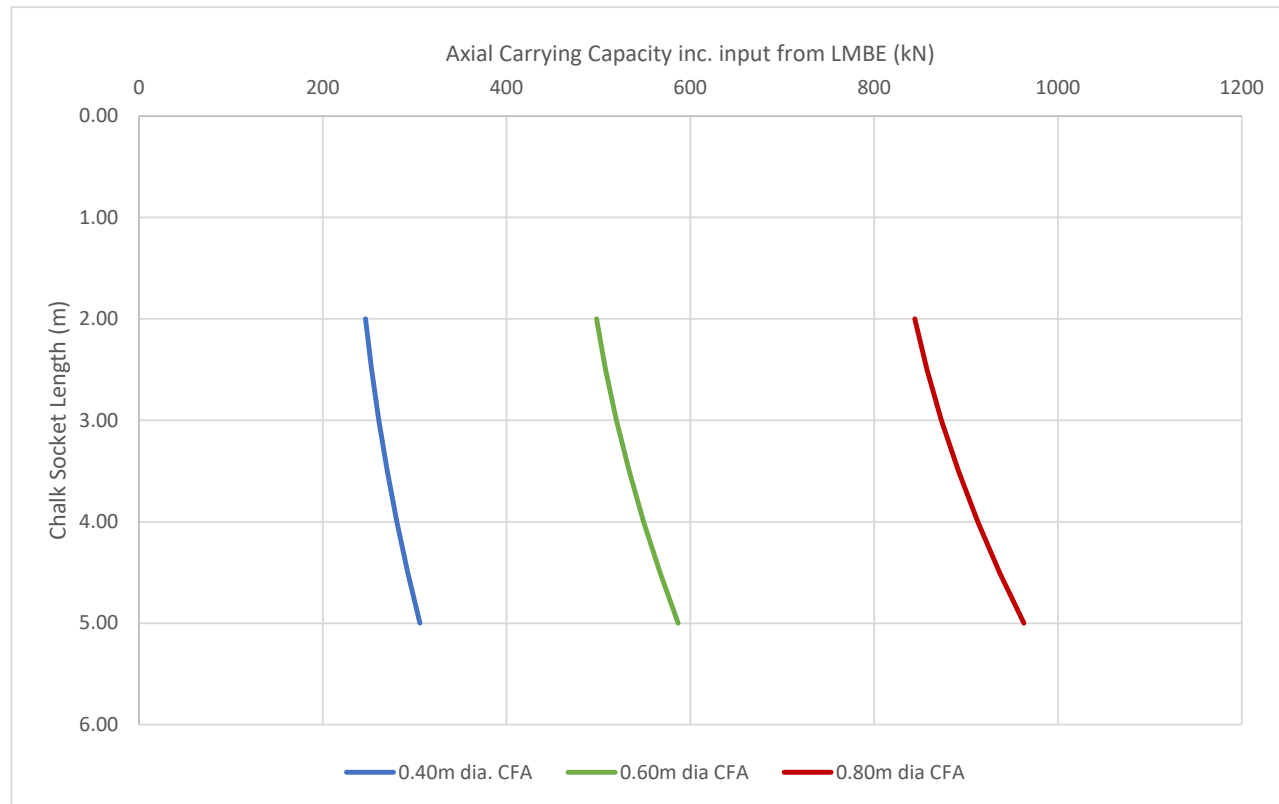
## CFA Pile Sockets into Chalk
