# LEVEL MONITORING

## for SMS (ESU)

### 1 Hartwood Gardens, Waterloooville, PO8 8RA

| Our Ref: | M25189 |

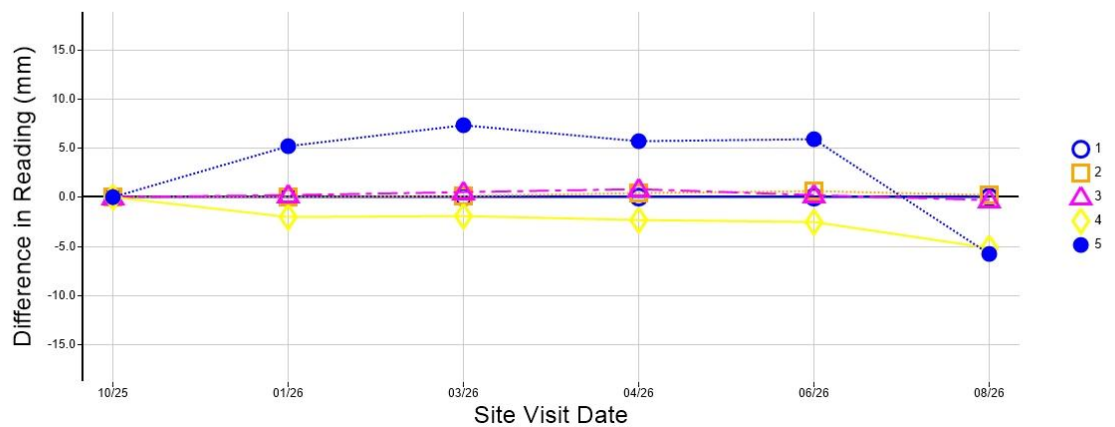
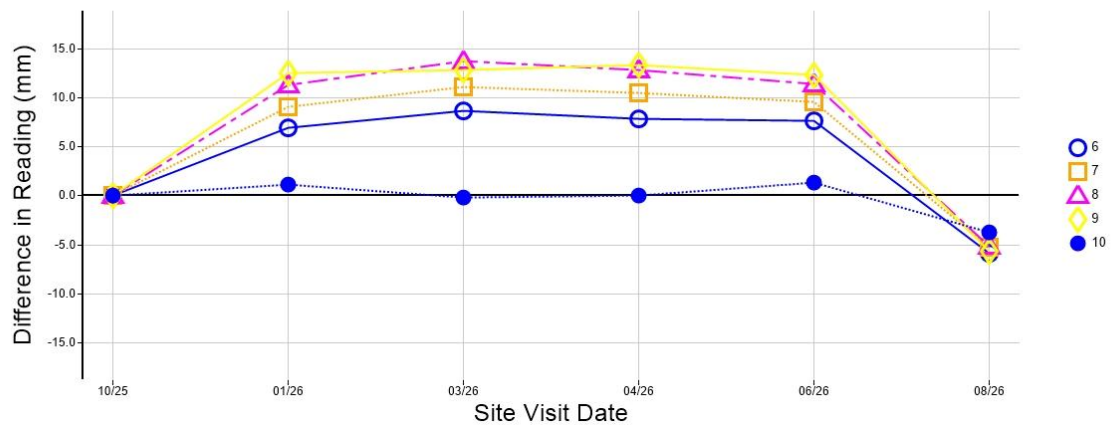
## Level Monitoring Difference Graphs

The following graphs display the progressive movement that each Level Monitoring Station recorded at each separate site visit date to give an overall look at how much the property is moving.

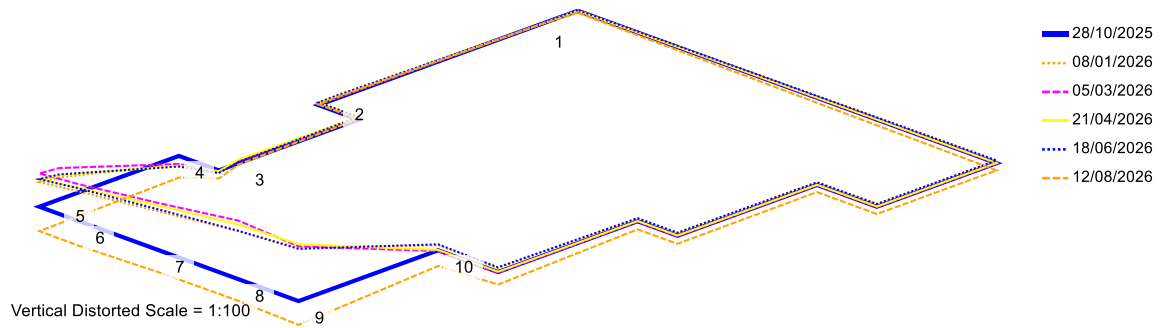
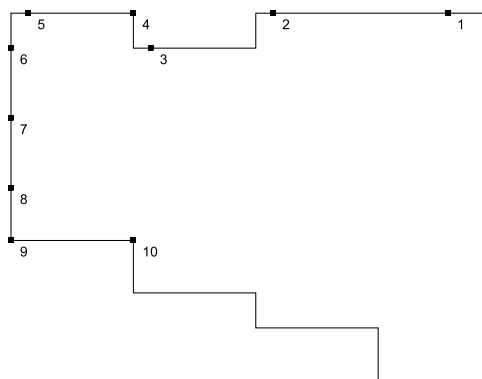
## Level Monitoring Displacement Map

The following image shows an isometric representation of the movement of the property, based on the Level Monitoring Stations that were installed.

FRONT
