28 November 2022

Jack Porter  
Estates Coordinator  
SGN  
St Lawrence House  
Station Approach  
Horley, RH6 9HJ

EMSWORTH ABANDONED RESIDENTIAL PROPERTY: STRUCTURAL BUILDING ASSESSMENT

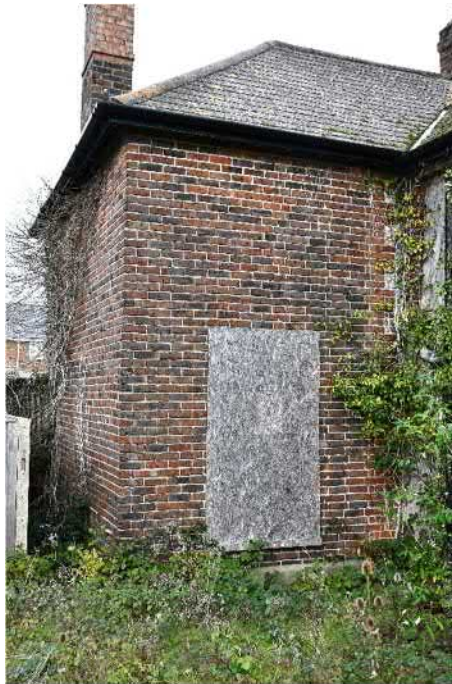
PLATE 15: View on western end of south elevation of house

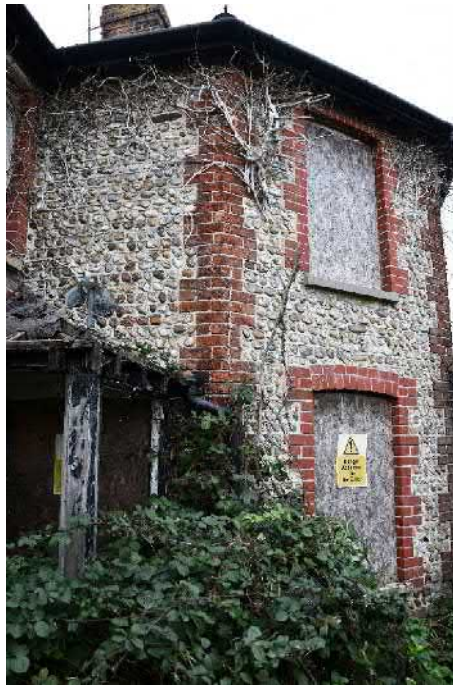
PLATE 33: Eastern corner of southern elevation of house

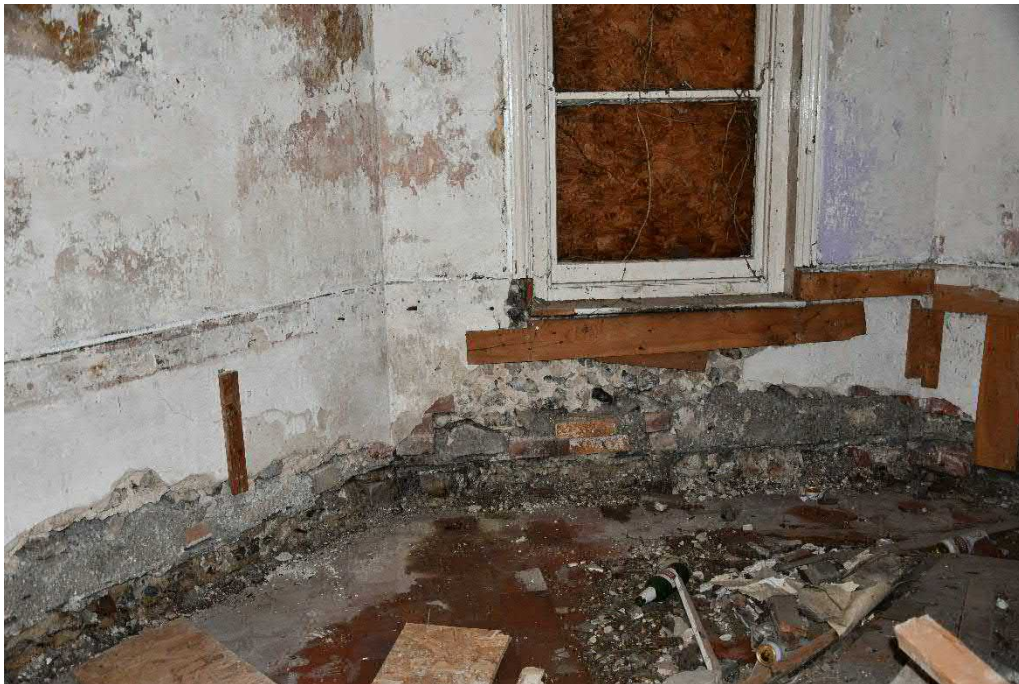
- 4.2.1. Extensive damage/theft/vandalism was noted within property (Plates 40, 41 and 44).
- 4.2.2. Two parallel full height vertical cracks to the eastern wall of the main house at ground floor level (Plate 43).
- 4.2.3. Evidence of water damage to walls generally to ground floor (Plates 42 and 43).
- 4.2.4. Diagonal cracking to the east side of the western ground floor window reveal to the rear wall of the main house in (Plates 45 and 46).

**PLATE 40:** General view of interior of eastern side of house at ground level

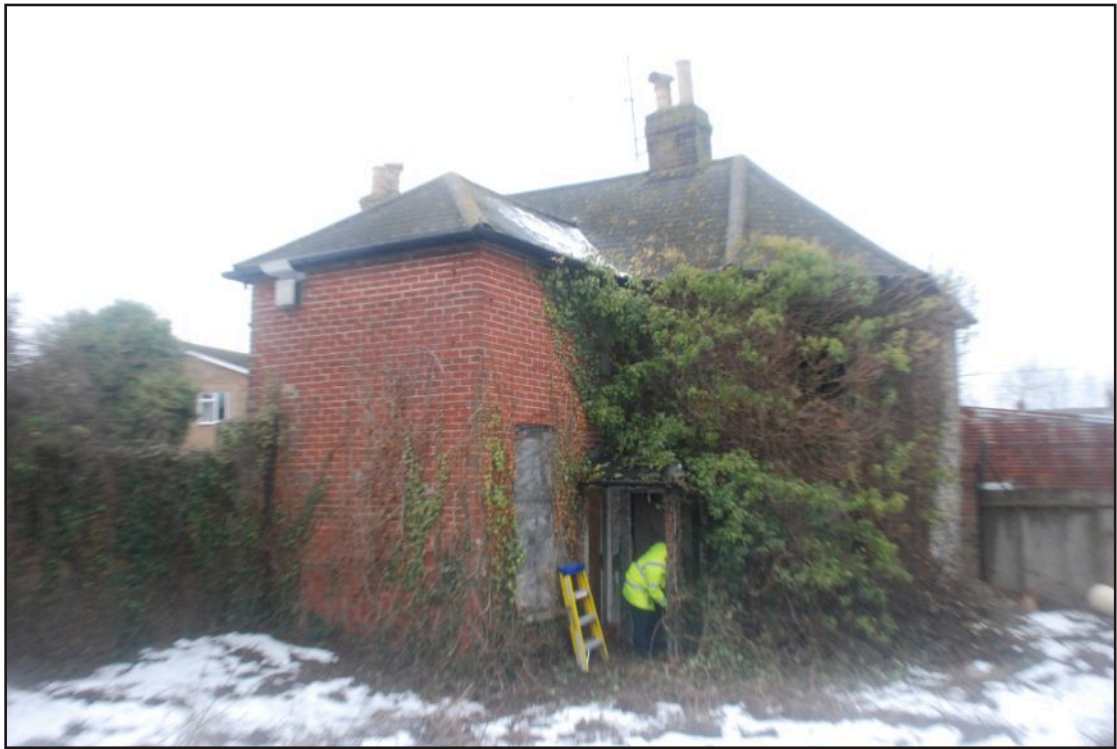
**Plate 7.** Rear elevation of house with later rear extension to left of view.

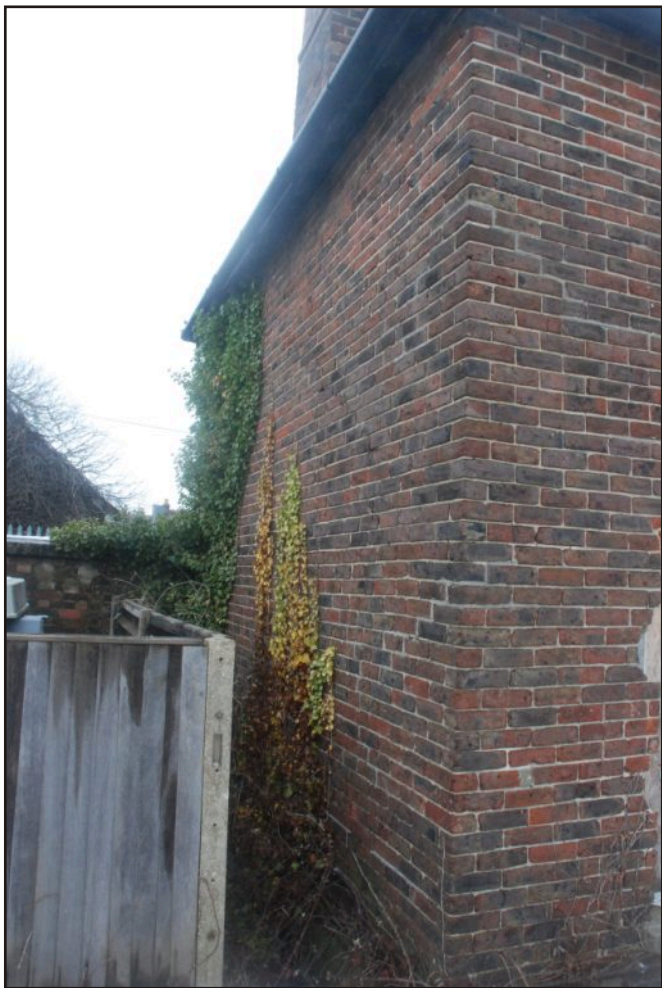
**Plate 12.**  
West elevation of house showing  
proximity of sub-station compound.

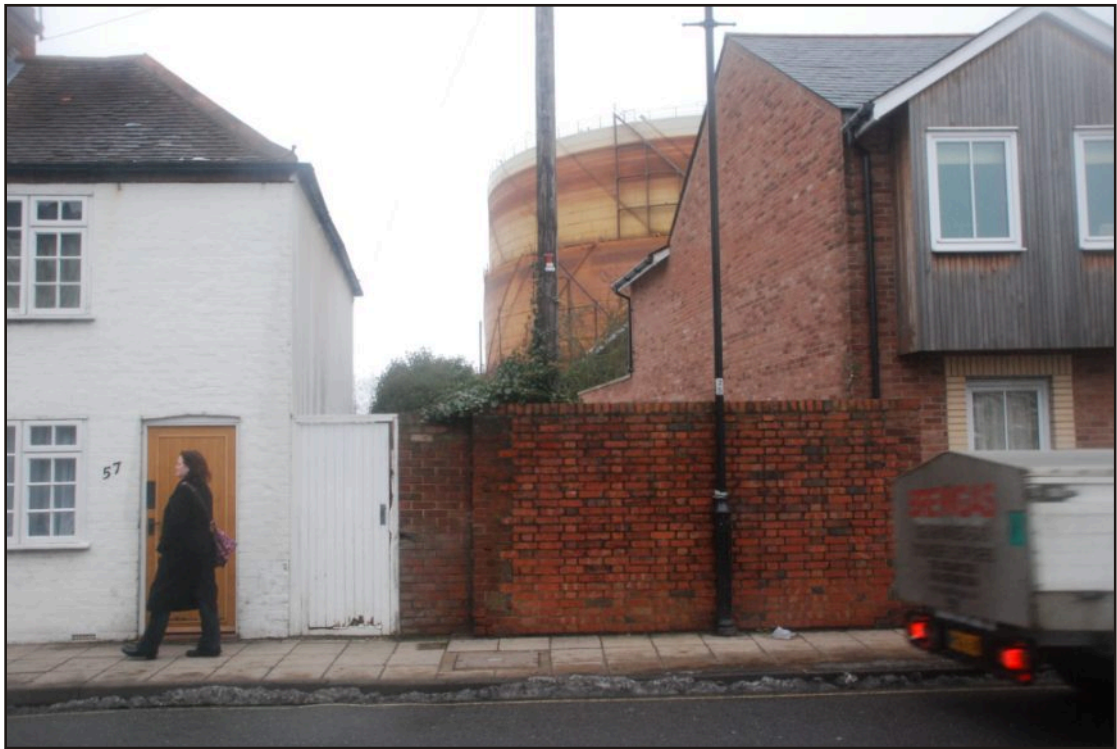
**Plate 17.** "Access" in (16) above viewed from North Street.

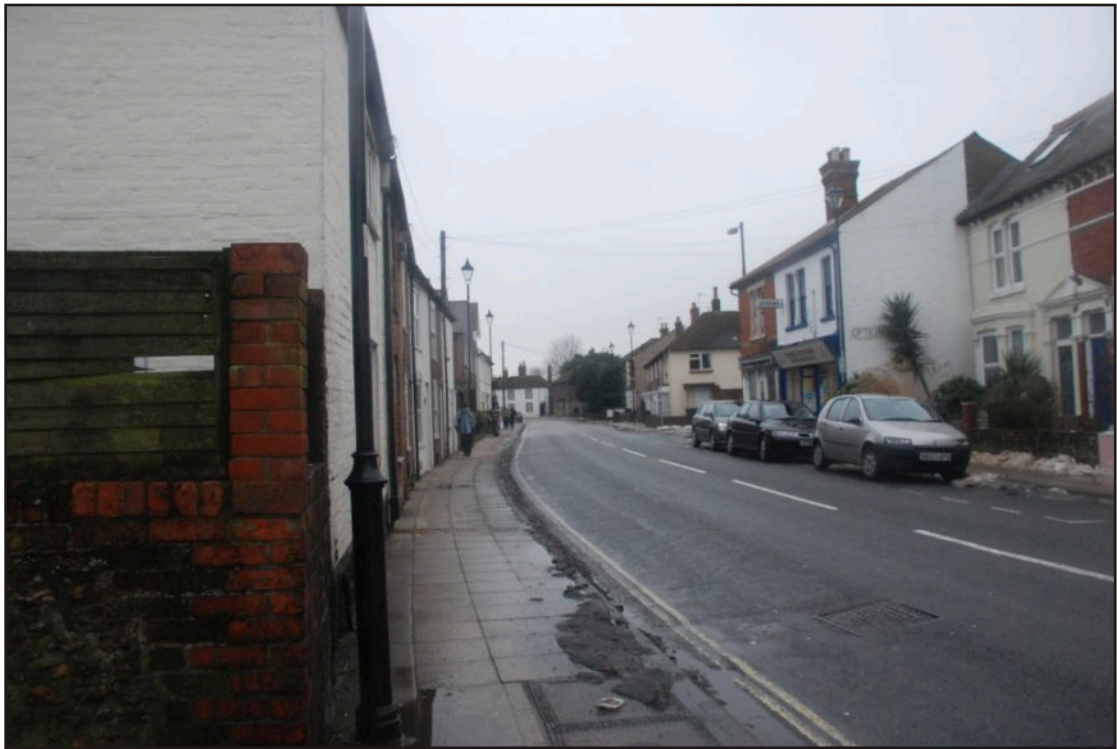
**Plate 18.** Close-up on (17) above - note lamp post and telegraph pole.

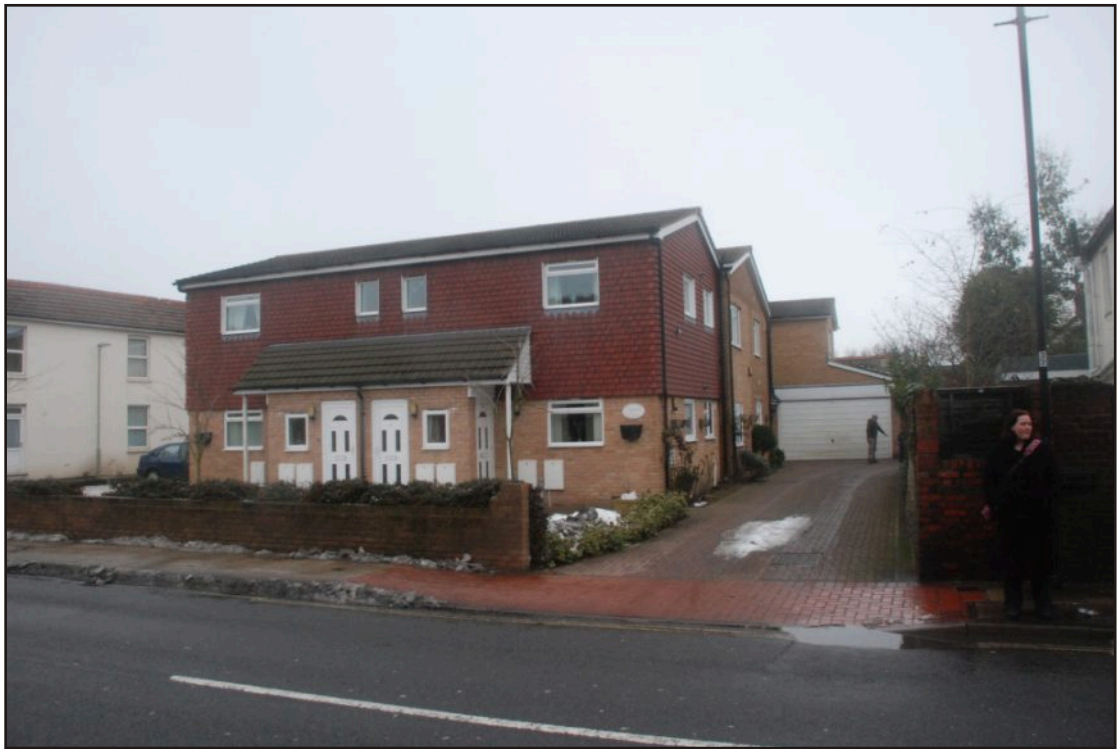
**Plate 19.** North Street viewed from entrance to Seagull Court, looking south.

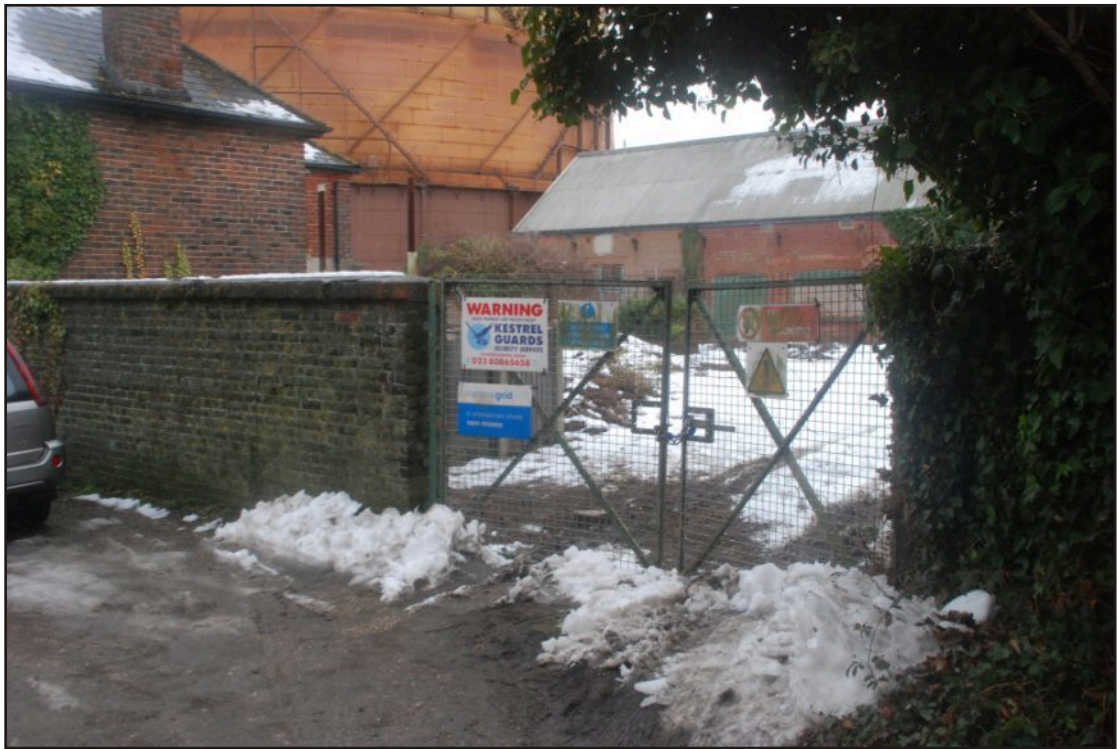
**Plate 21.** Private driveway to Seagull Court viewed from east.

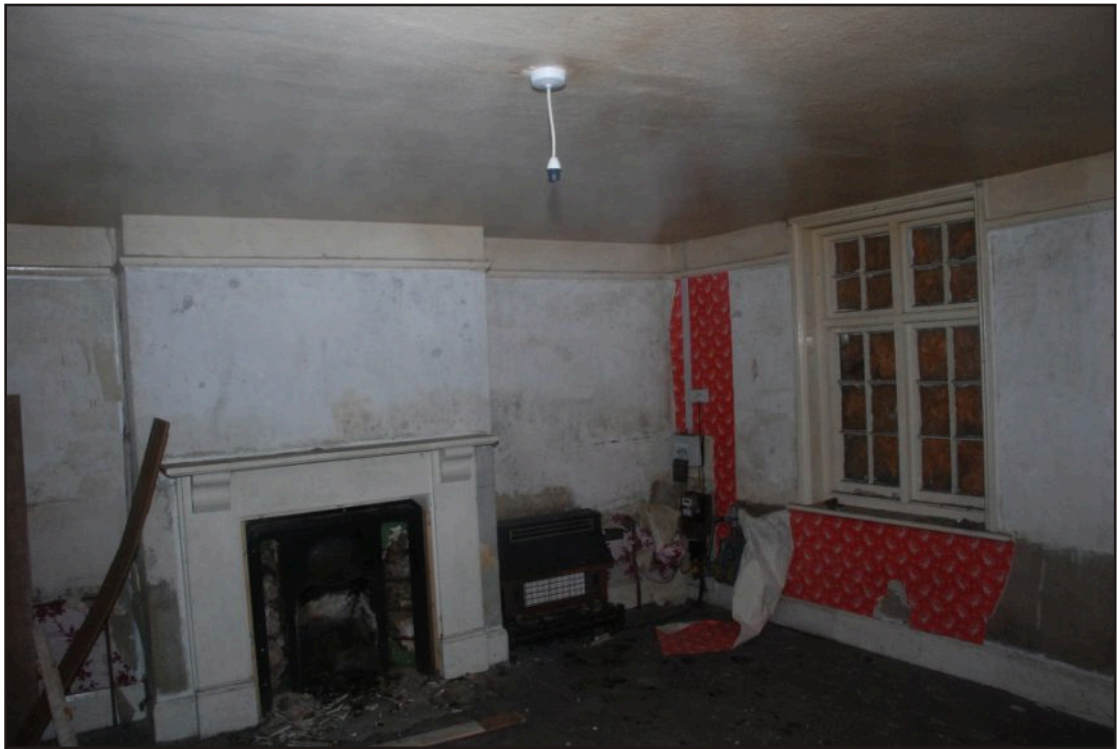
**Plate 24.** Further view on room in (23) above showing damage caused by removal of fireplace.

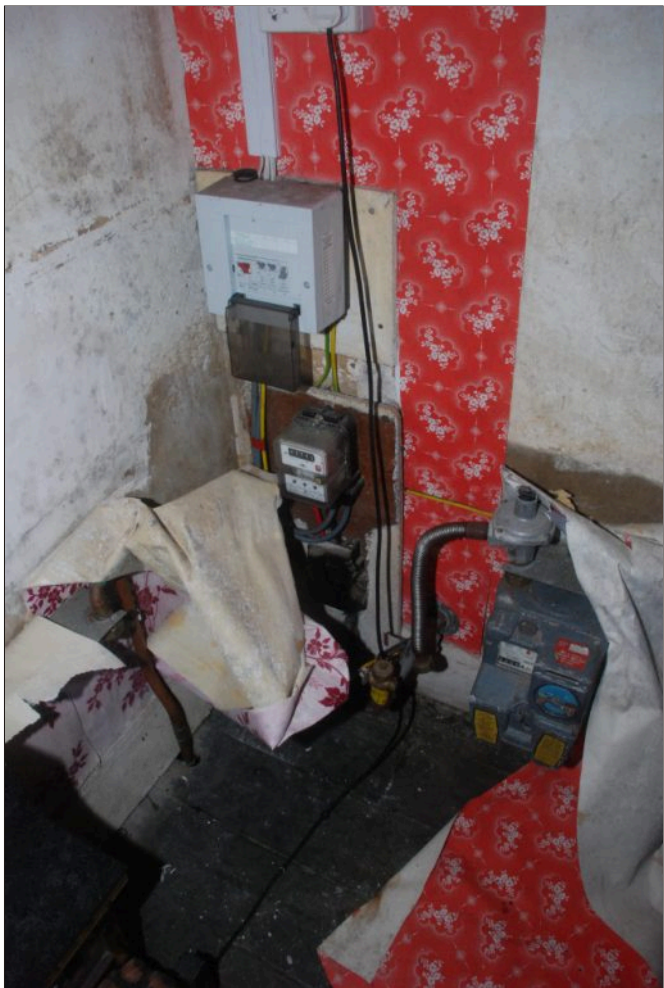
**Plate 25.** Main room at ground floor level.

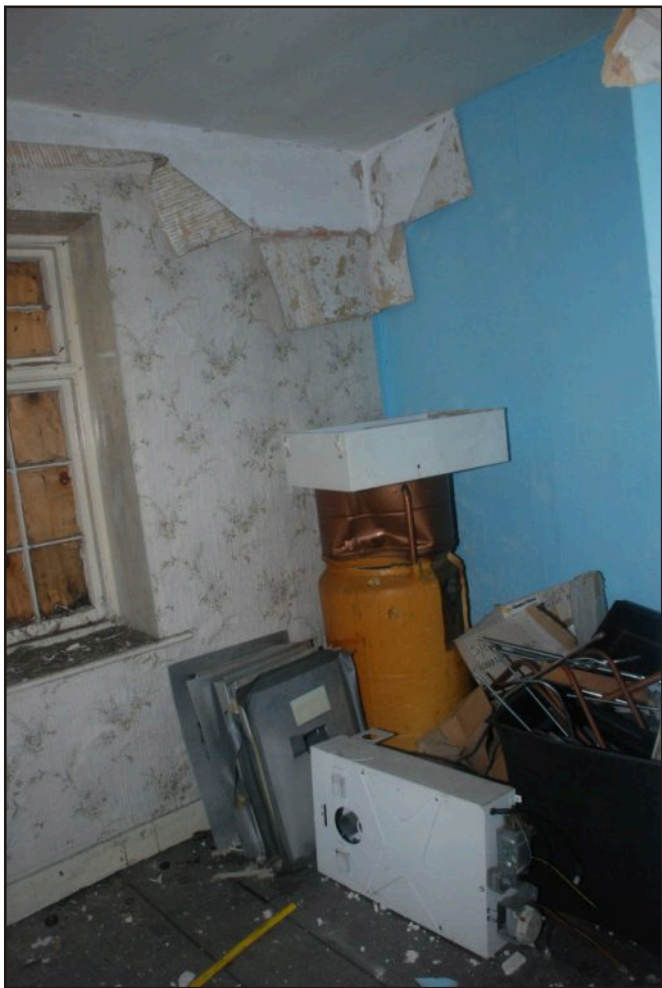
**Plate 29.** First floor room - note damage to lath and plaster internal walls.
