# Hutton + Rostron

### Southleigh Park House; Mansion House, Coach House and Stables: Preliminary condensation risk assessment

Site note A7 for 15 December 2020 and 05 January 2021 Job no.  
152.09

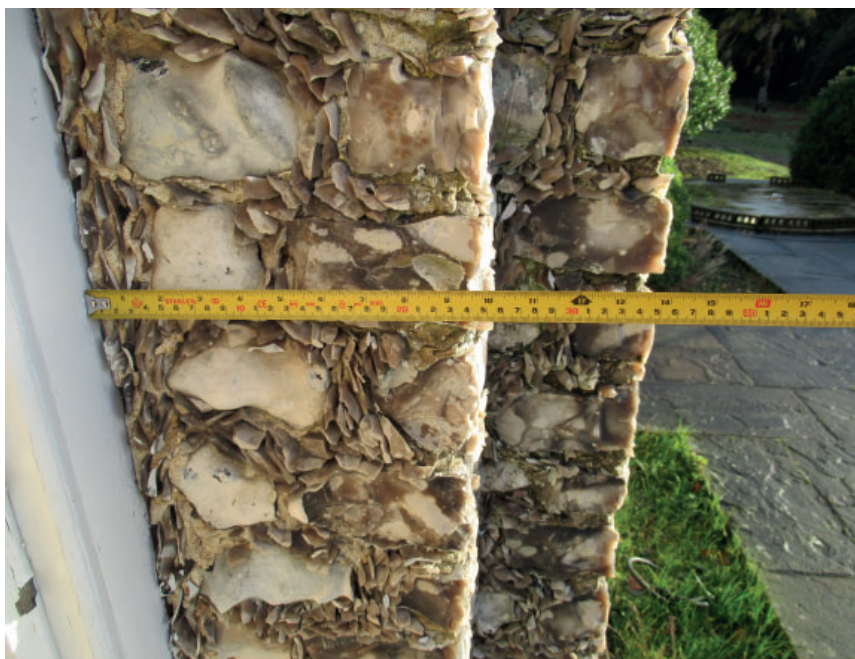
**Fig 3 :**

View of the wall/reveal width across a window opening

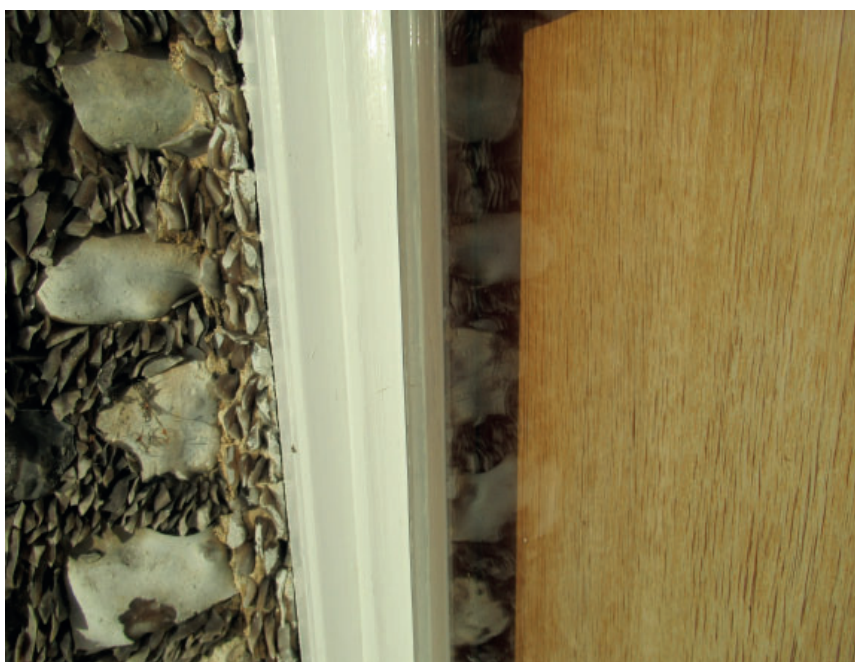
**Fig 4 :**

View of the wall/reveal width across a window opening

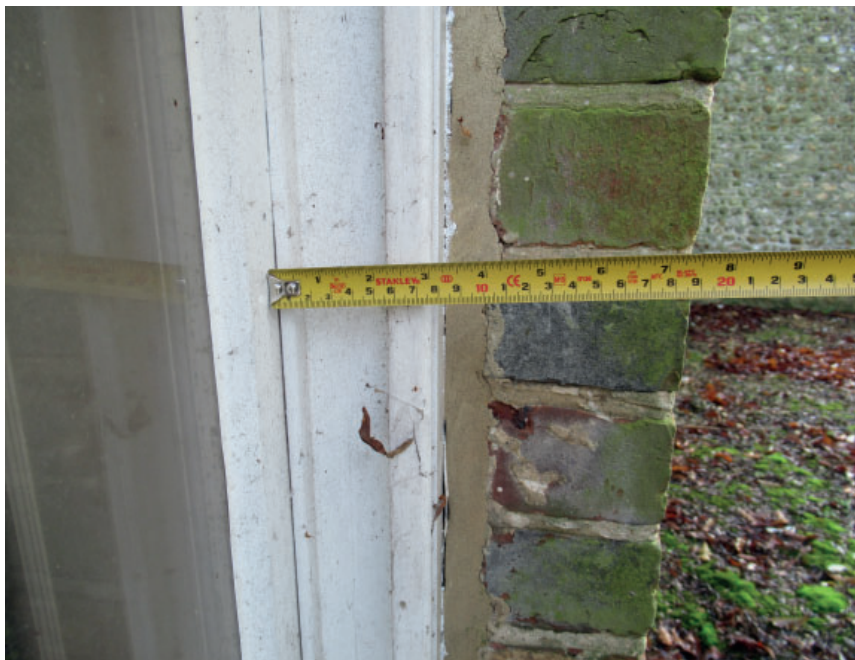
**Fig 7 :**

View of the wall/reveal width across a window opening

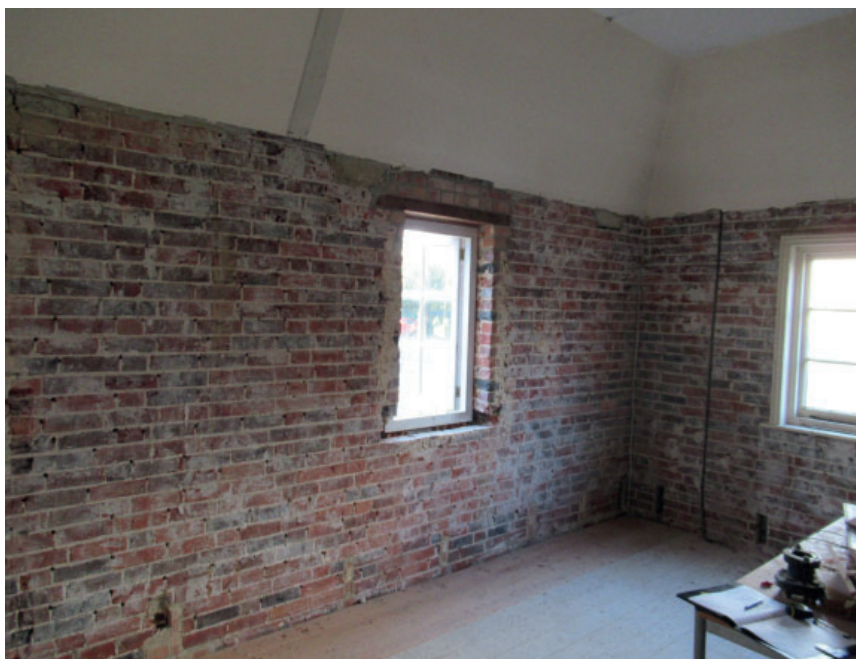
**Fig 11 :**

View of the internal wall construction

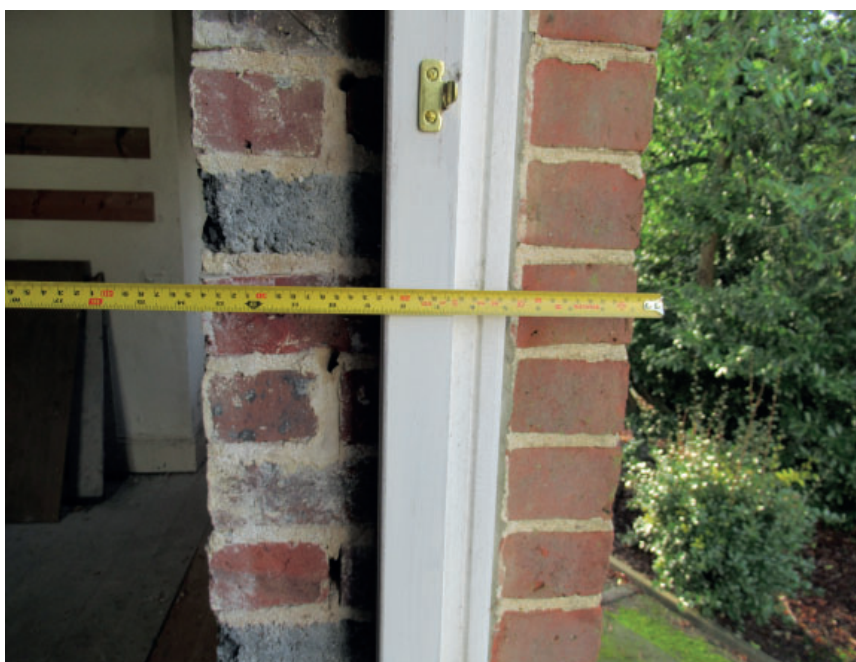
**Fig 12 :**

View of the wall/reveal width across a window opening

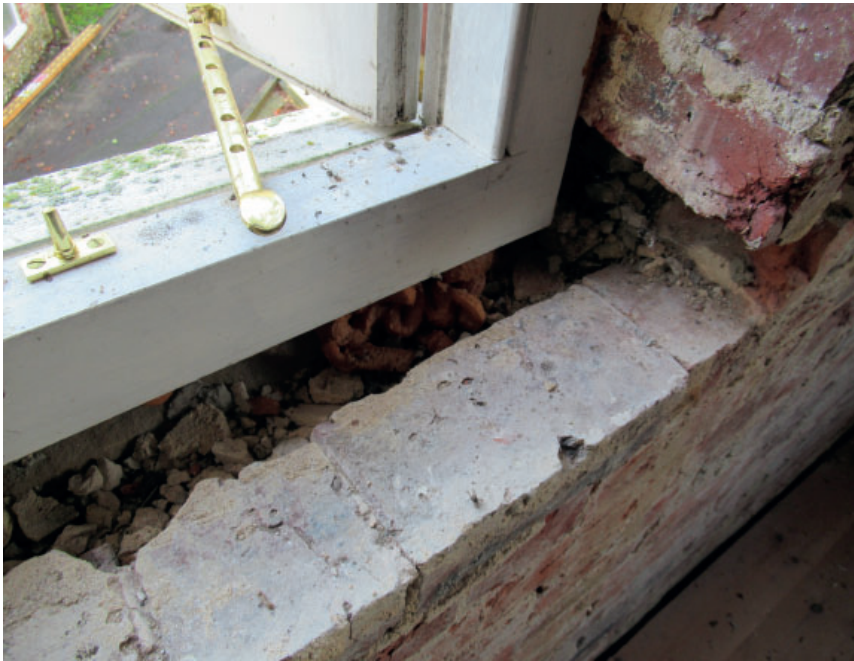
**Fig 13 :**

View of the wall/reveal width across a window opening

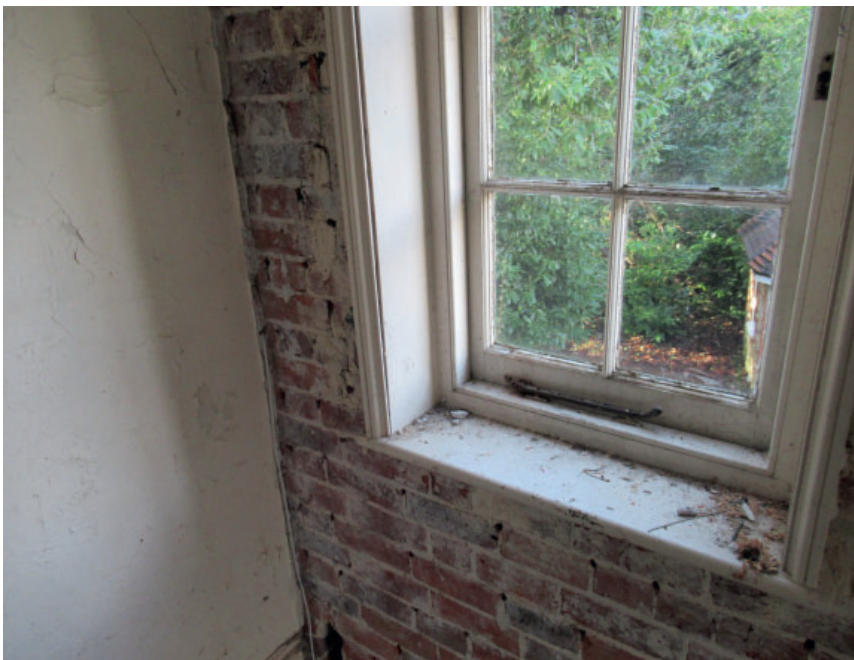
**Fig 14 :**

View of the wall/reveal width across a window opening

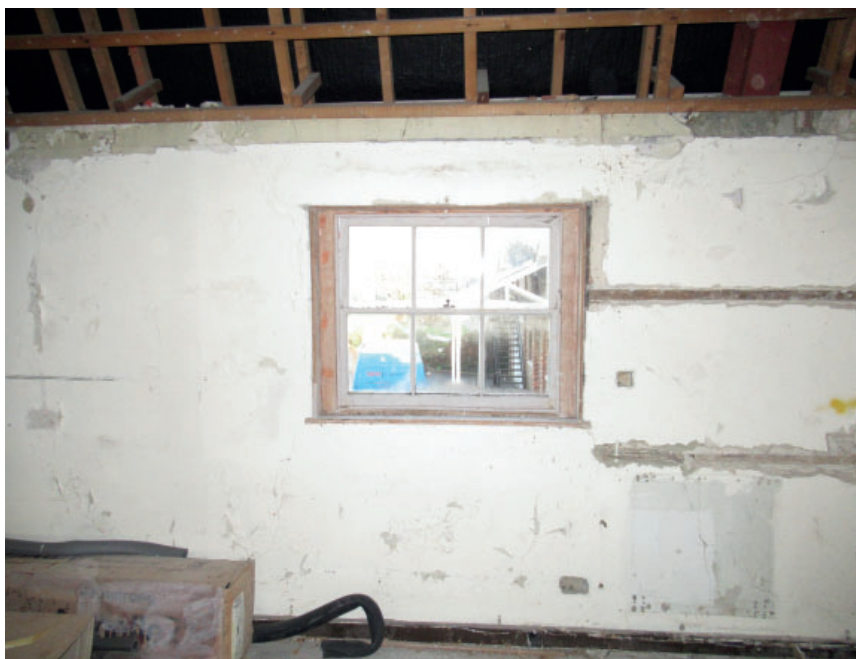
**Fig 15 :**

View of window openings used to establish the construction type of the building

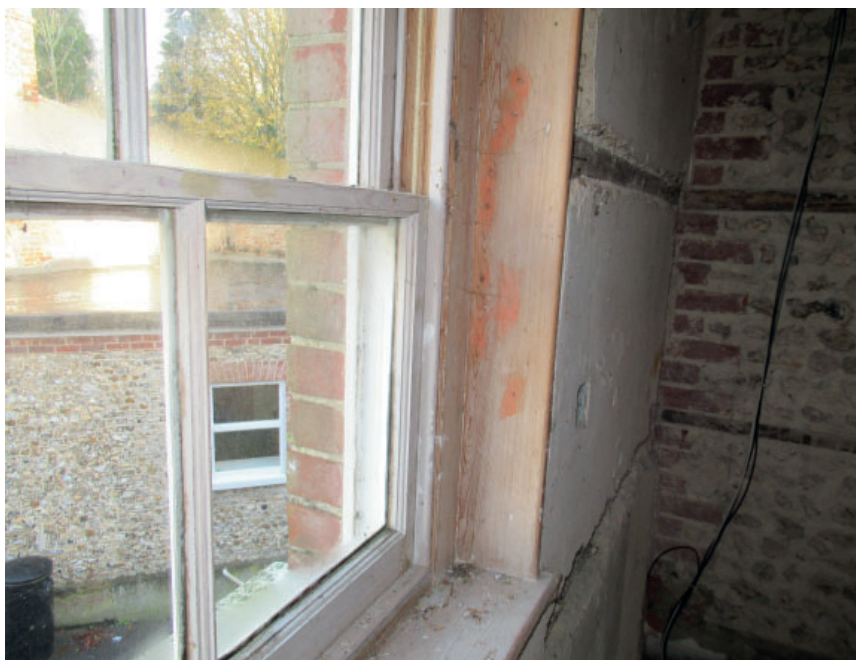
**Fig 16 :**

View of the wall/reveal width across a window opening

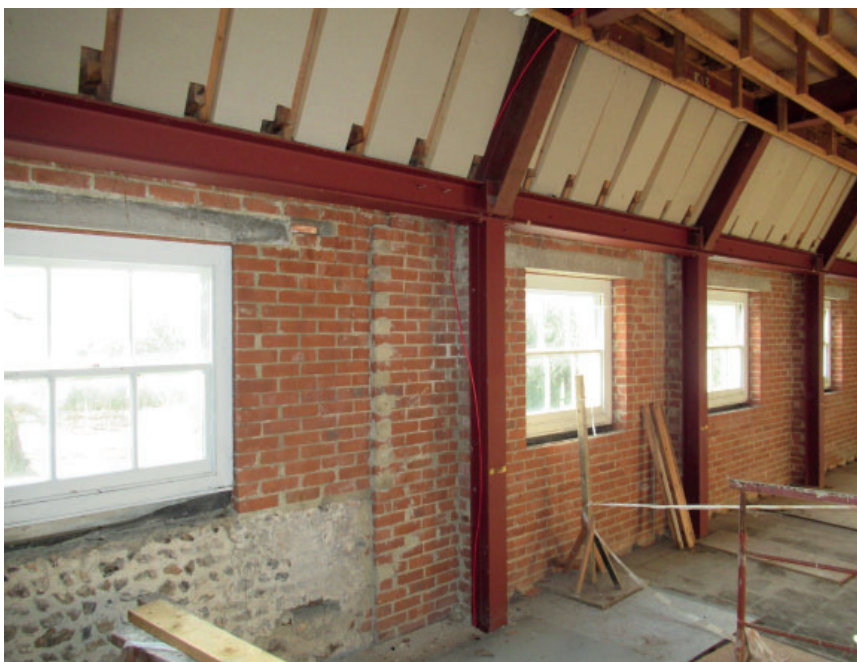
**Fig 18 :**

View of window openings used to establish the construction type of the building

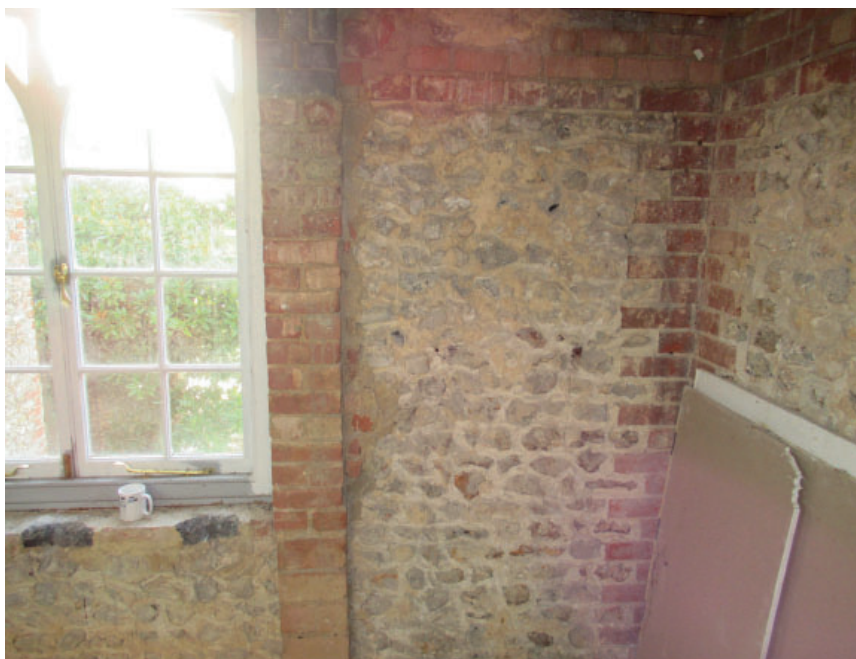
**Fig 19 :**

View of the internal wall construction

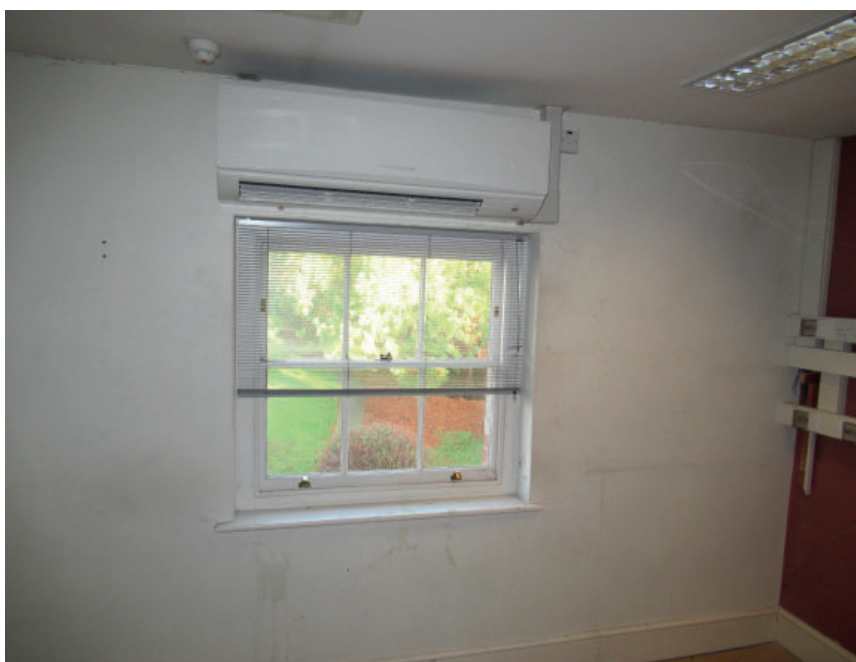
**Fig 20 :**

View of window openings used to establish the construction type of the building

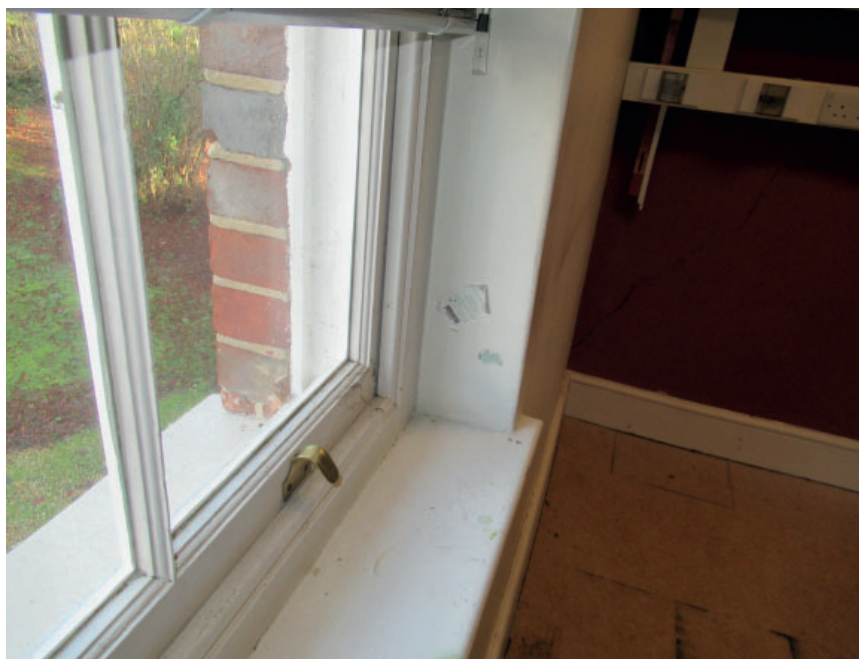
**Fig 21 :**

View of the wall/reveal width across a window opening

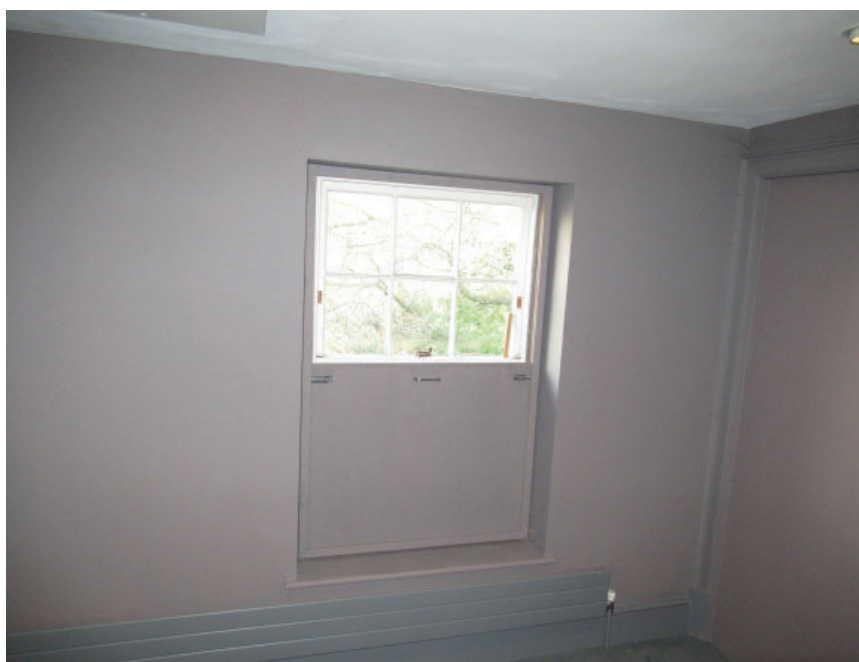
**Fig 22 :**

View of window openings used to establish the construction type of the building

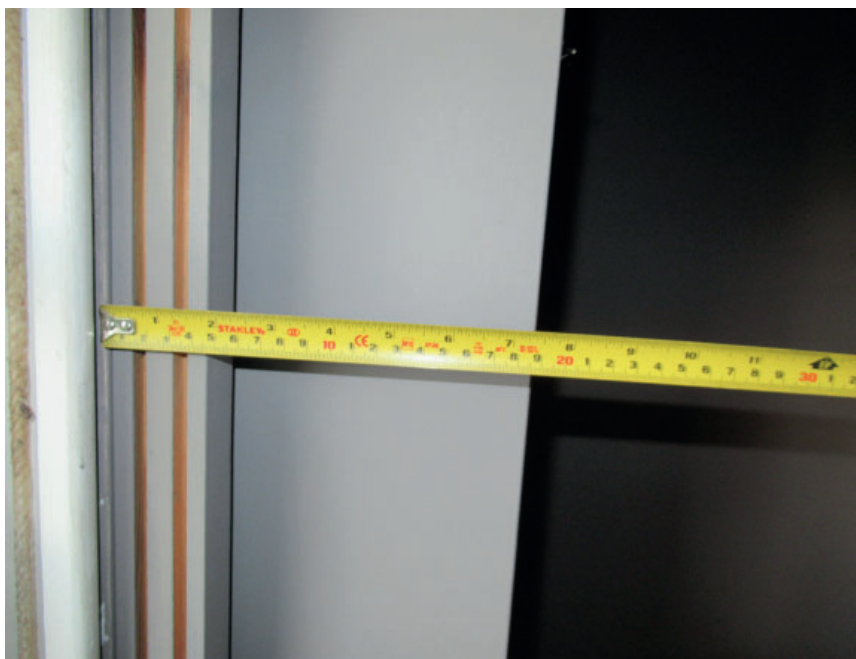
**Fig 23 :**

View of the wall/reveal width across a window opening

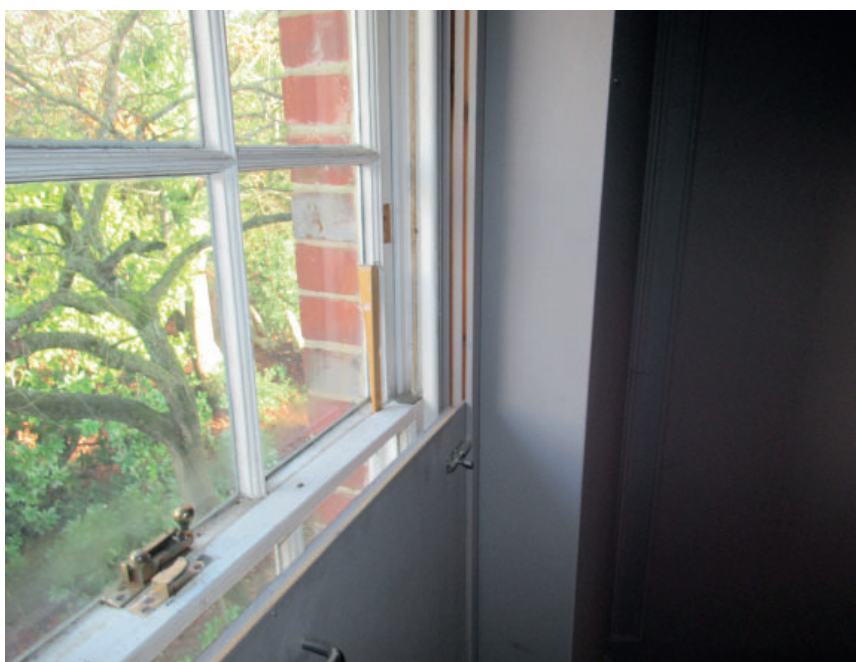
**Fig 24 :**

View of the wall/reveal width across a window opening

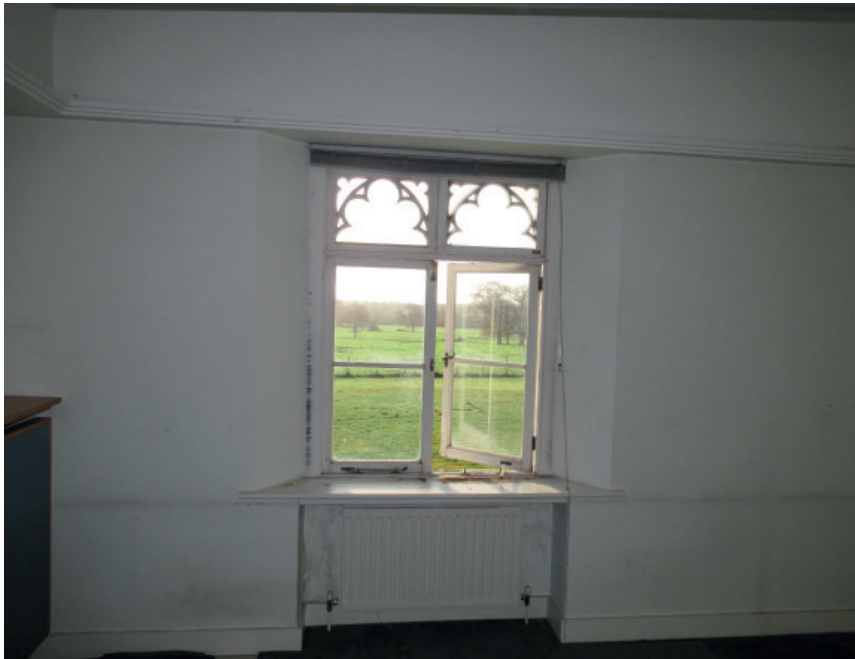
**Fig 25 :**

View of window openings used to establish the construction type of the building

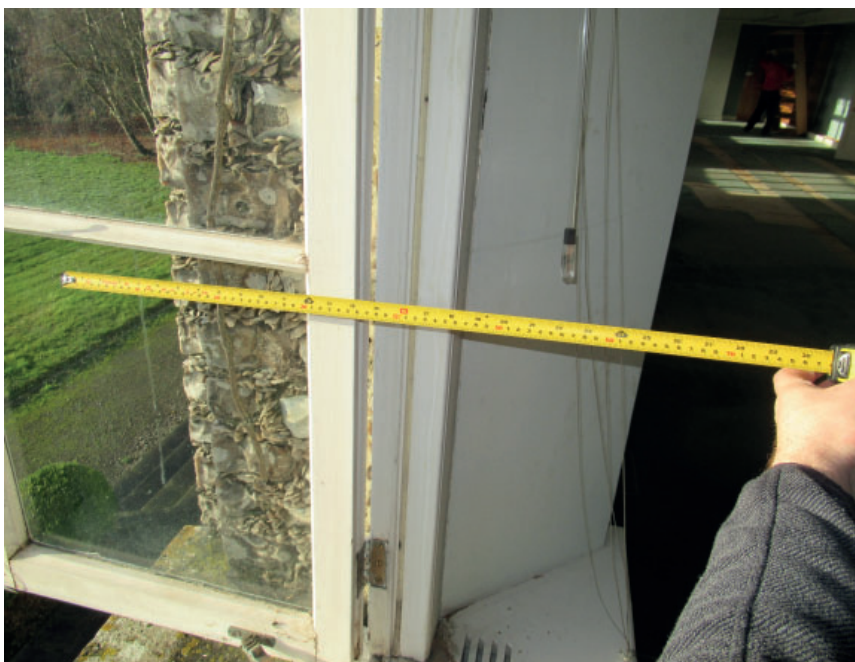
**Fig 26 :**

View of the wall/reveal width across a window opening

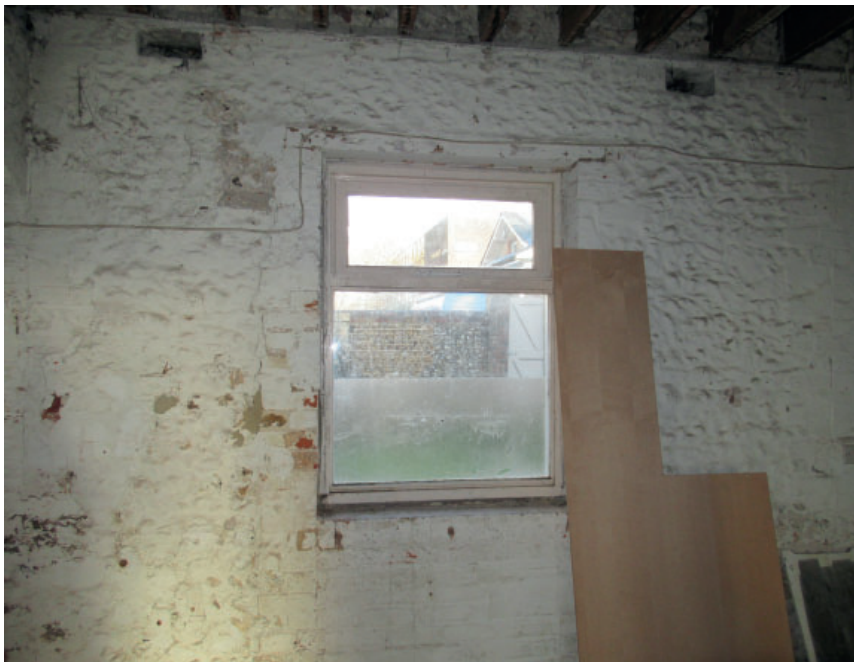
**Fig 27 :**

View of window openings used to establish the construction type of the building

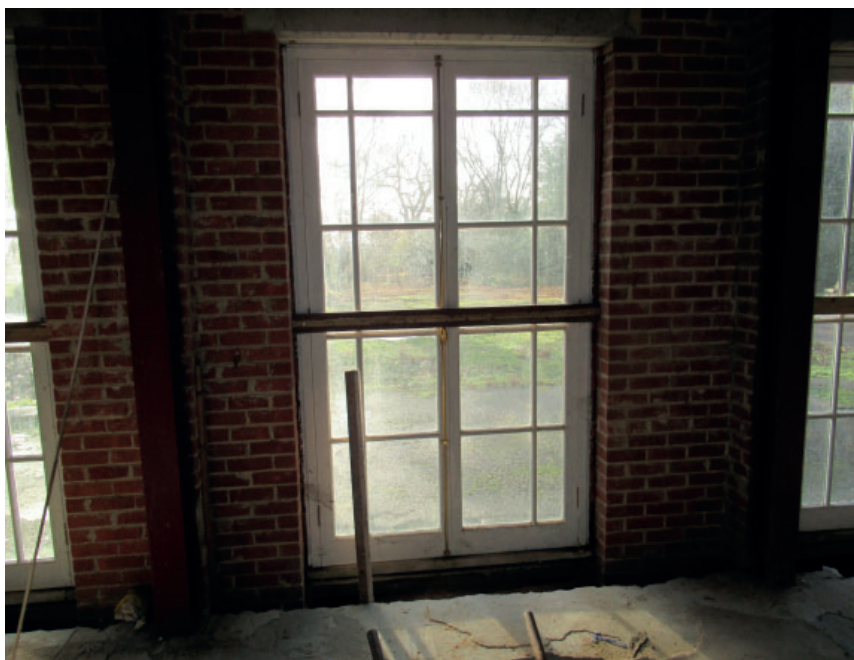
**Fig 28 :**

View of window openings used to establish the construction type of the building

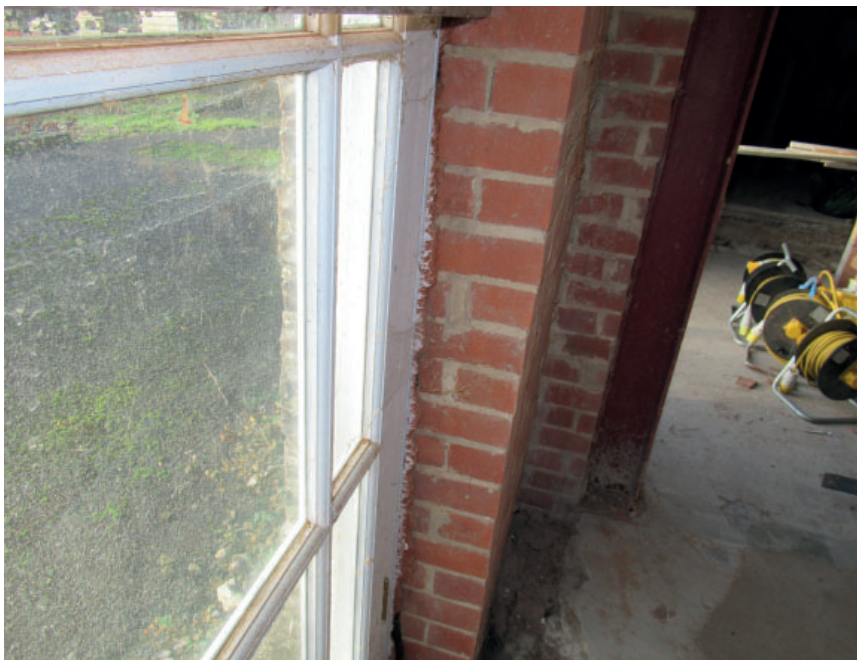
**Fig 29 :**

View of the wall/reveal width across a window opening

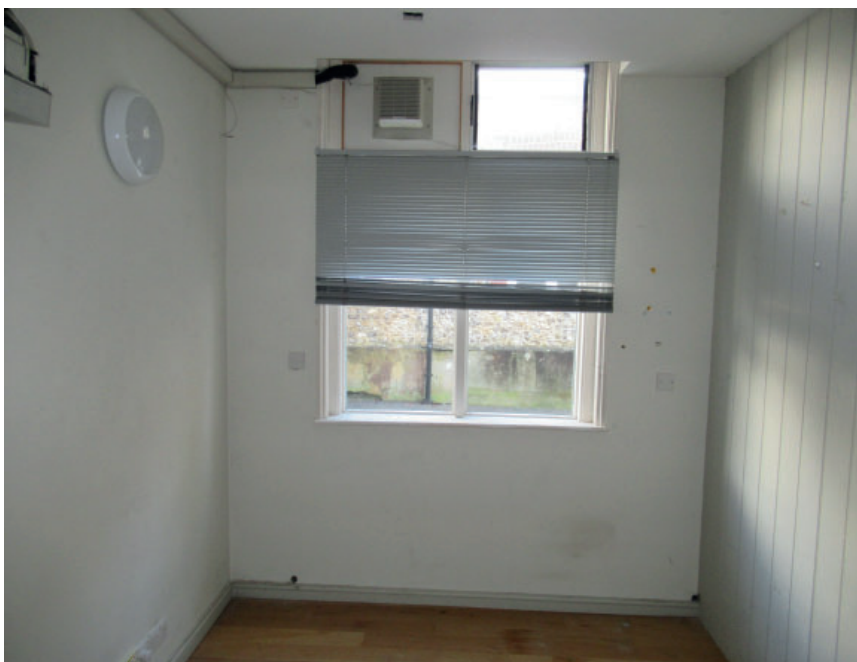
**Fig 30 :**

View of window openings used to establish the construction type of the building

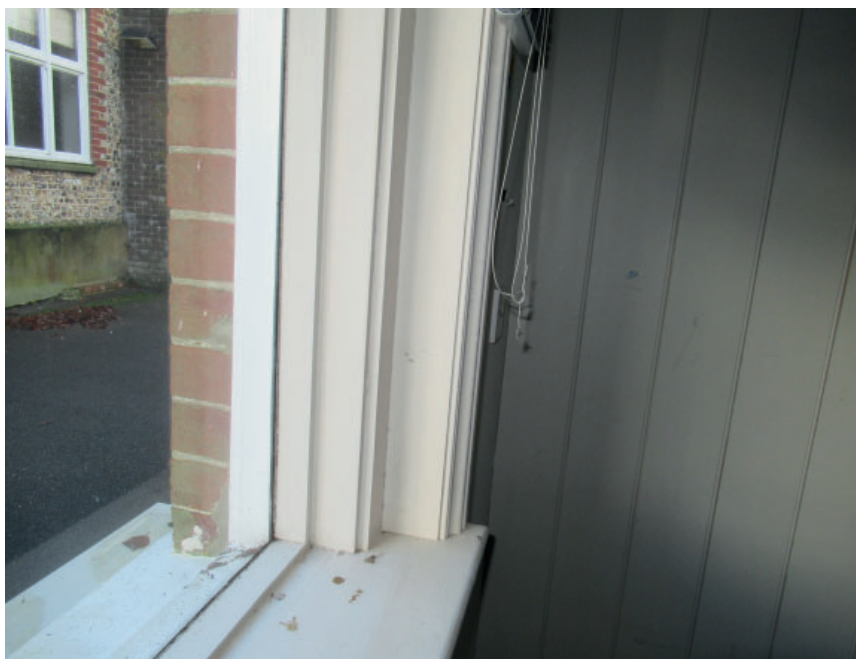
**Fig 31 :**

View of the wall/reveal width across a window opening

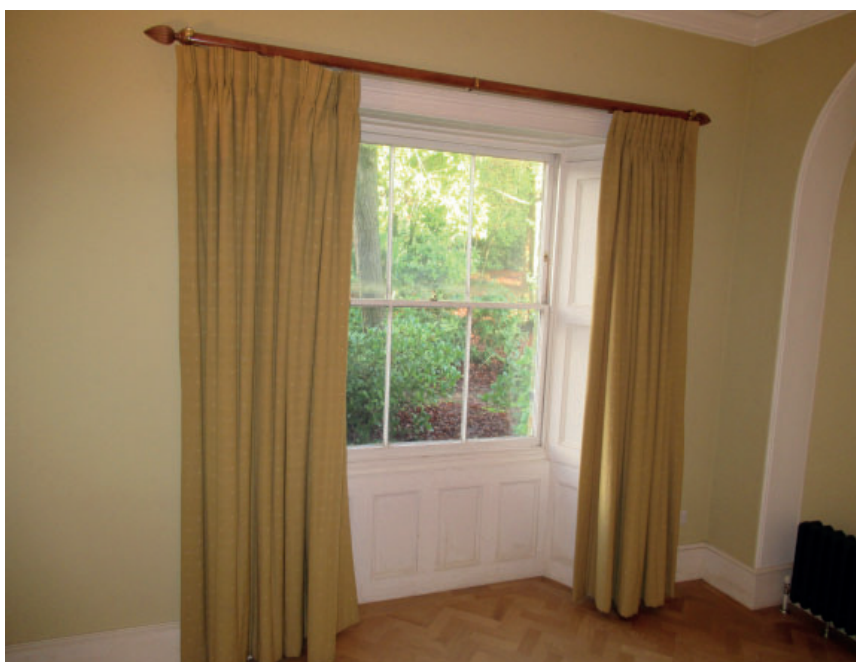
**Fig 32 :**

View of window openings used to establish the construction type of the building

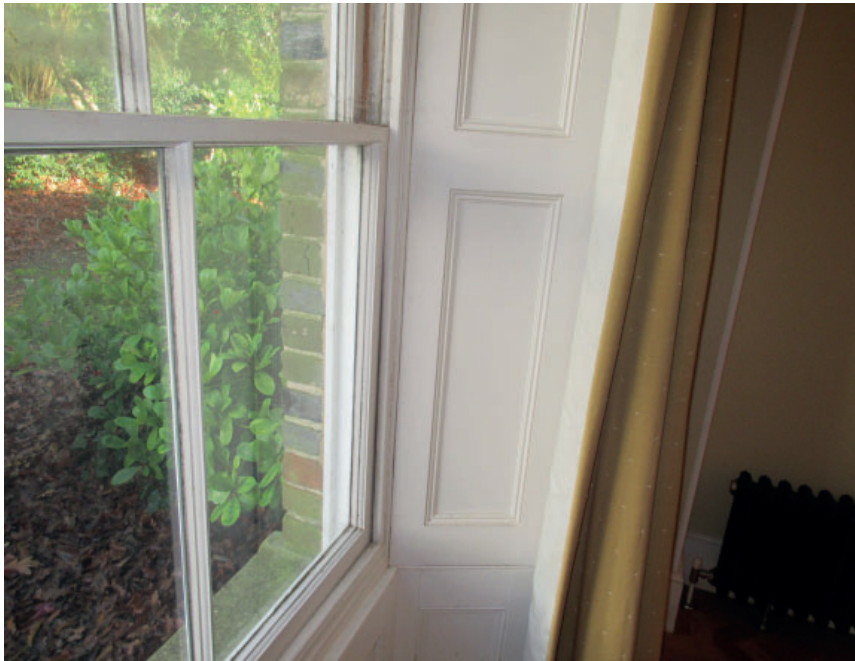
**Fig 33 :**

View of the wall/reveal width across a window opening

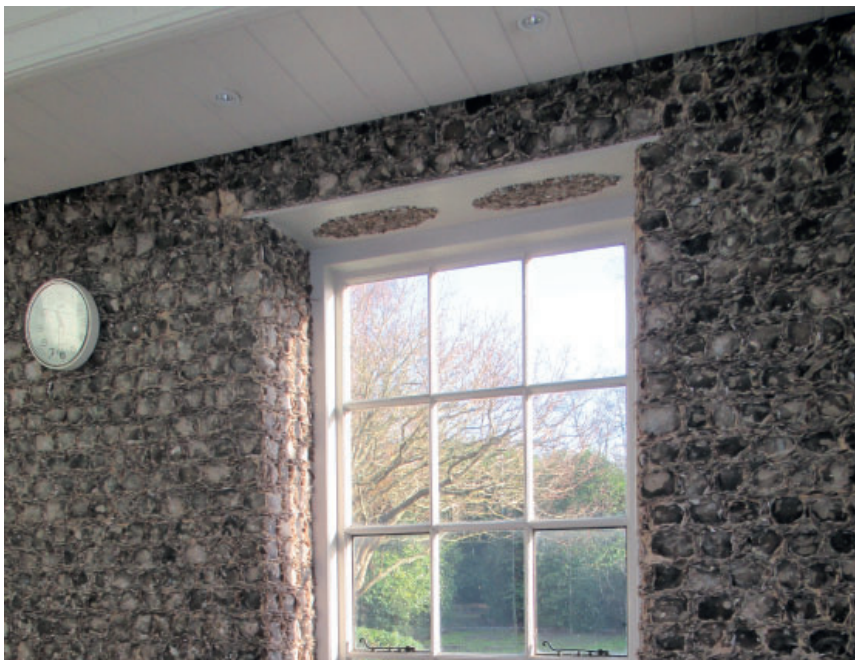
**Fig 34 :**

View of window openings used to establish the construction type of the building

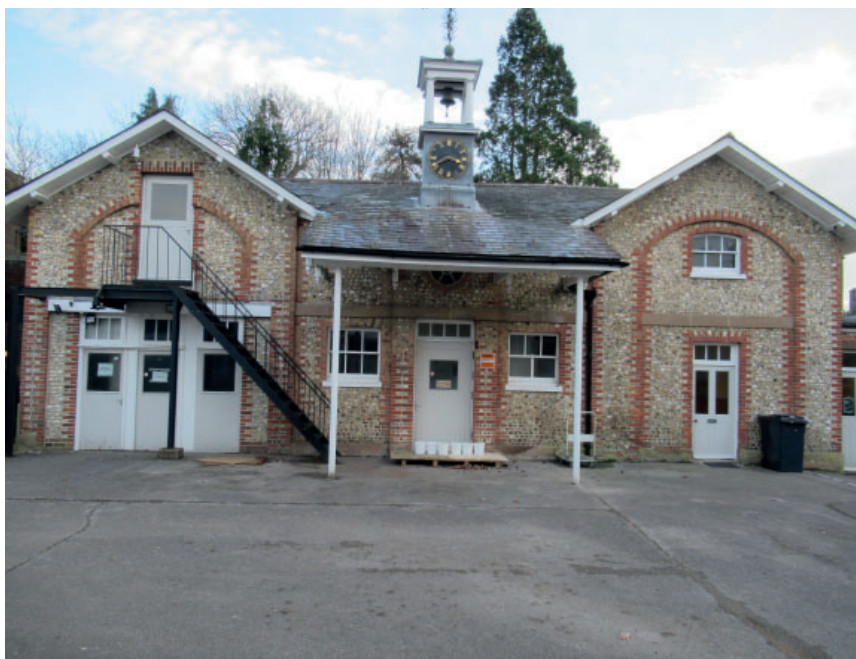
**Fig 35 :**

General view of façades. The exterior faces were found to be knapped flint bedded on a lime-based mortar

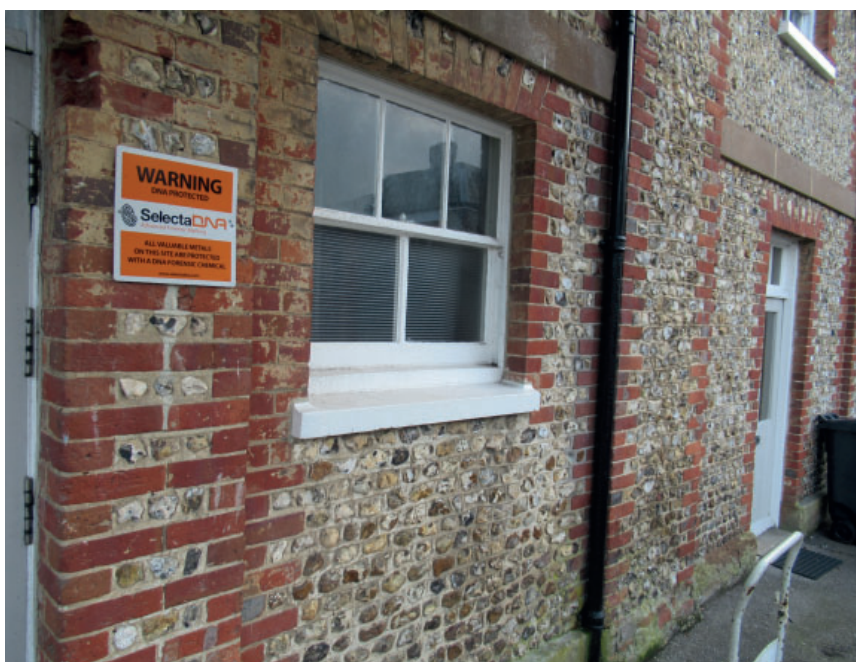
**Fig 36 :**

General view of façades. The exterior faces were found to be knapped flint bedded on a lime-based mortar

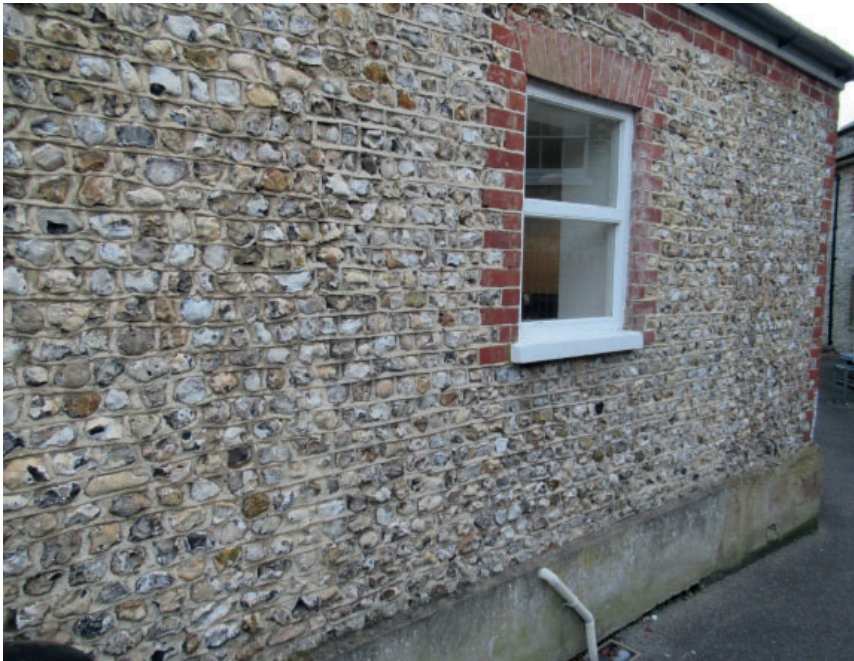
**Fig 37 :**

General view of façades. The exterior faces were found to be knapped flint bedded on a lime-based mortar

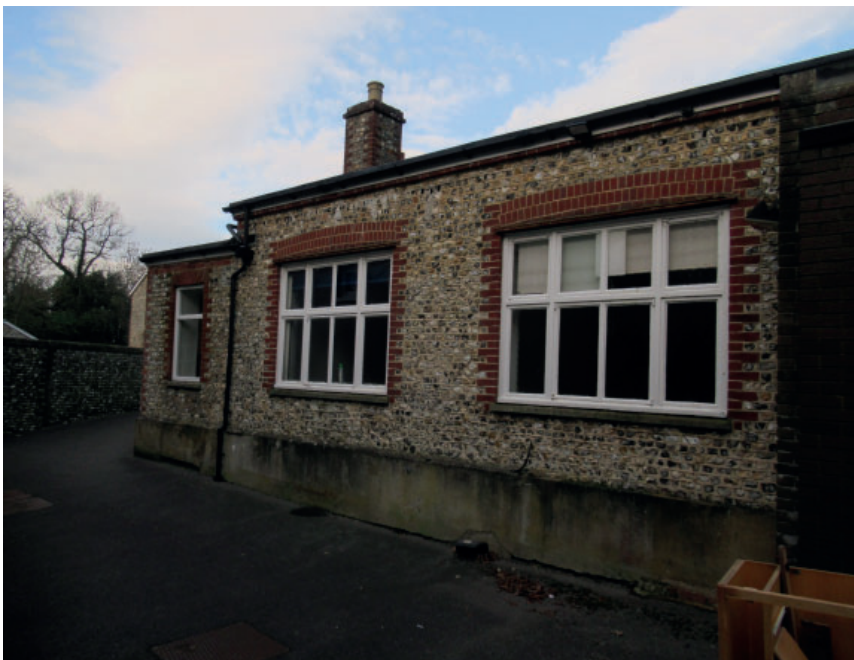
**Fig 38 :**

General view of façades. The exterior faces were found to be knapped flint bedded on a lime-based mortar

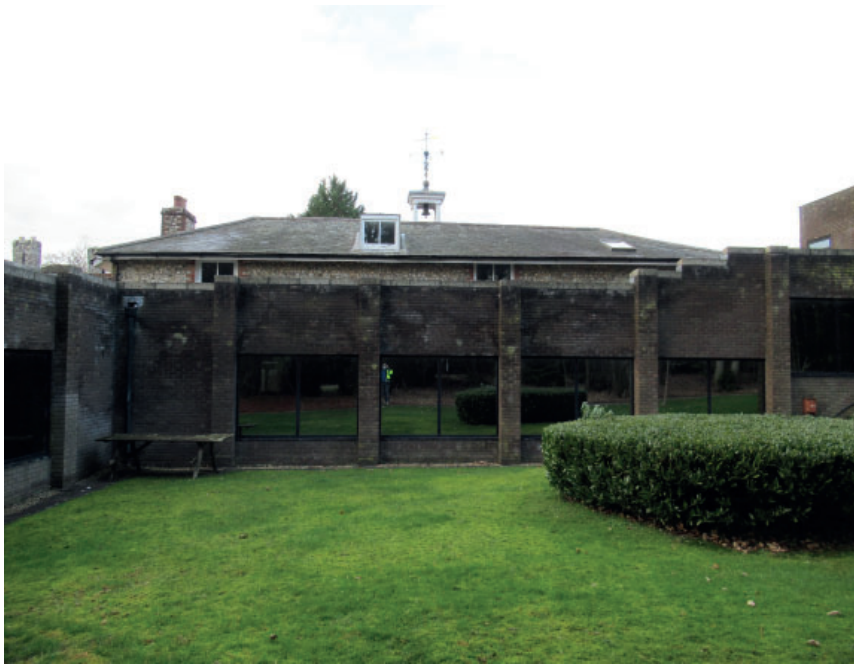
**Fig 39 :**

General view of façades. The exterior faces were found to be knapped flint bedded on a lime-based mortar

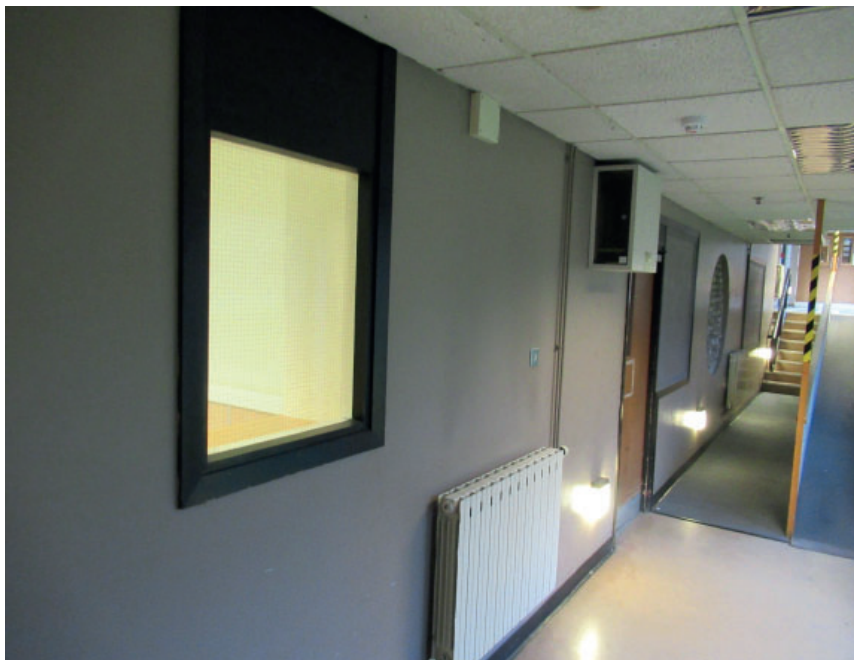
**Fig 40 :**

View of window openings used to establish the construction type of the building

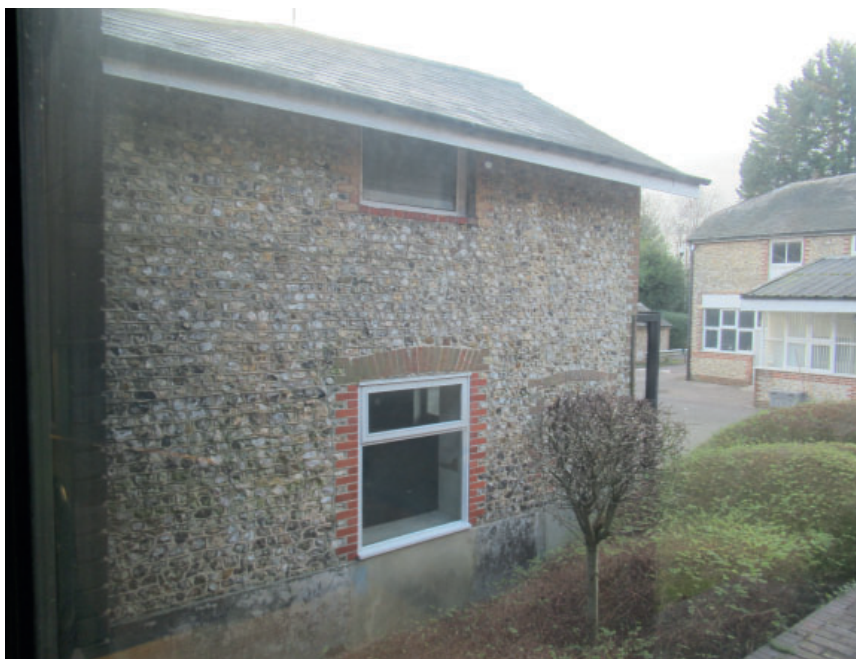
**Fig 43 :**

General view of façades. The exterior faces were found to be knapped flint bedded on a lime-based mortar

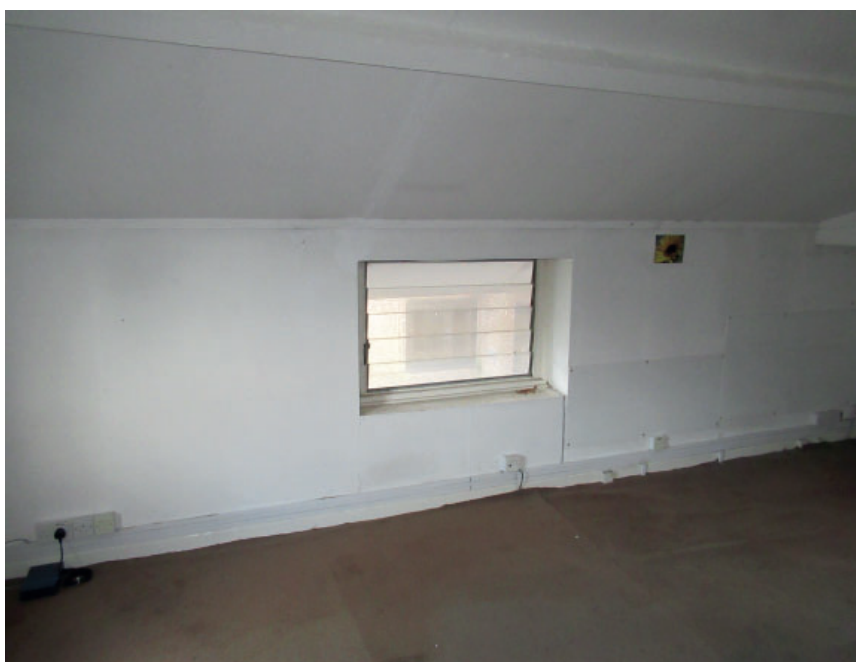
**Fig 44 :**

View of window openings used to establish the construction type of the building

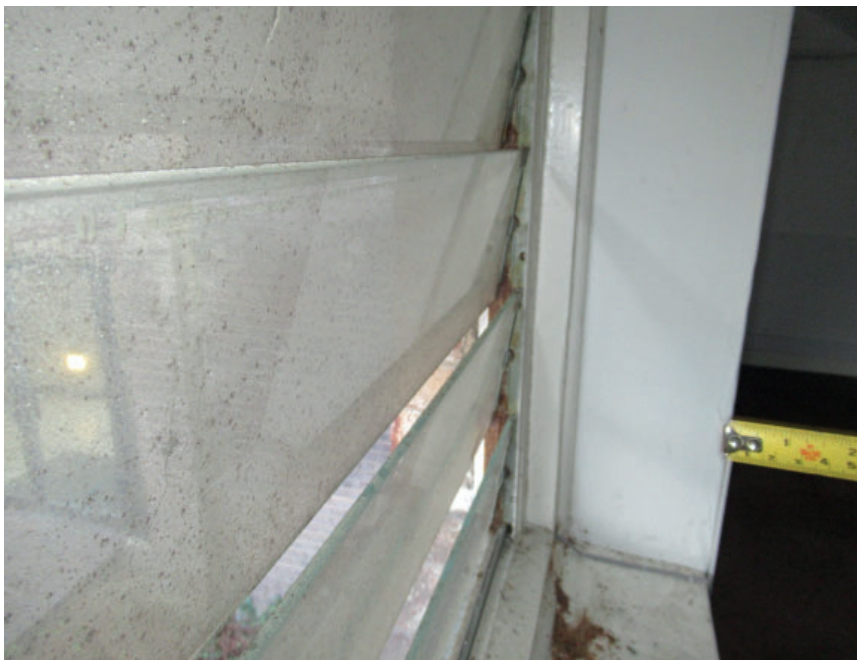
**Fig 45 :**

View of the wall/reveal width across  
a window opening

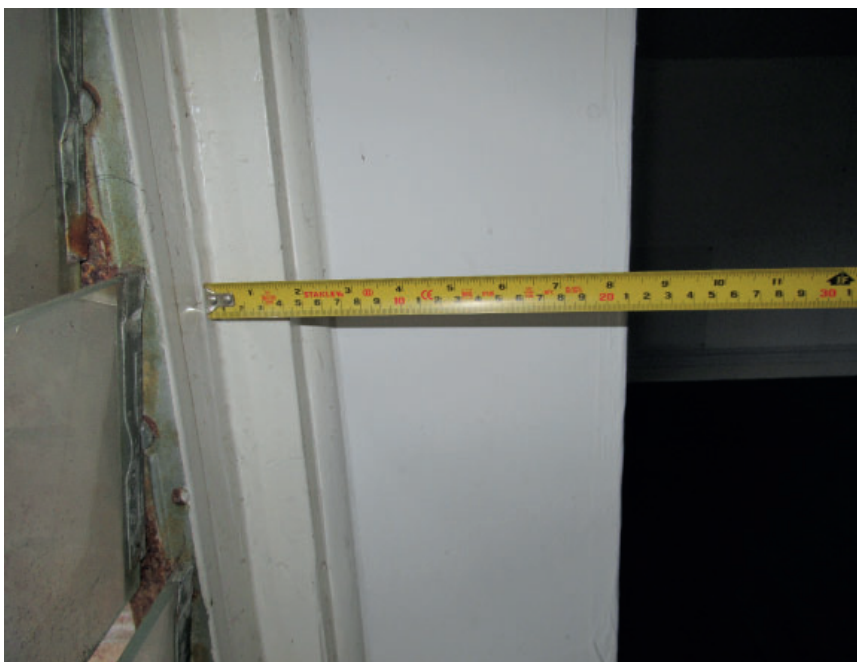
**Fig 46 :**

View of the wall/reveal width across  
a window opening

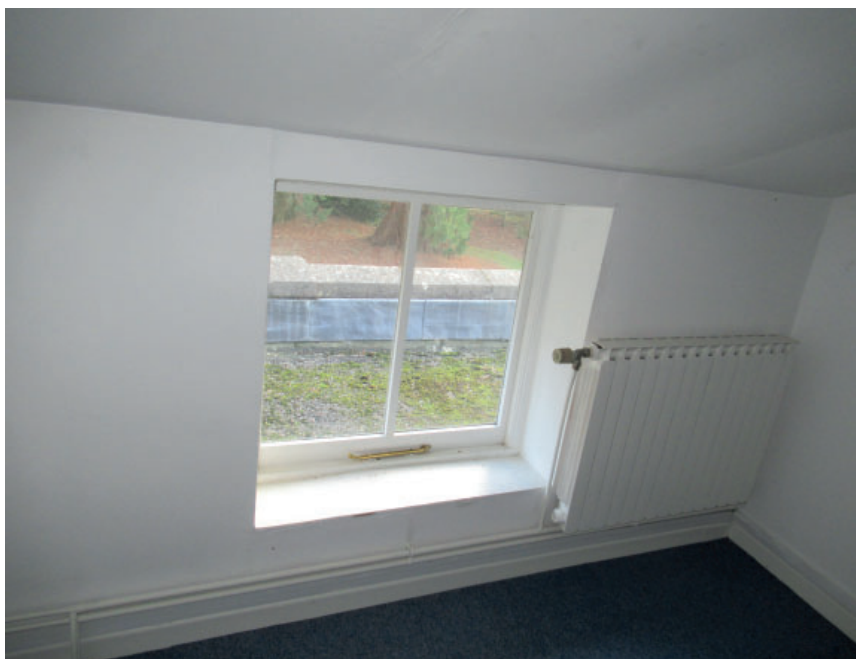
**Fig 47 :**

View of window openings used to establish the construction type of the building

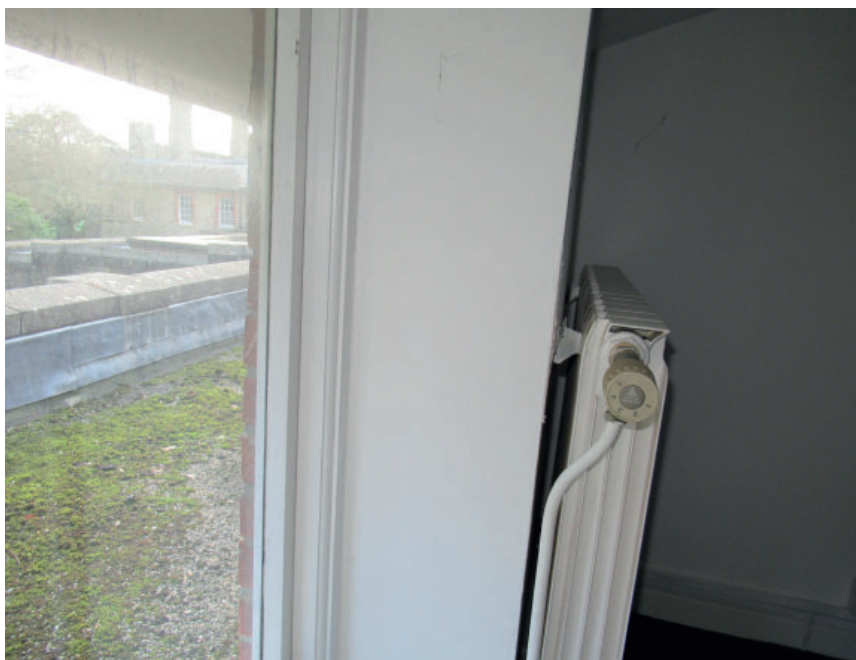
**Fig 48 :**

View of the wall/reveal width across a window opening

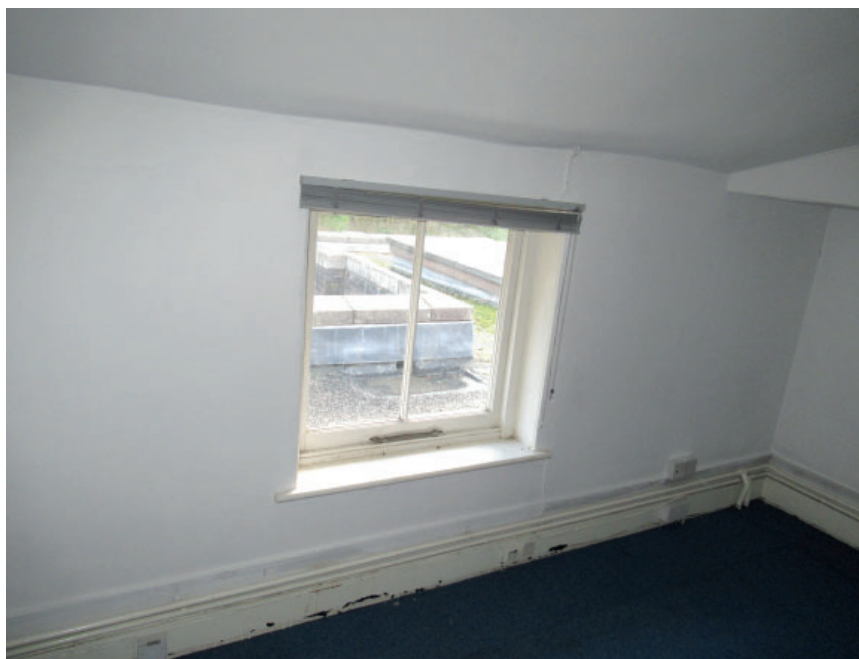
**Fig 49 :**

View of window openings used to establish the construction type of the building
