# Hutton + Rostron

### Southleigh Park House; Mansion House, Coach House and Stables: Preliminary condensation risk assessment

Site note A7 for 15 December 2020 and 05 January 2021 Job no.  
152.09

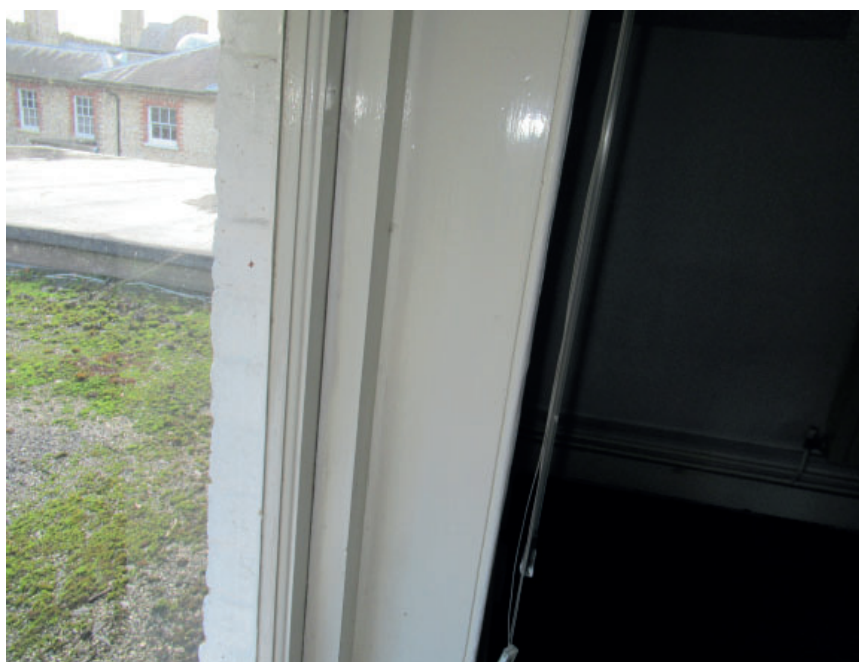
**Fig 50 :**

View of the wall/reveal width across a window opening

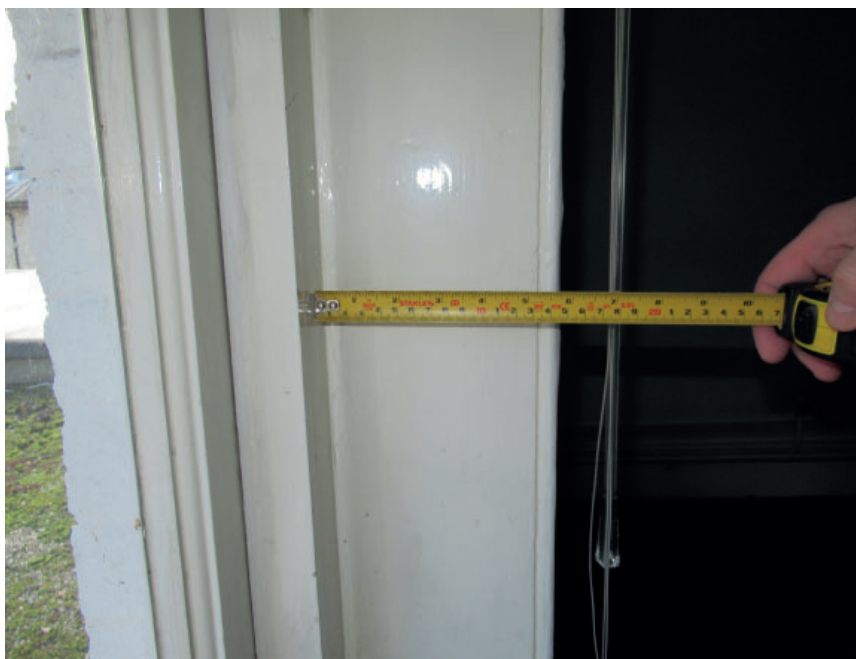
**Fig 51 :**

View of the wall/reveal width across a window opening

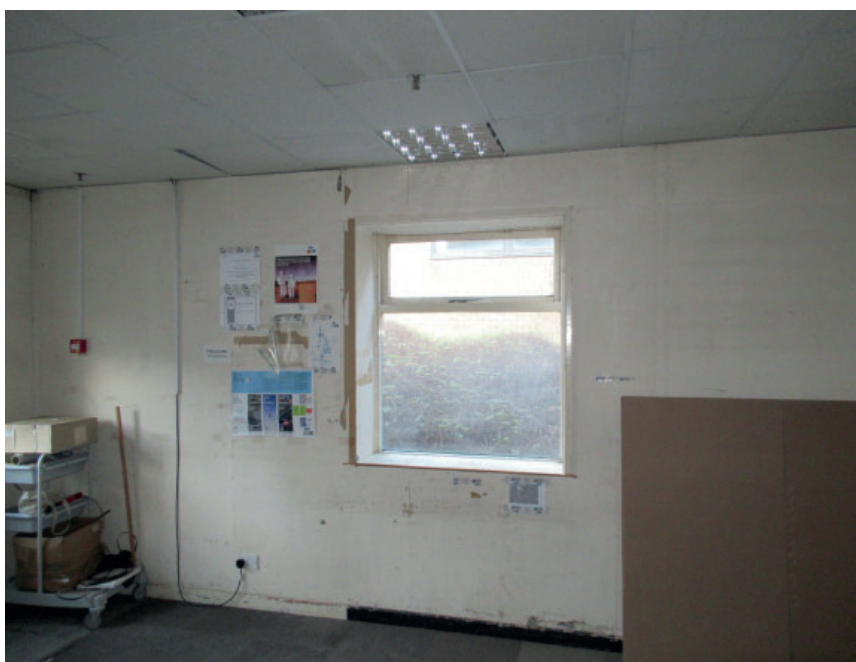
**Fig 52 :**

View of window openings used to establish the construction type of the building

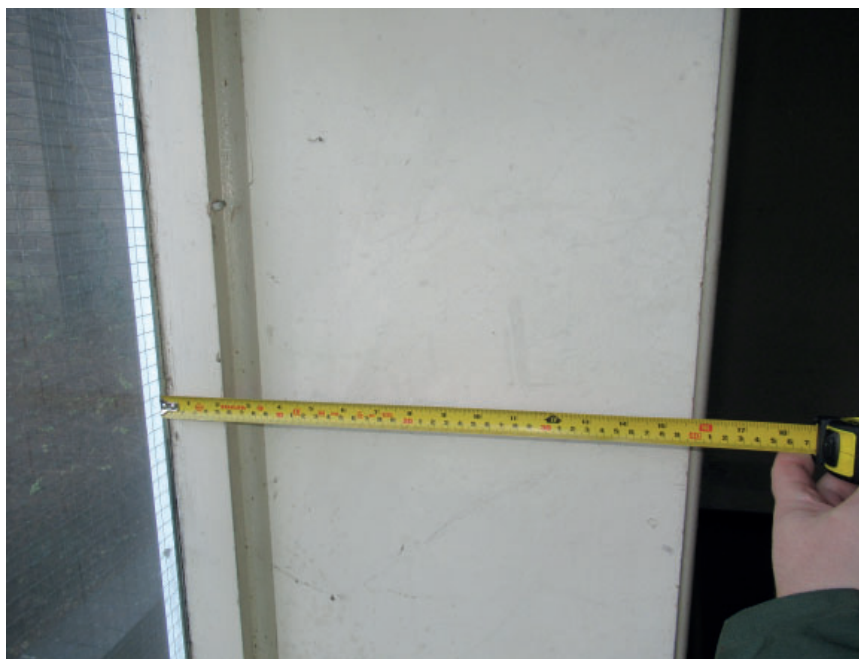
**Fig 53 :**

View of the wall/reveal width across a window opening

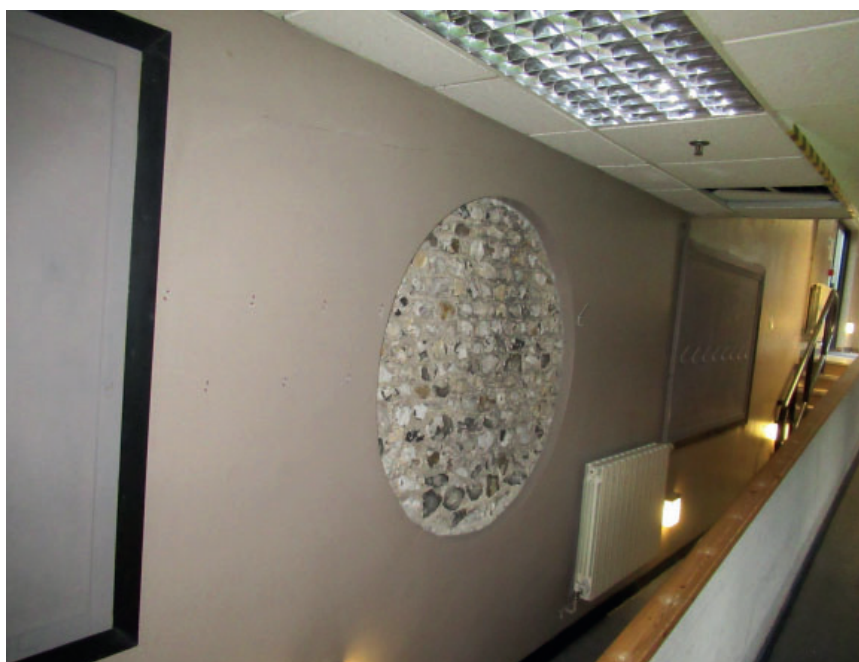
**Fig 54 :**

View of the internal wall construction

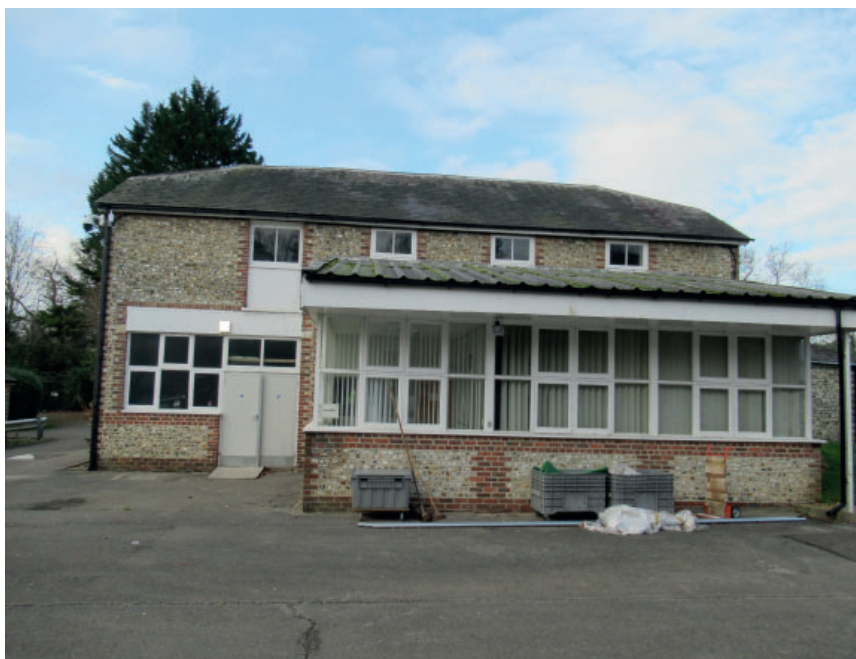
**Fig 55 :**

General view of façades. The exterior faces were found to be knapped flint bedded on a lime-based mortar

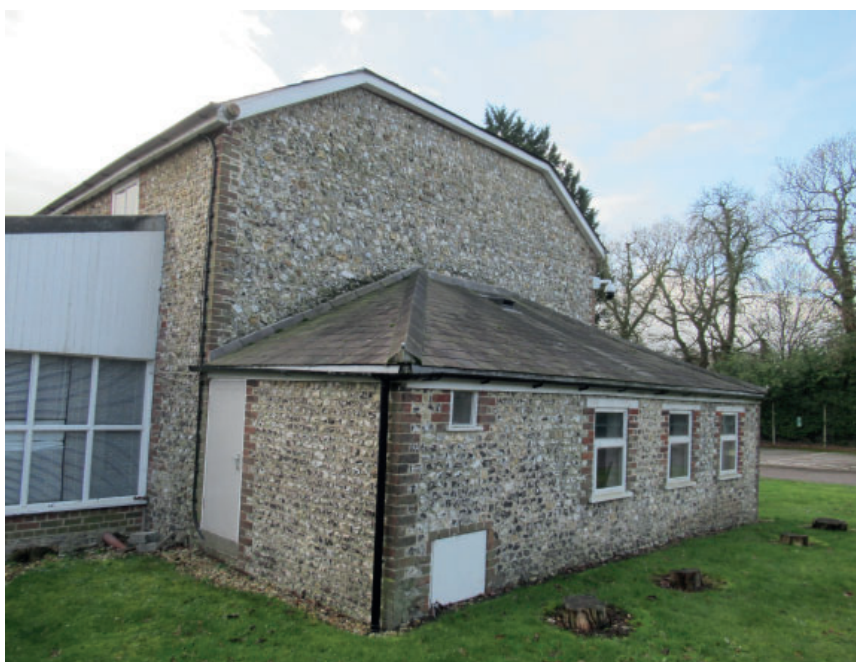
**Fig 56 :**

General view of façades. The exterior faces were found to be knapped flint bedded on a lime-based mortar

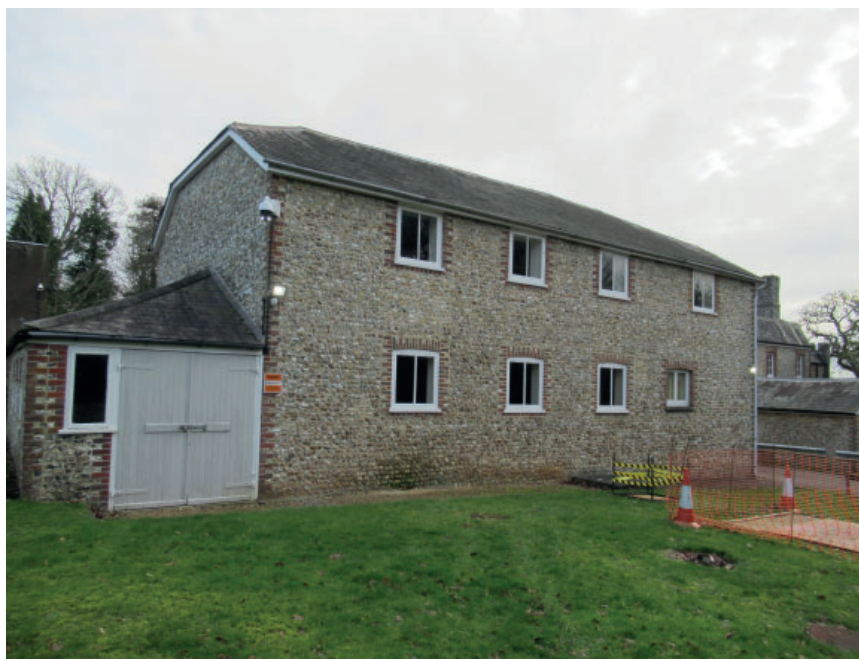
**Fig 57 :**

General view of façades. The exterior faces were found to be knapped flint bedded on a lime-based mortar

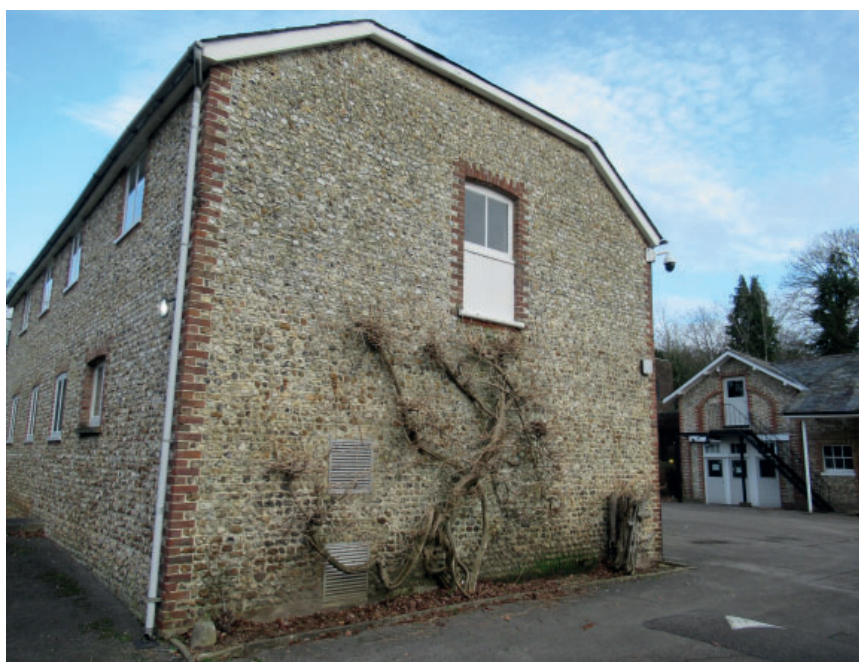
**Fig 58 :**

General view of façades. The exterior faces were found to be knapped flint bedded on a lime-based mortar

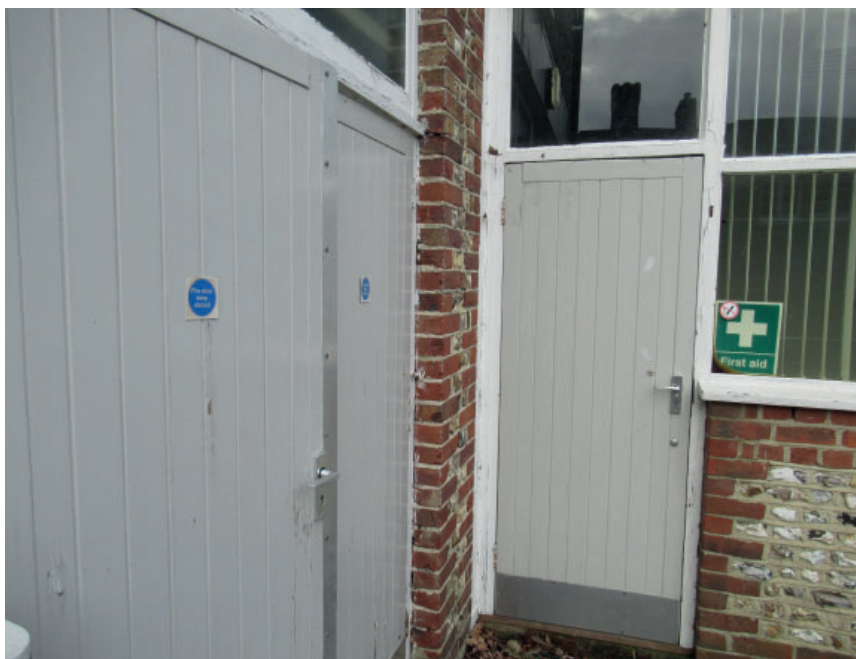
**Fig 59 :**

View of the external wall construction

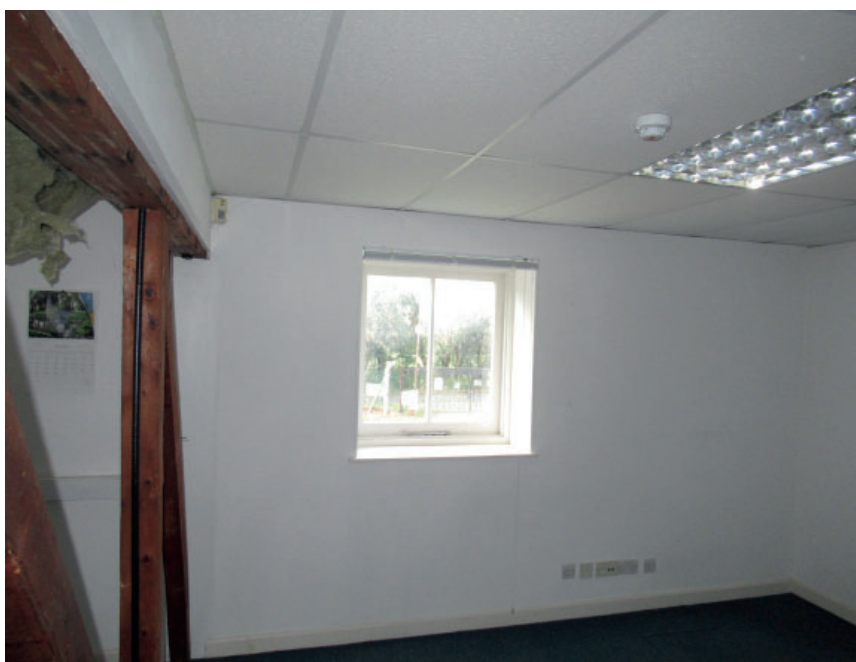
**Fig 60 :**

View of window openings used to establish the construction type of the building

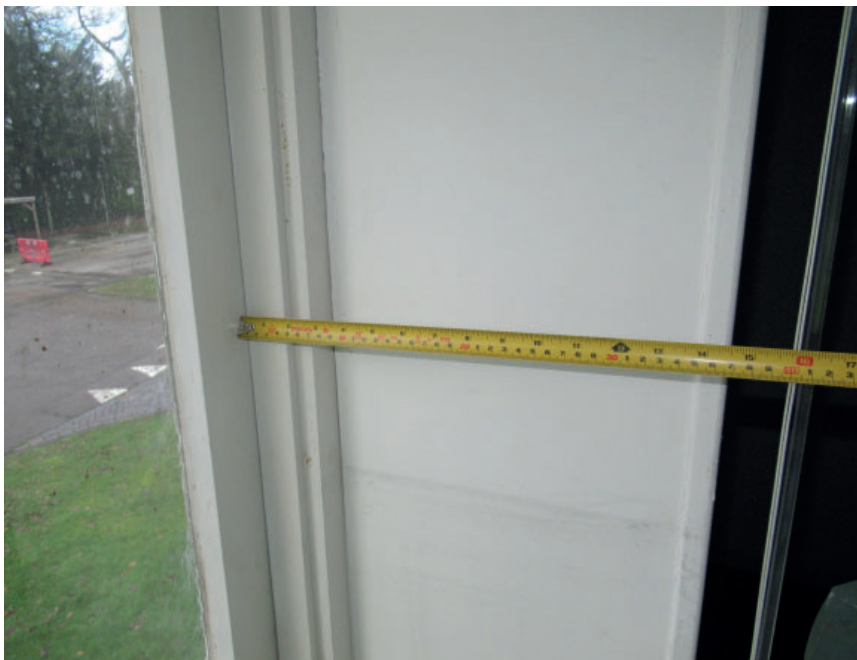
**Fig 61 :**

View of the wall/reveal width across a window opening

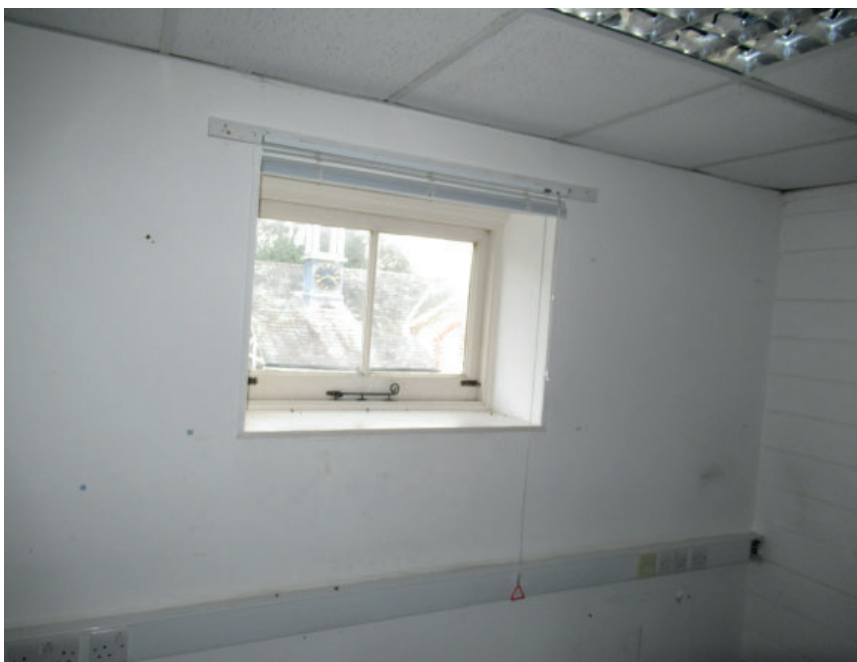
**Fig 62 :**

View of window openings used to establish the construction type of the building

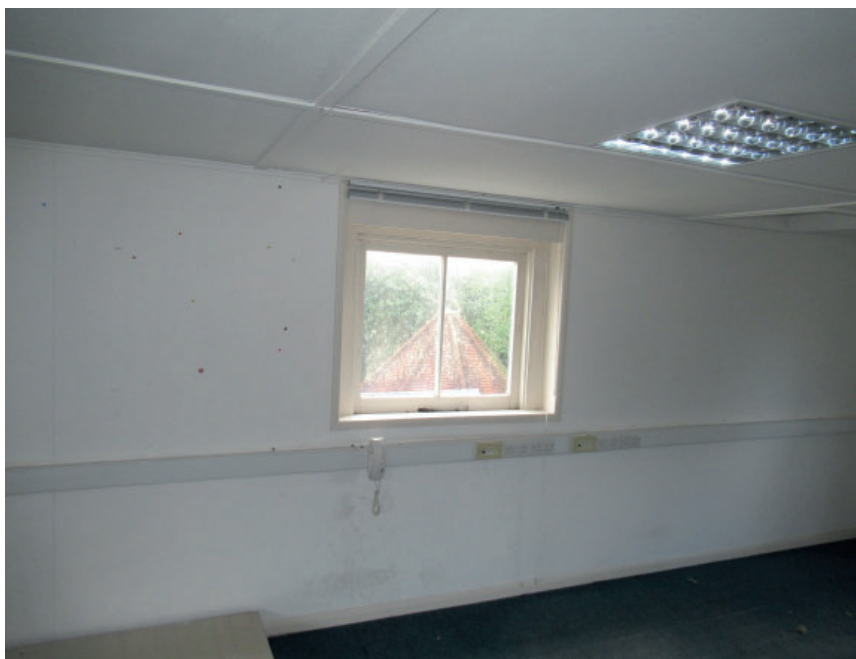
**Fig 63 :**

View of window openings used to establish the construction type of the building

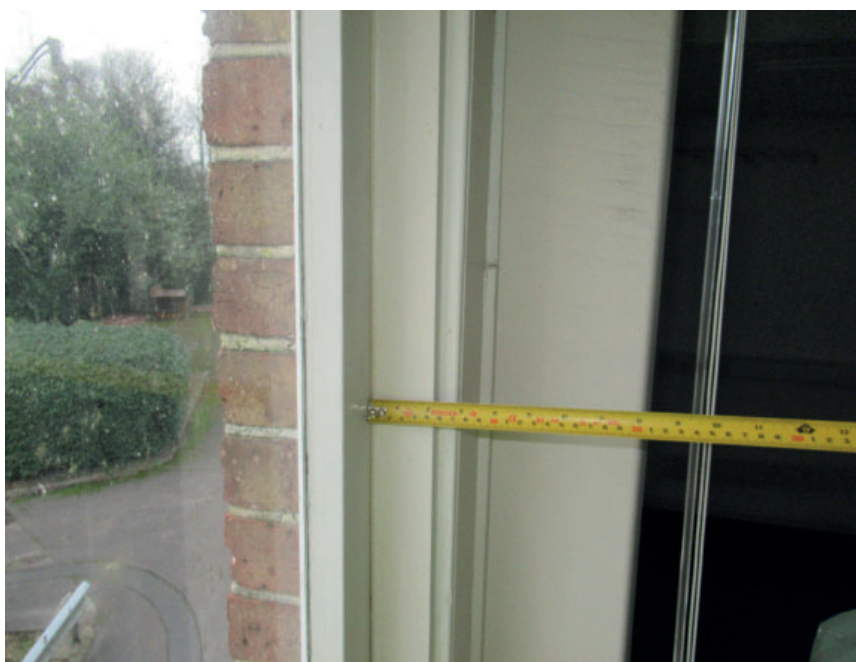
**Fig 64 :**

View of the wall/reveal width across a window opening

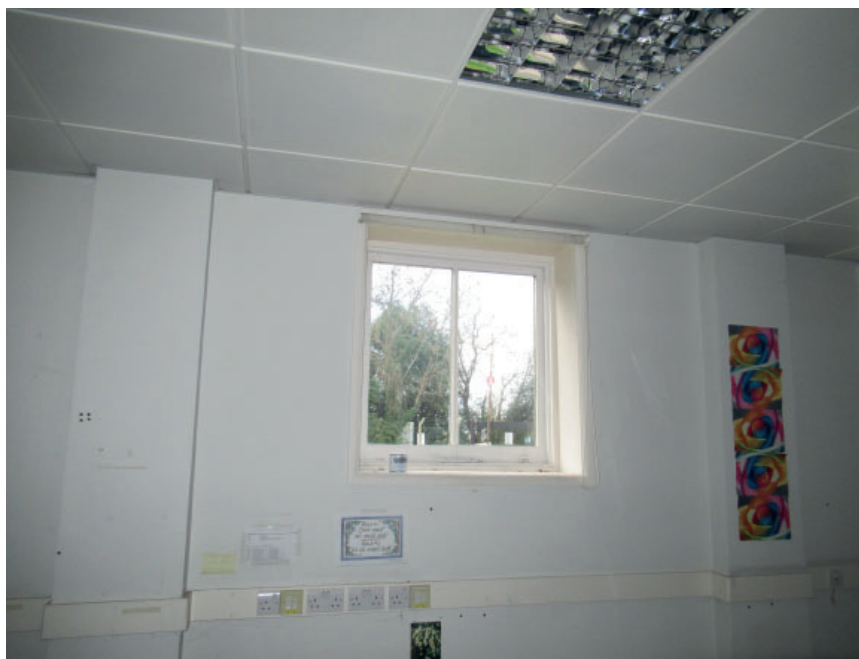
**Fig 65 :**

View of window openings used to establish the construction type of the building

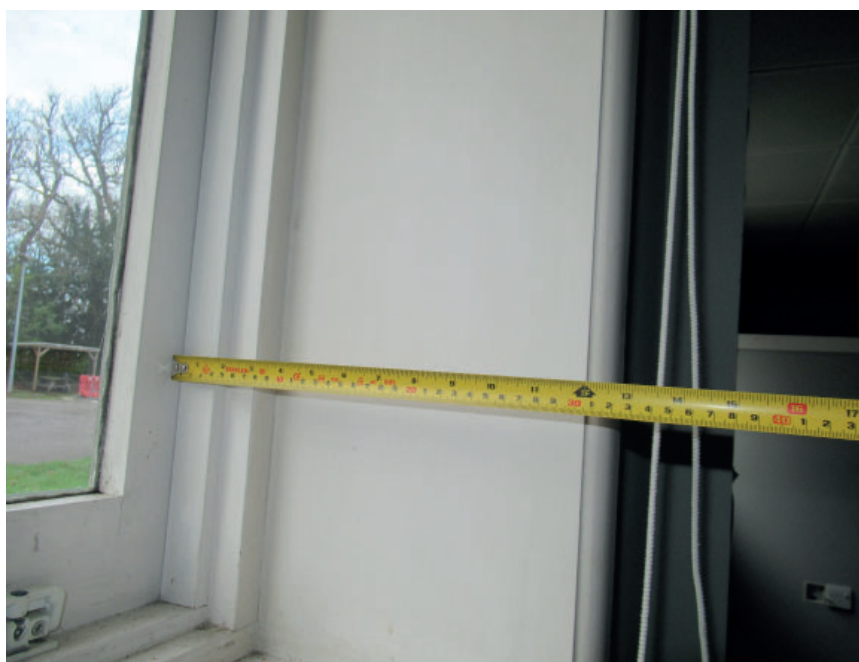
**Fig 66 :**

View of the wall/reveal width across a window opening

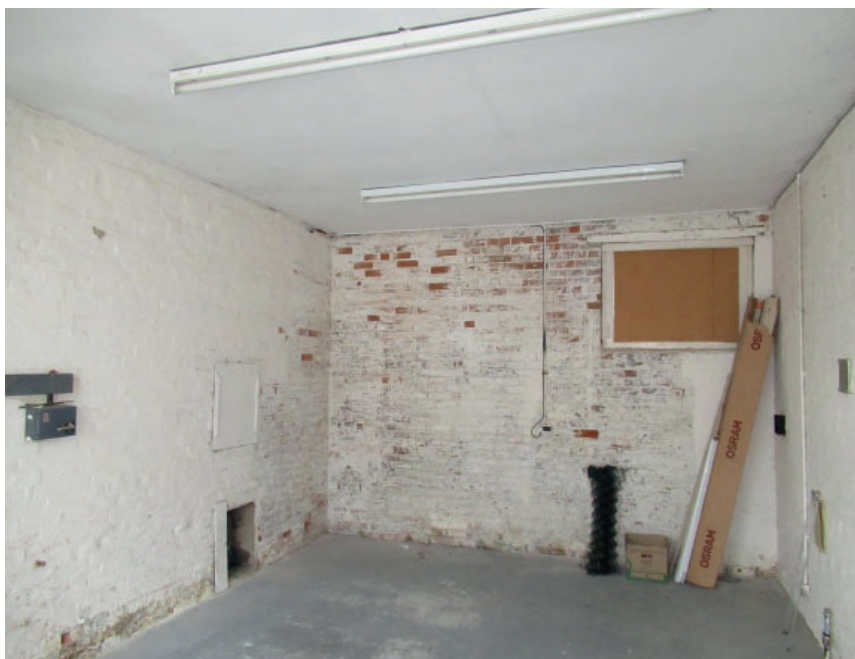
**Fig 67 :**

View of the internal wall construction

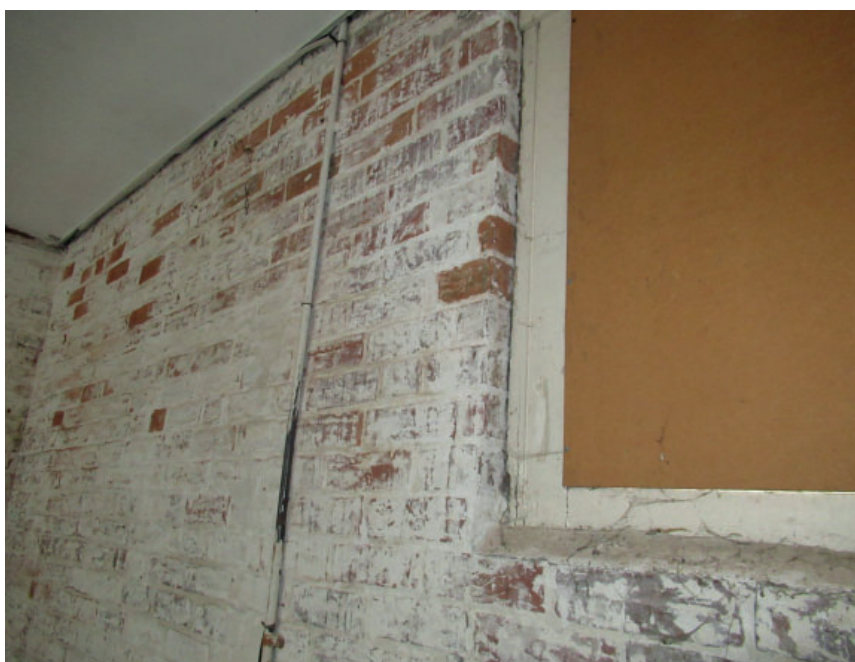
**Fig 68 :**

View of the wall/reveal width across a window opening

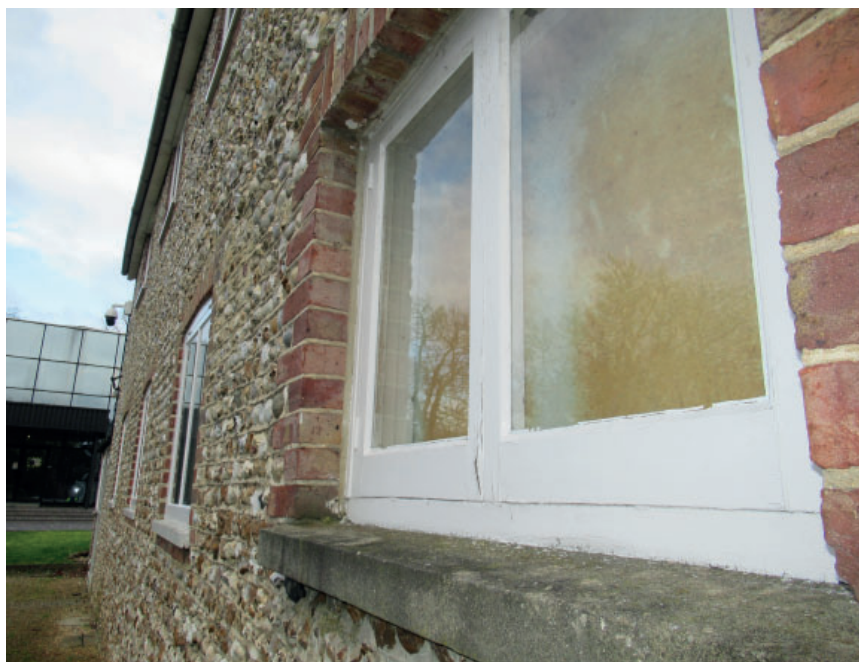
**Fig 69 :**

View of the wall/reveal width across  
a window opening
