**BELLWAY HOMES LTD (WESSEX) & THE  
BORROW FOUNDATION LTD  
PADNELL GRANGE  
WATERLOOVILLE**

**FLOOD RISK ASSESSMENT AND  
DRAINAGE STRATEGY**

**MARCH 2019**

| <b>Project Code:</b> | <b>A/BHPADNELL</b> |

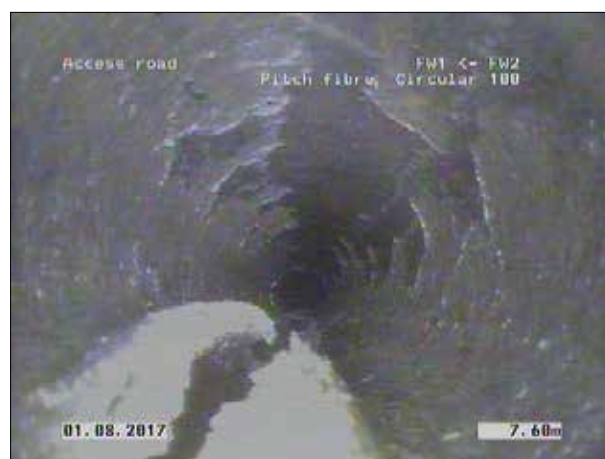
Photo: 1\_9a  
7.6m, Survey abandoned, Remark: to much scale in line

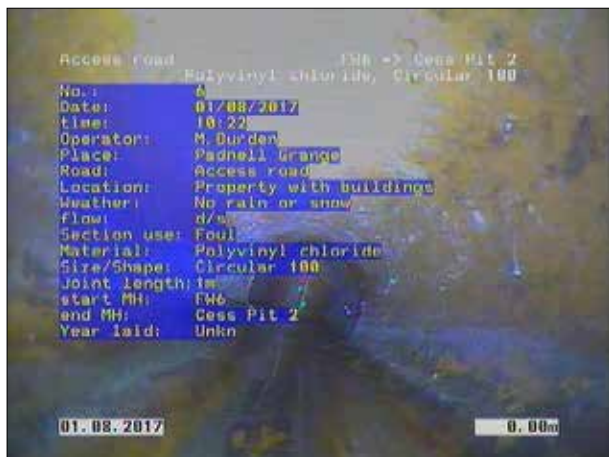
Photo: 46\_1a  
 0m, Water level 5 % height/diameter

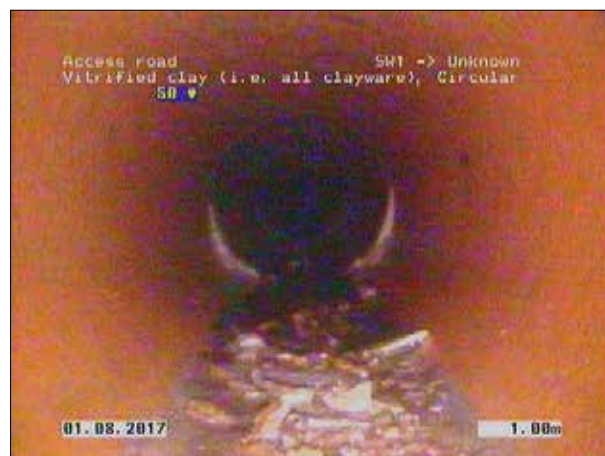
Photo: 69\_6a  
 1m, Survey abandoned, Remark: to much debris in line

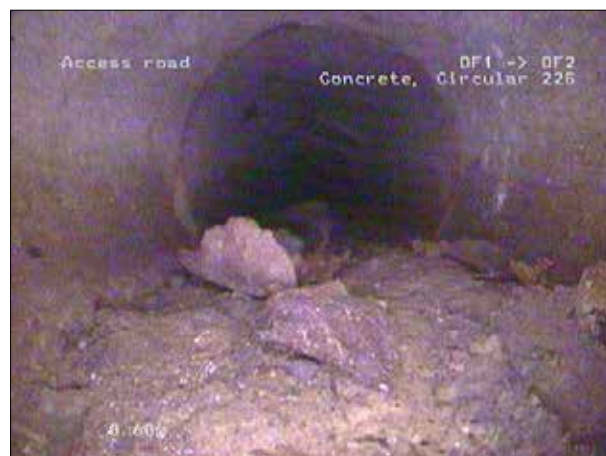
Photo: 118\_2a, 00:00:00  
0.6m, Settled deposits fine 10 % cross-sectional area loss

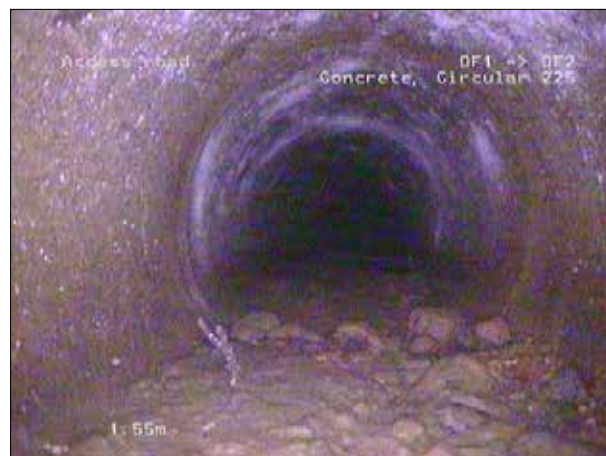
Photo: 120\_4a, 00:00:00  
1.55m, Survey abandoned, Remark: to much debris in line

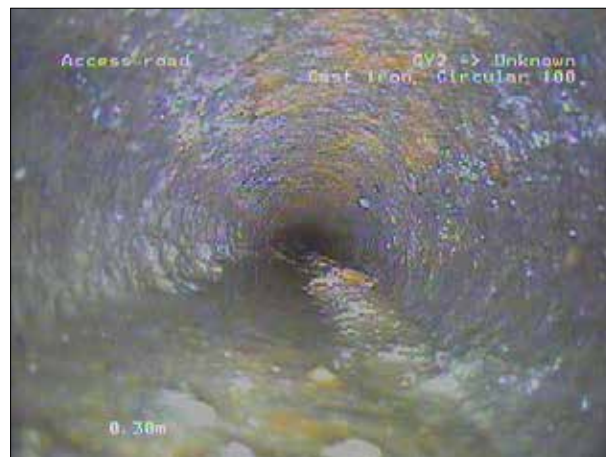
Photo: 123\_3a, 00:00:00  
 0.3m, Settled deposits fine 10 % cross-sectional area loss

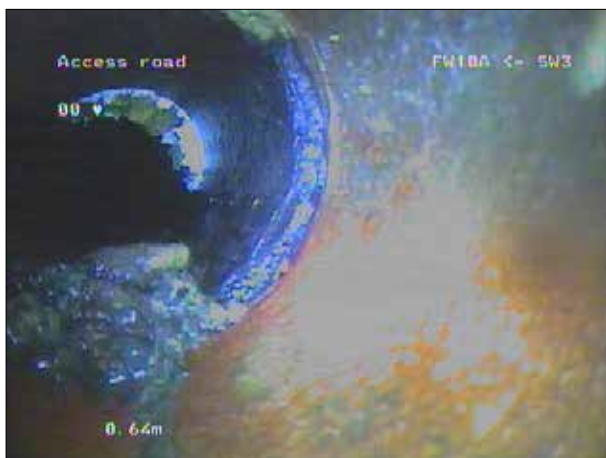
Photo: 173\_4a, 00:00:00  
0.62m, Settled deposits fine 10 % cross-sectional area loss
