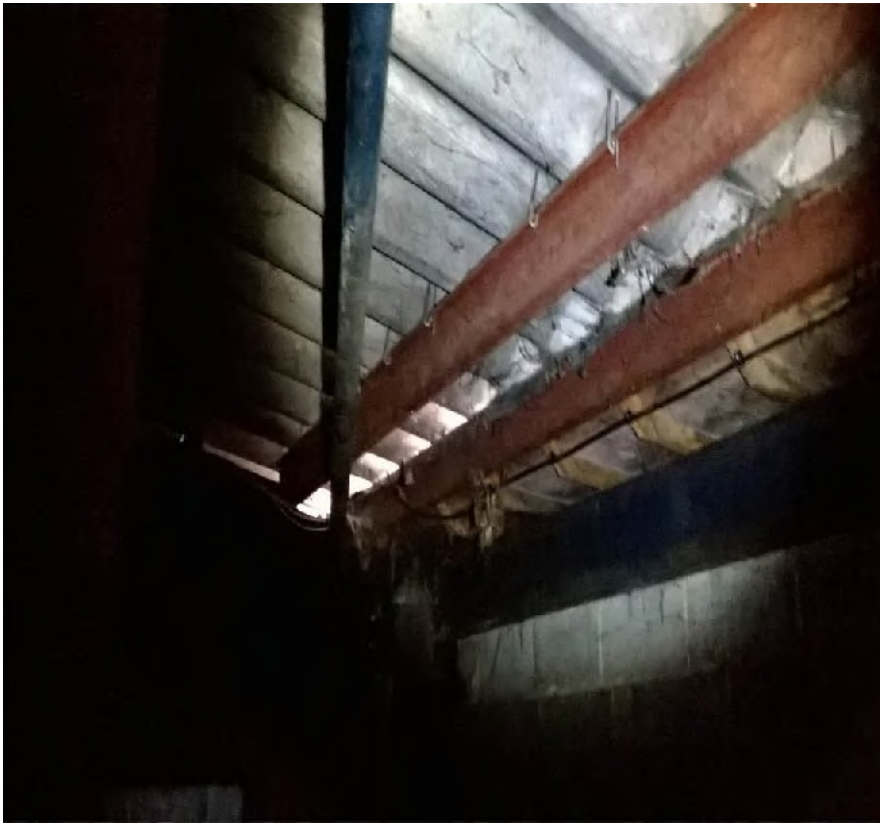
**PHOTOPLATE 147**

| Ground Floor High Level Stores |
| Corrugated roof sheets |
| Chrysotile |
| Very low |

| Sample Reference (Bulk ID) |
| - |
| Mark and manage |

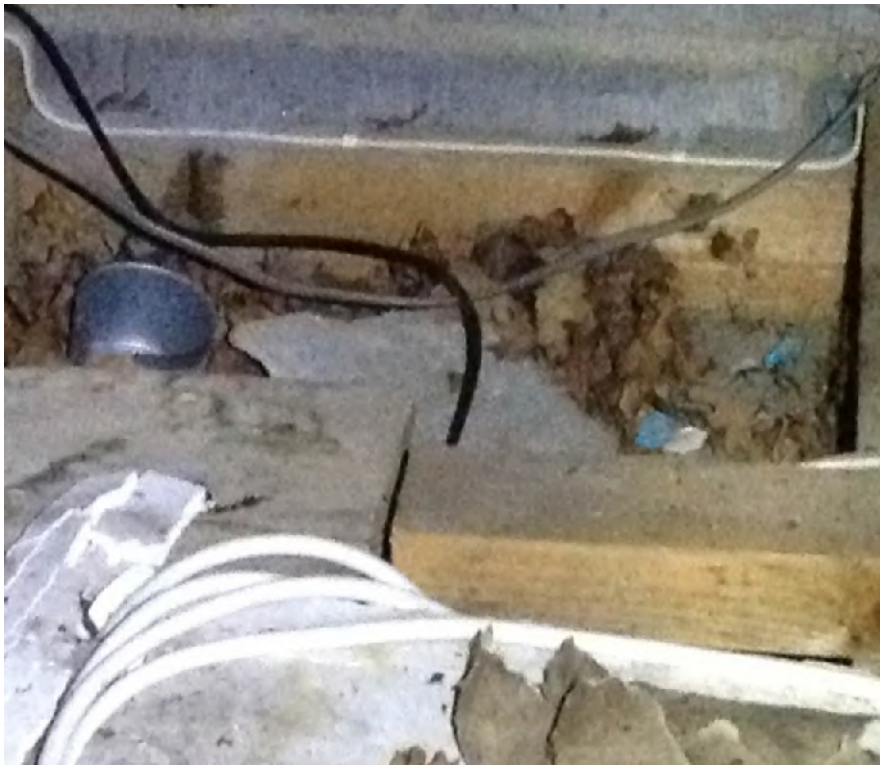
**PHOTOPLATE 148**

| Ground Floor High Level Stores |
| Redundant cement panel |
| Chrysotile |
| Very low |

| Sample Reference (Bulk ID) |
| - |
| Mark and manage |

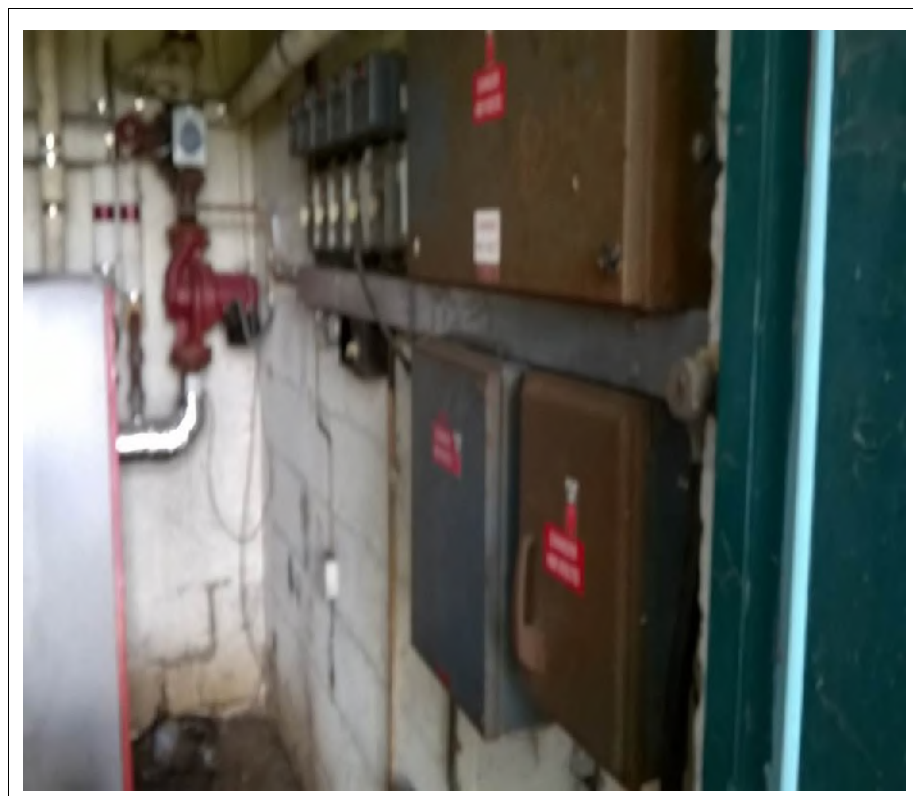
PHOTOPLATE 200

Ground Floor Boiler House

Mark and manage

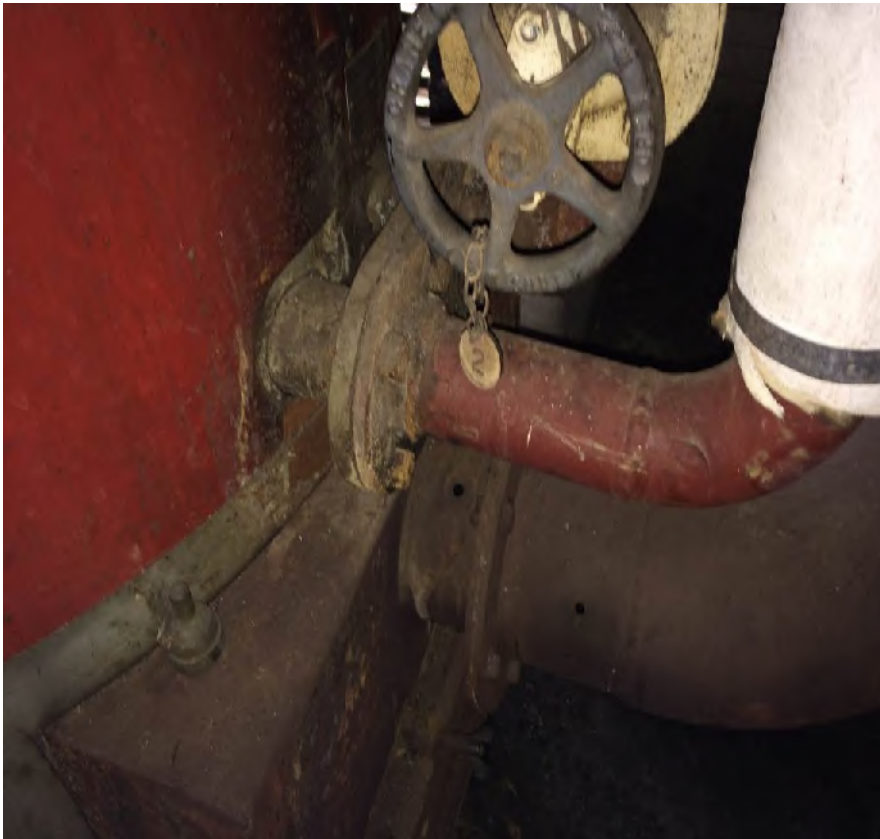
PHOTOPLATE 203

| Ground Floor Boiler House 1 |

| Sample Reference (Bulk ID) |
| - |
| Mark and manage |

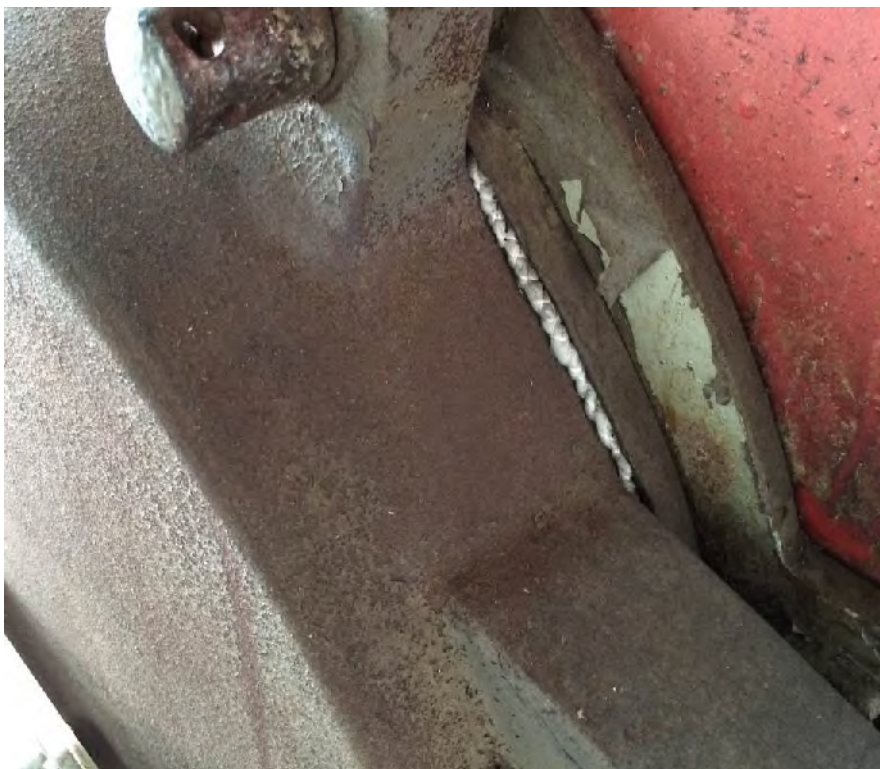
PHOTOPLATE 204

| Ground Floor Boiler House 1 |

| Sample Reference (Bulk ID) |
| - |
| Mark and manage |

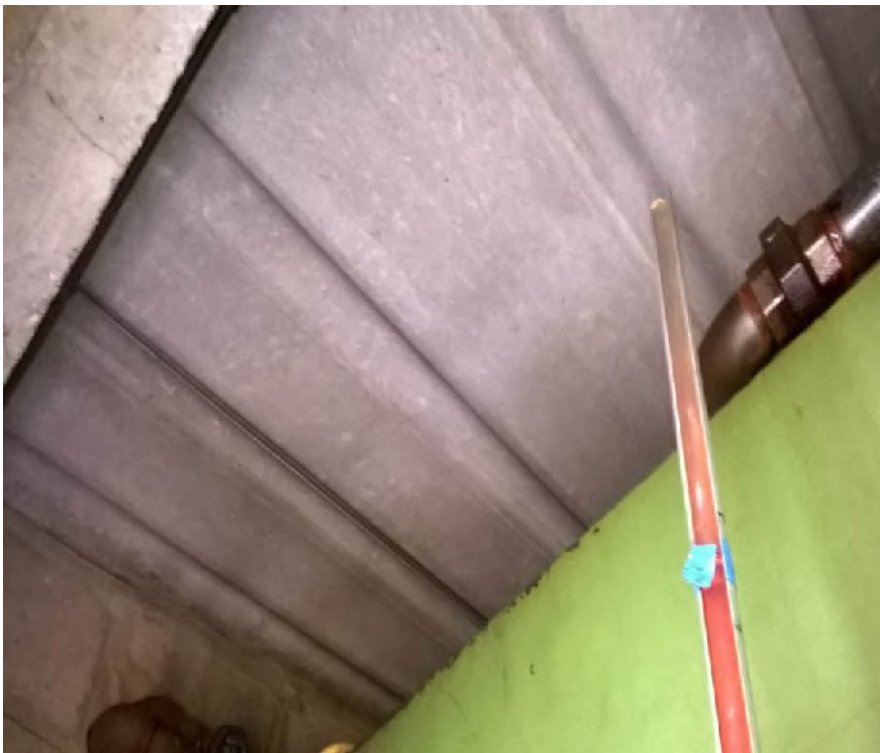
PHOTOPLATE 208

Ground Floor Tank Room

Mark and manage

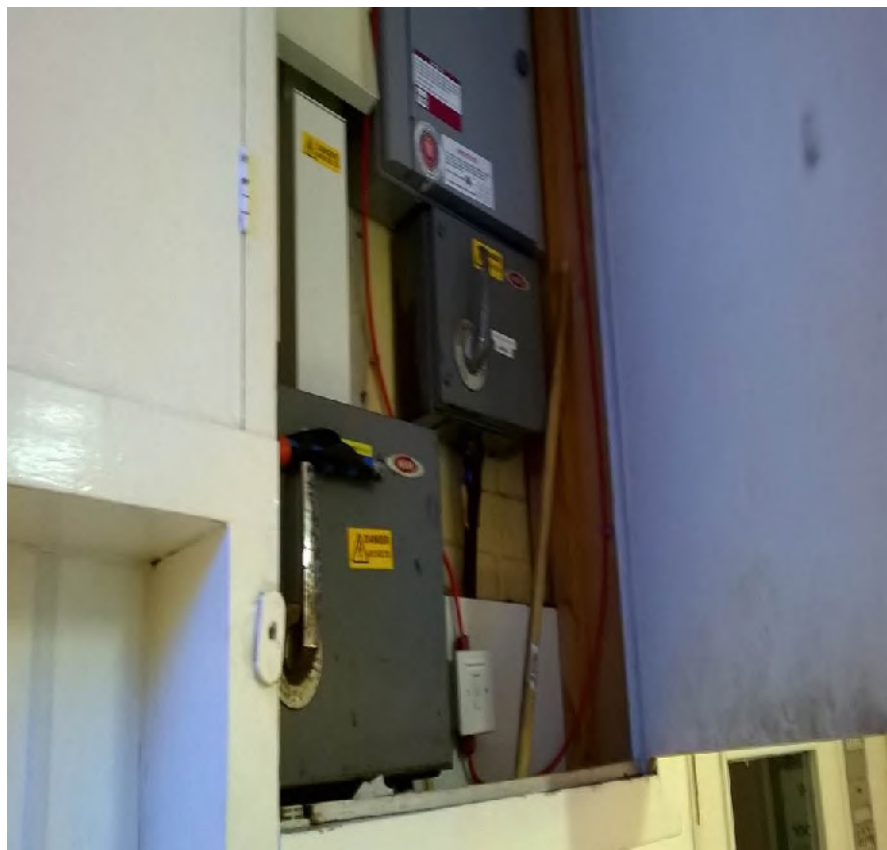
**PHOTOPLATE 209**

Ground Floor Open Plan Kitchen

Mark and manage

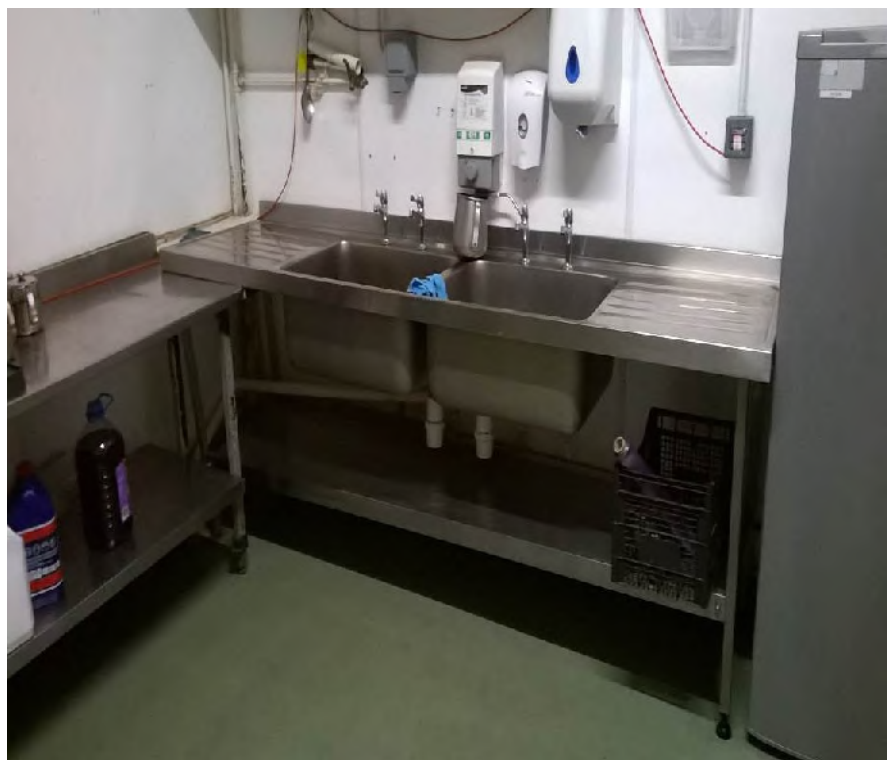
**PHOTOPLATE 210**

Ground Floor Still Room

Mark and manage

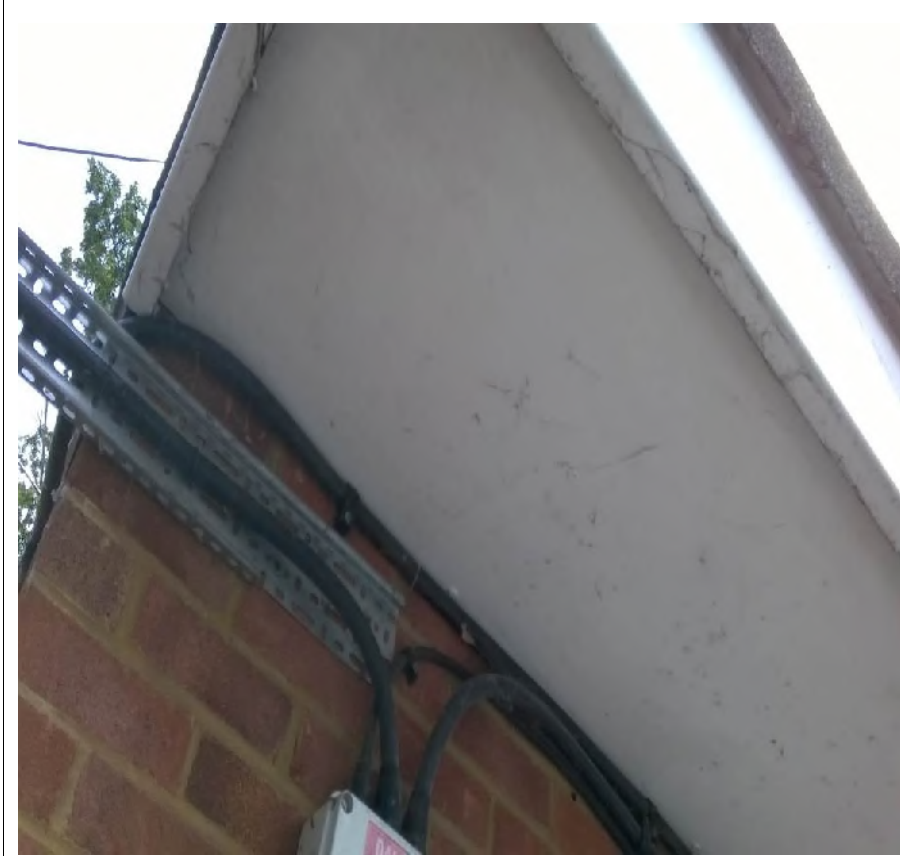
**PHOTOPLATE 211**

| External Front Elevation |

| Sample Reference (Bulk ID) |
| - |
| Encapsulate |

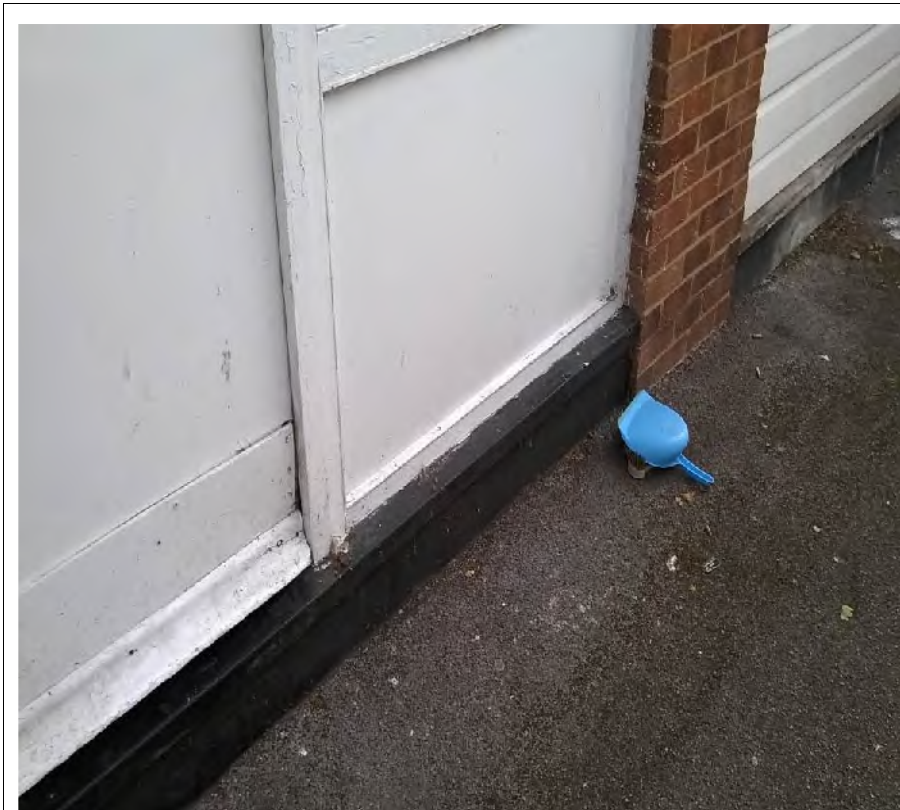
**PHOTOPLATE 212**

| External Front Elevation |

| Sample Reference (Bulk ID) |
| - |
| Mark and manage |

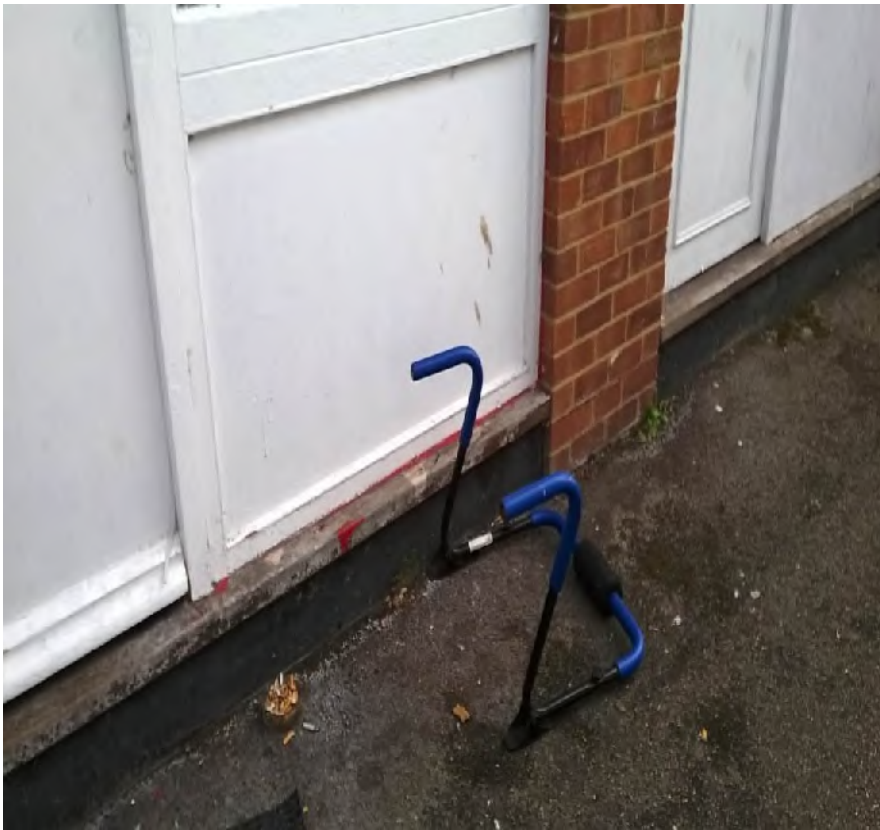
**PHOTOPLATE 213**

| External Front Elevation |

| Sample Reference (Bulk ID) |
| - |
| Mark and manage |

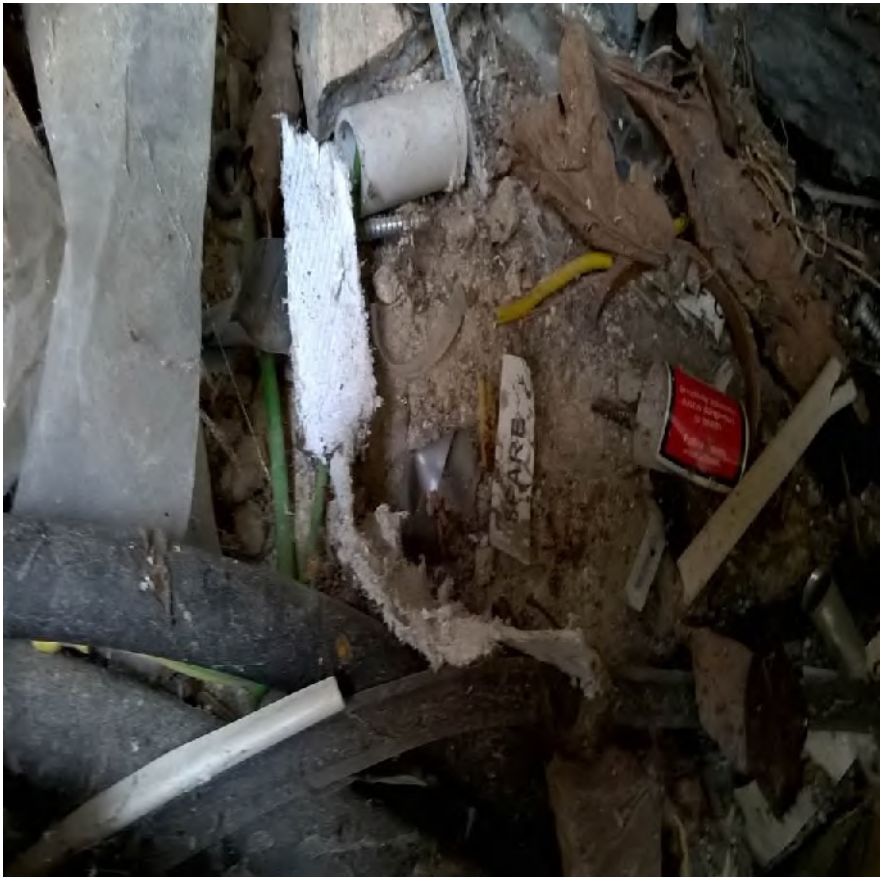
PHOTOPLATE 215

Ground Floor Electrical Switch Gear  
Room

Mark and manage

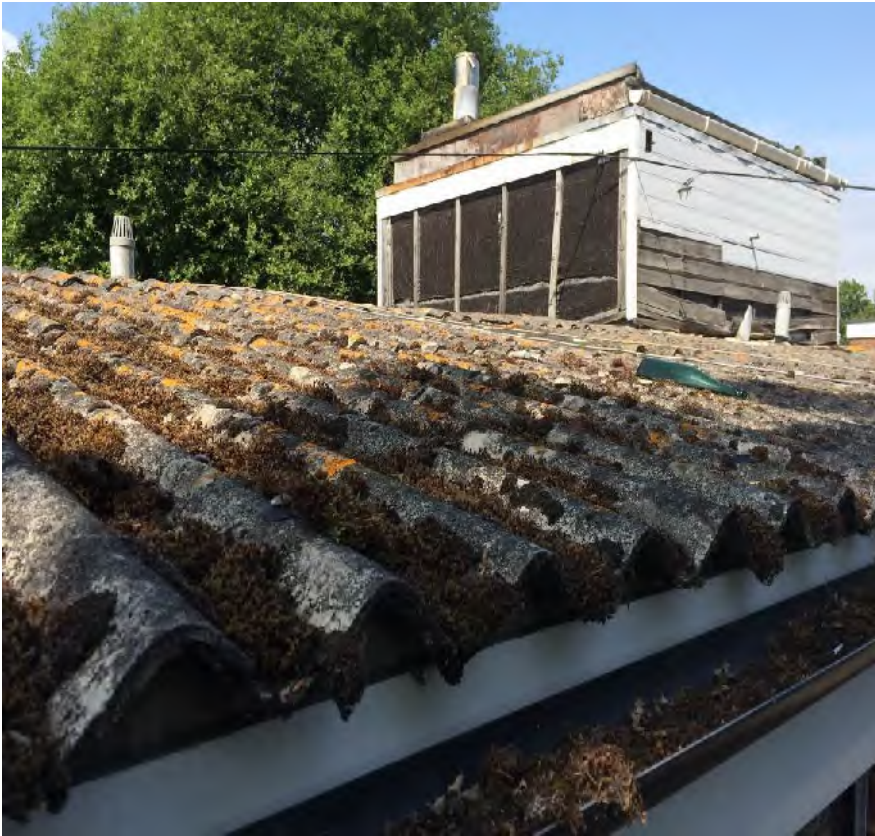
PHOTOPLATE 217

External Tank Room

Mark and manage

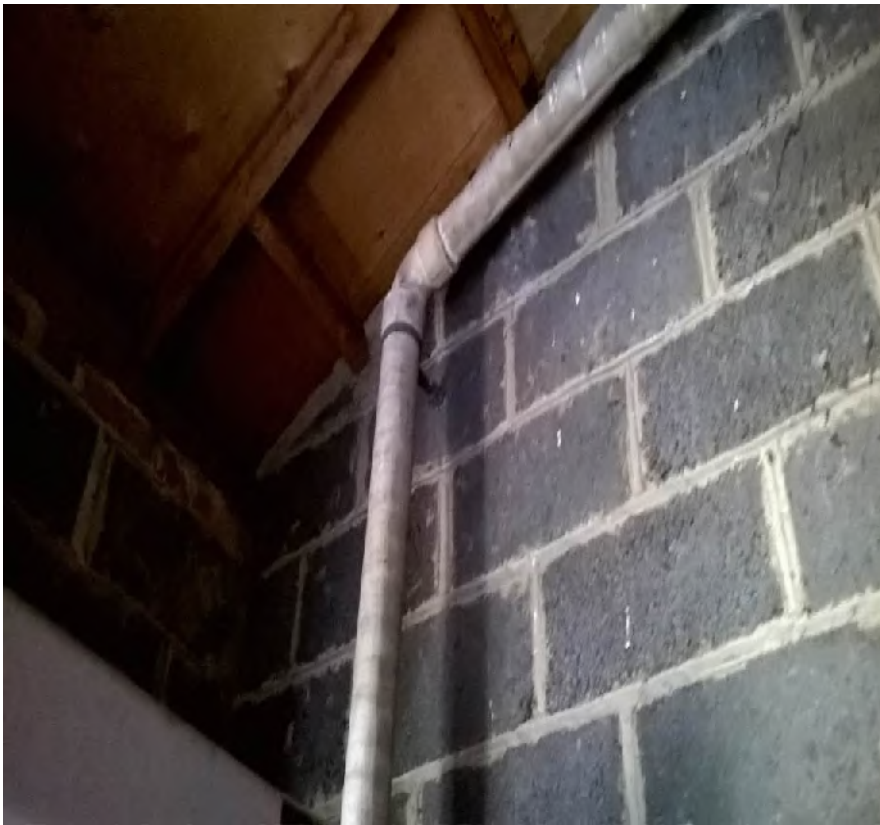
PHOTOPLATE 225

Ground Floor Tank Room

Mark and manage

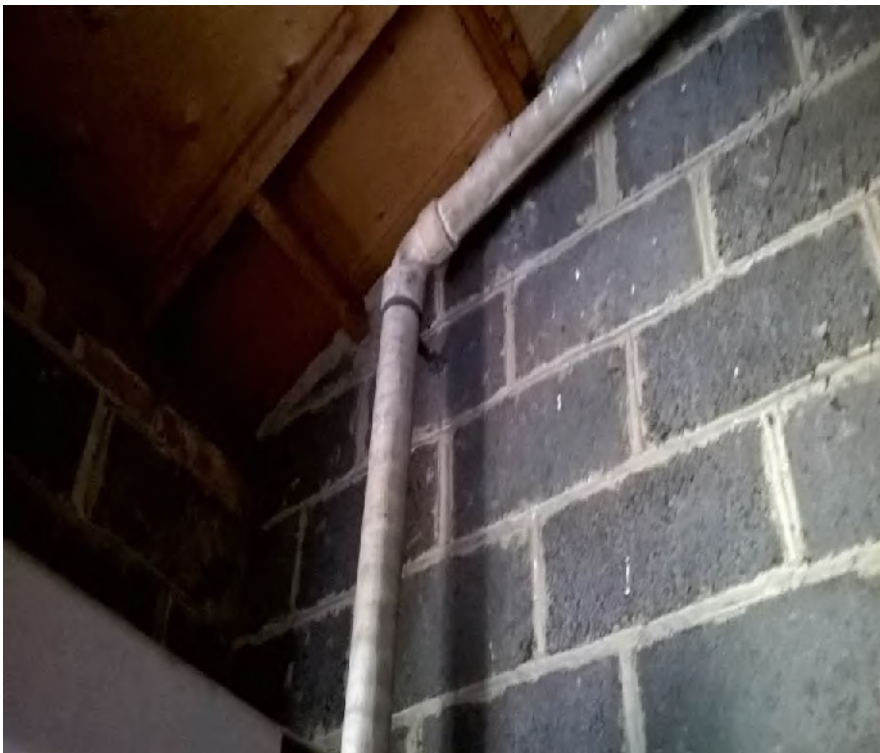
PHOTOPLATE 226

Ground Floor Tank Room

Mark and manage

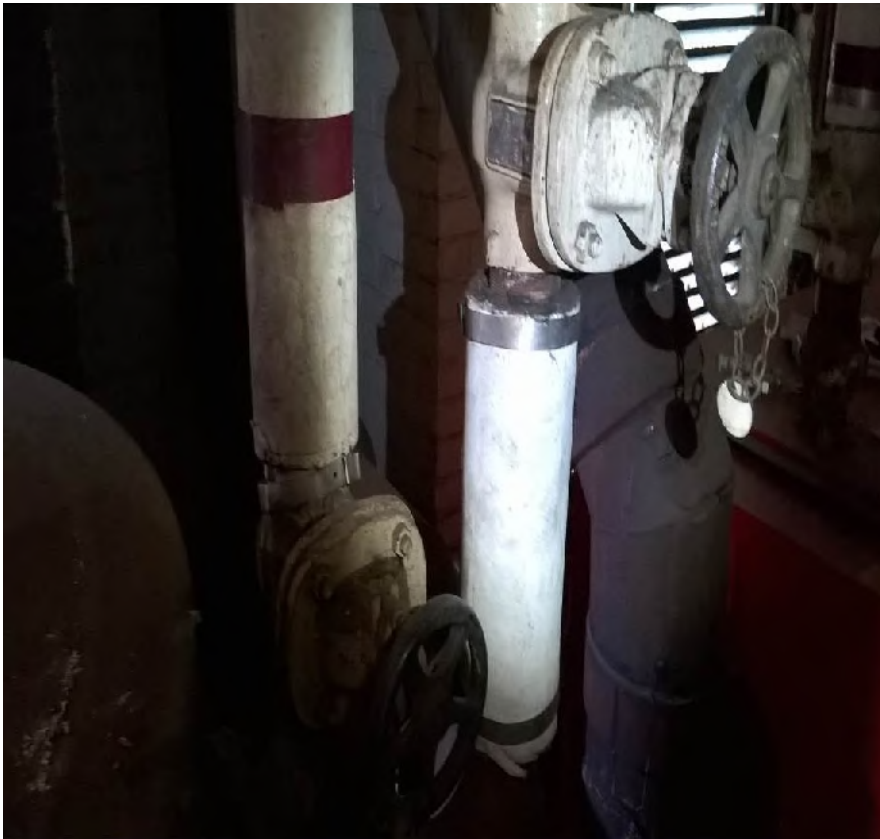
PHOTOPLATE 227

Ground Floor Tank Room

Mark and manage

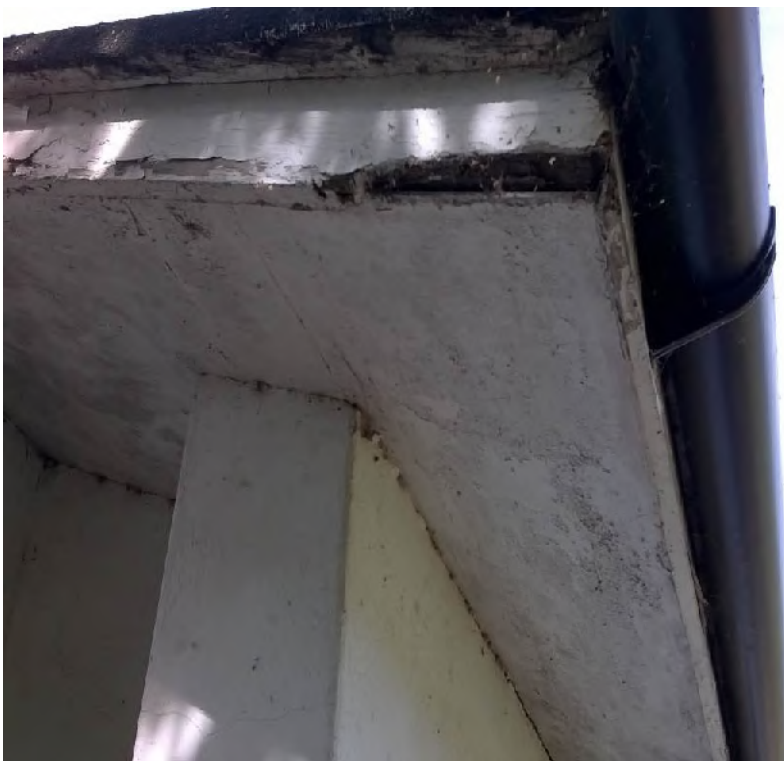
PHOTOPLATE 228

External Boiler Room

Mark and manage

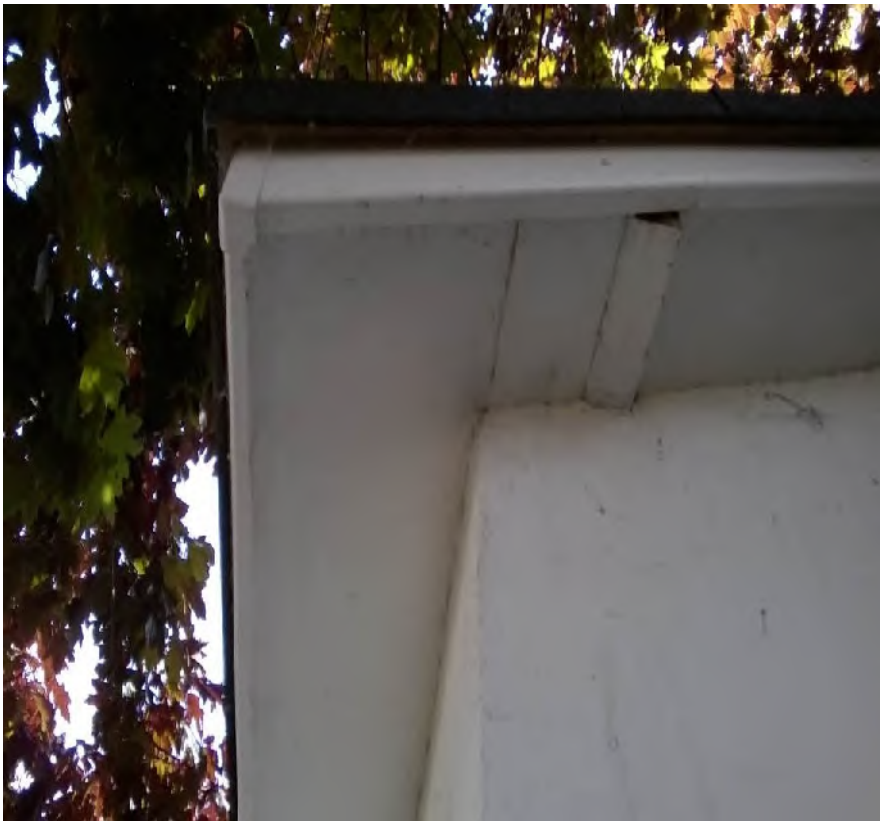
**PHOTOPLATE 229**

External Stores

Mark and manage

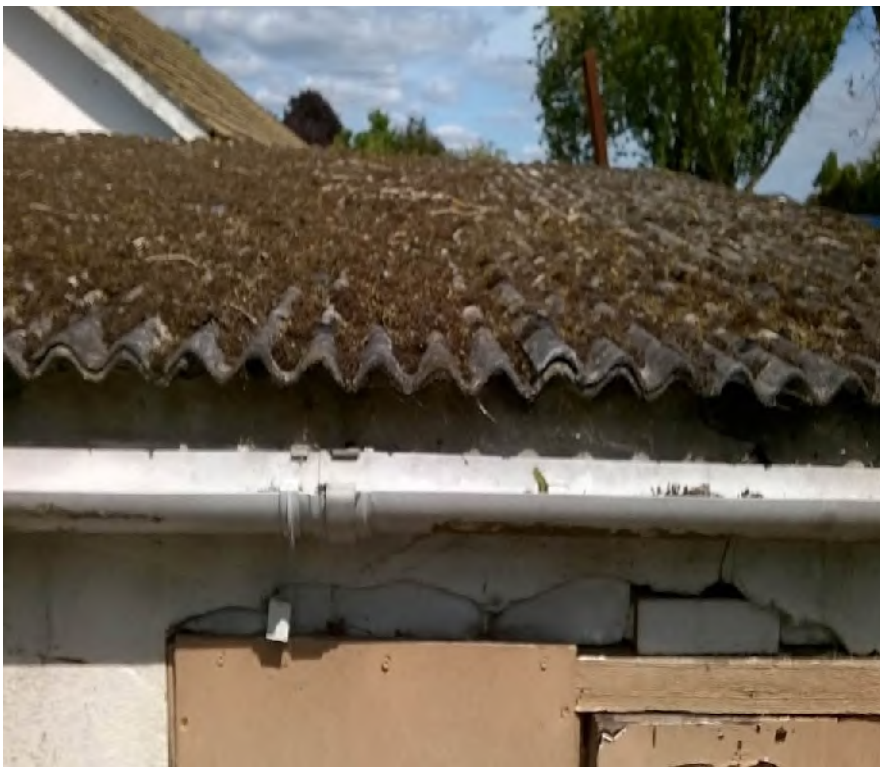
**PHOTOPLATE 230**

External Outside Areas

Mark and manage

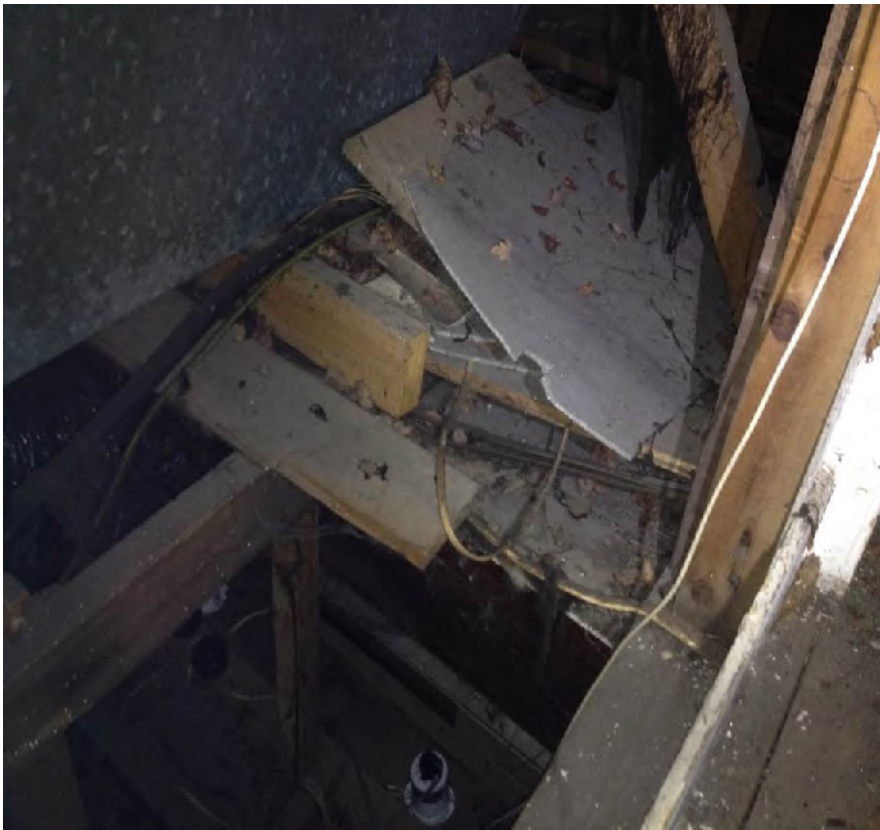
**PHOTOPLATE 233**

First Floor Void

**Remove****PHOTOPLATE 234**

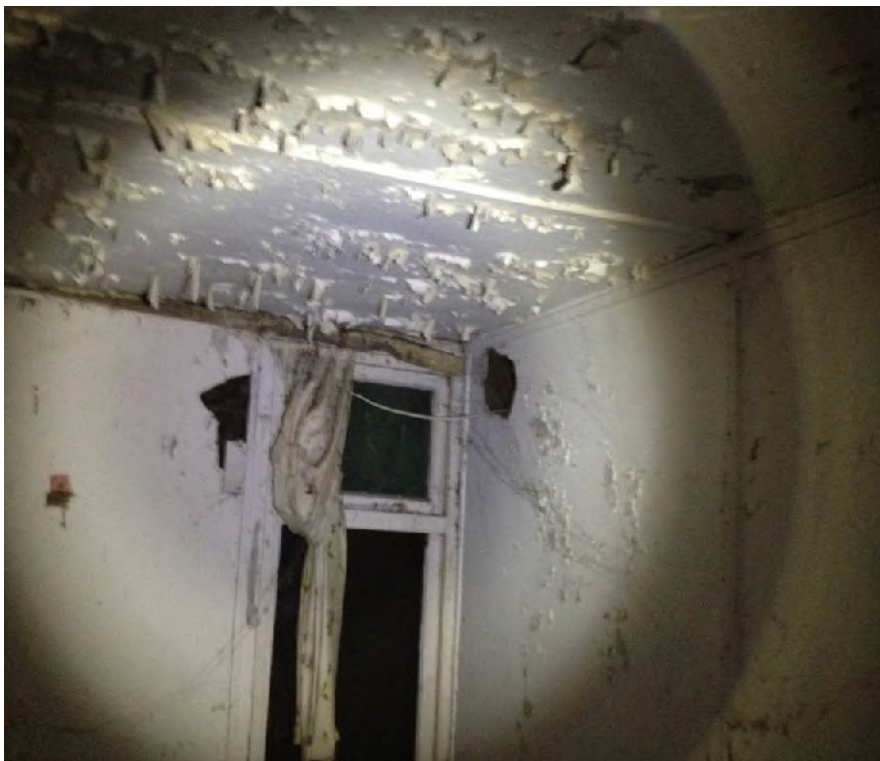
First Floor Store

**Encapsulate**

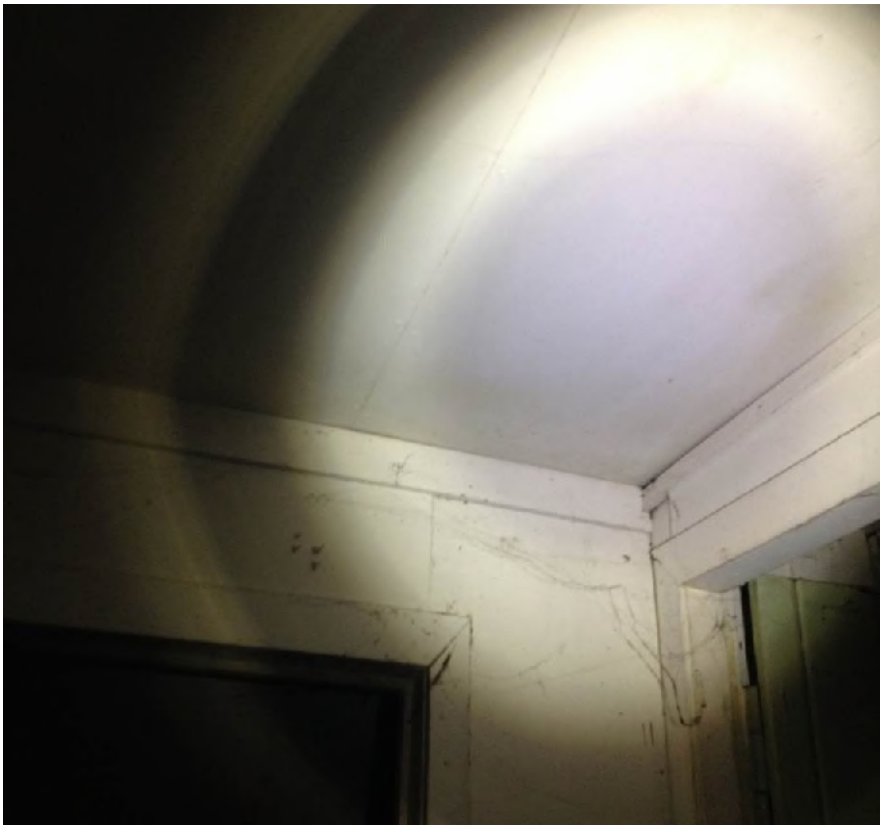
PHOTOPLATE 235

First Floor Store

Encapsulate

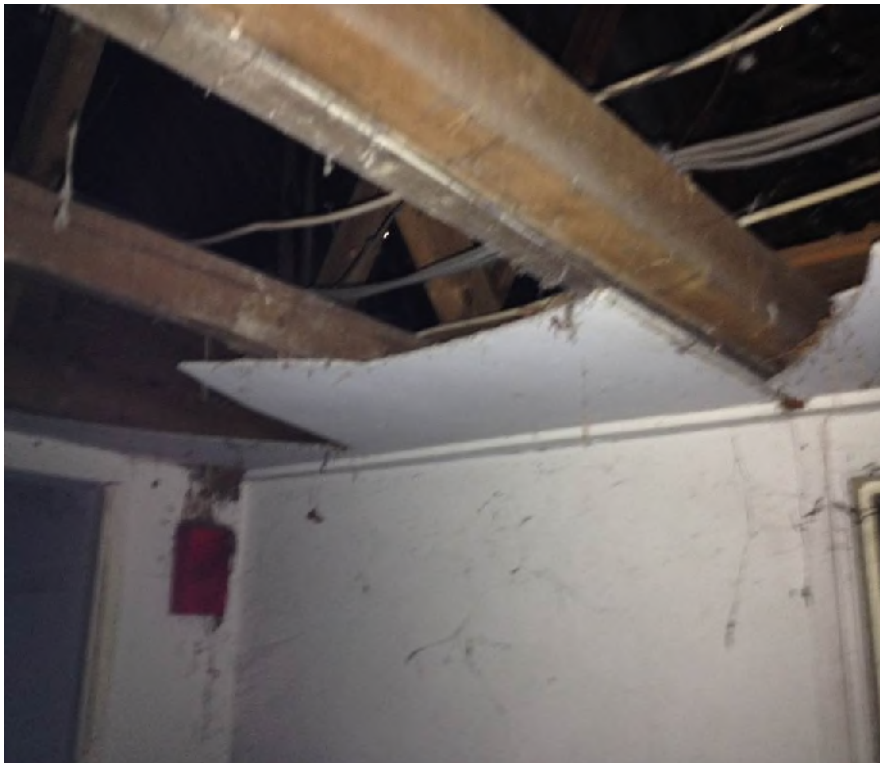
PHOTOPLATE 236

First Floor Store

Encapsulate

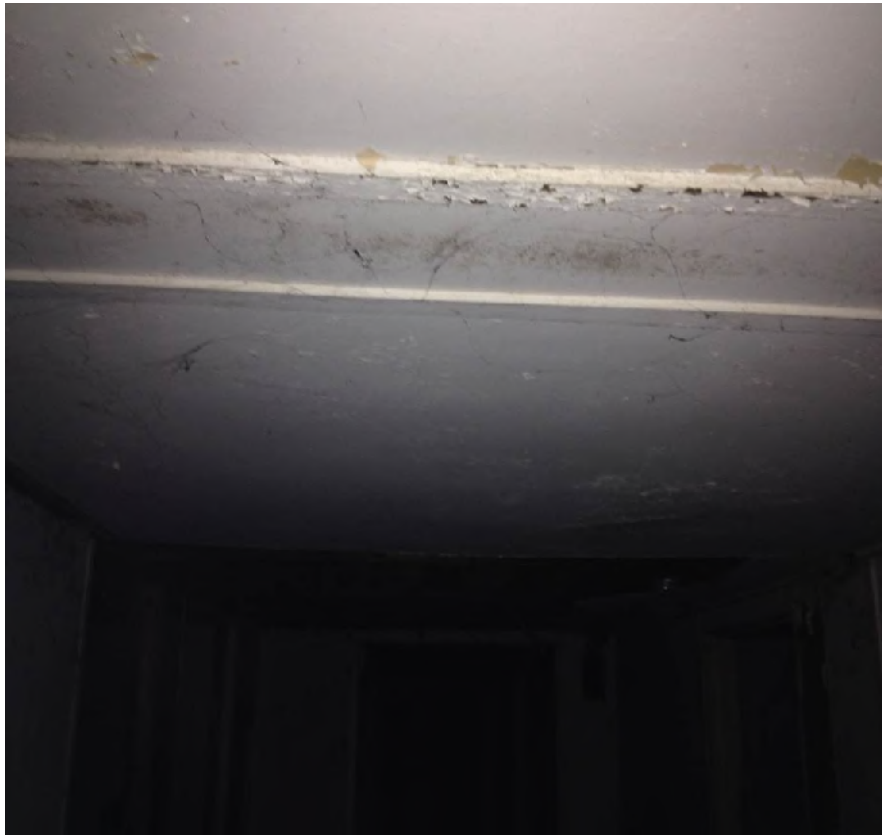
**PHOTOPLATE 237**

First Floor Corridor

Encapsulate

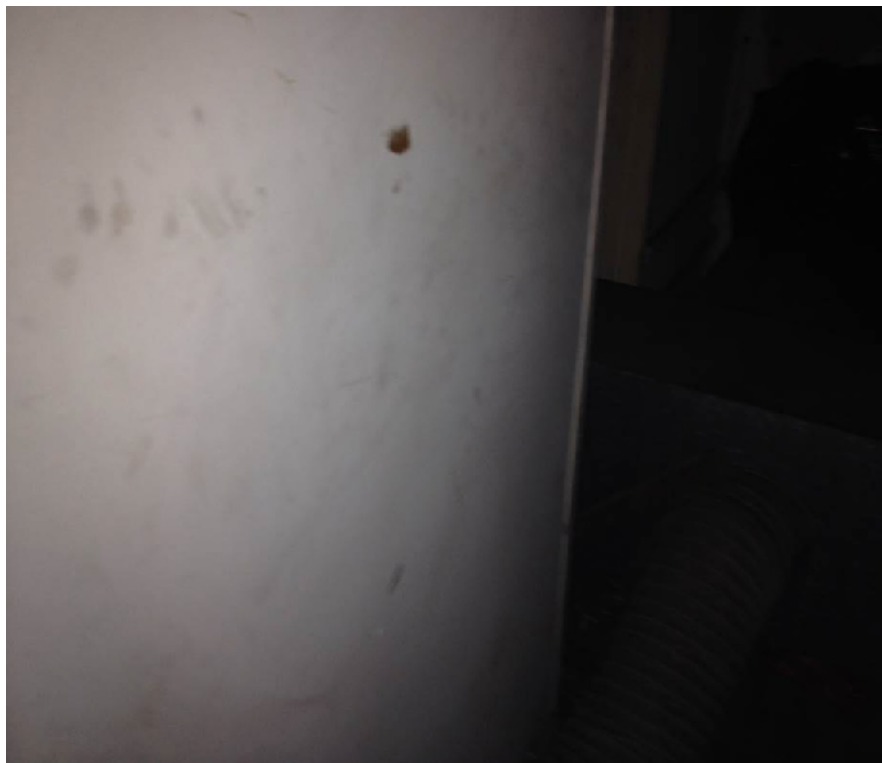
**PHOTOPLATE 238**

First Floor Store

Encapsulate

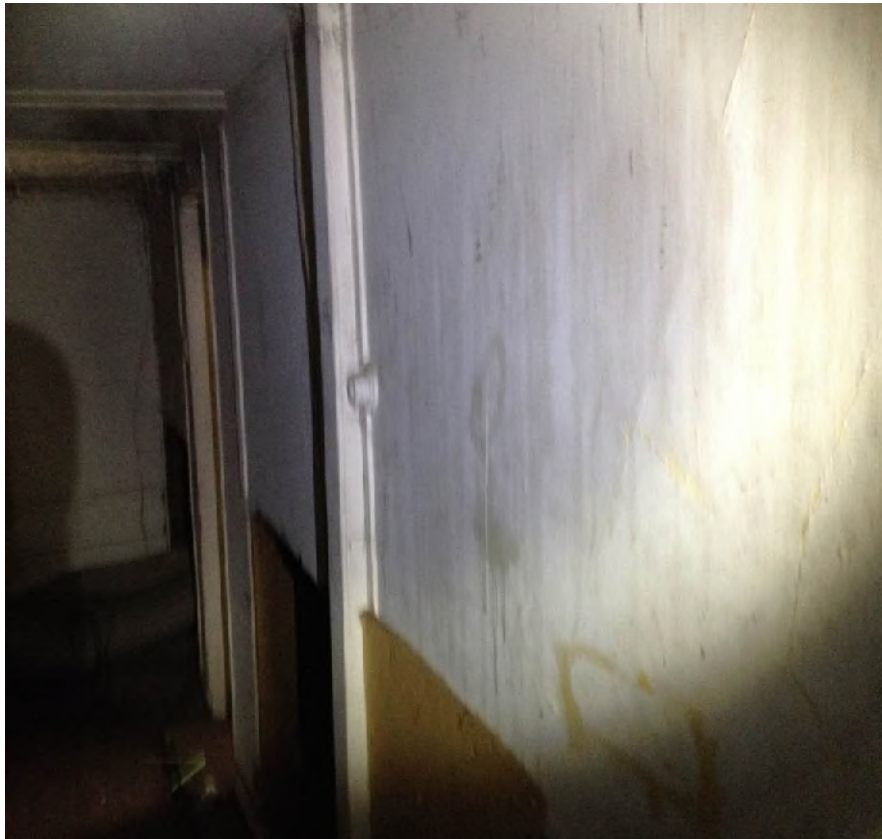
PHOTOPLATE 239

First Floor Hall

Encapsulate

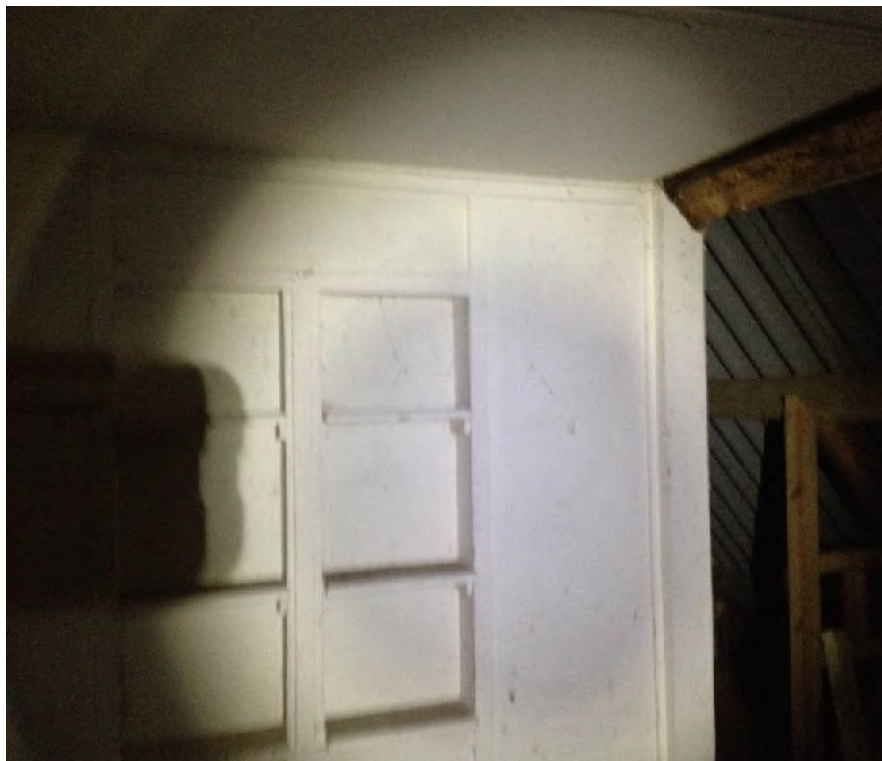
PHOTOPLATE 240

First Floor Store

Encapsulate

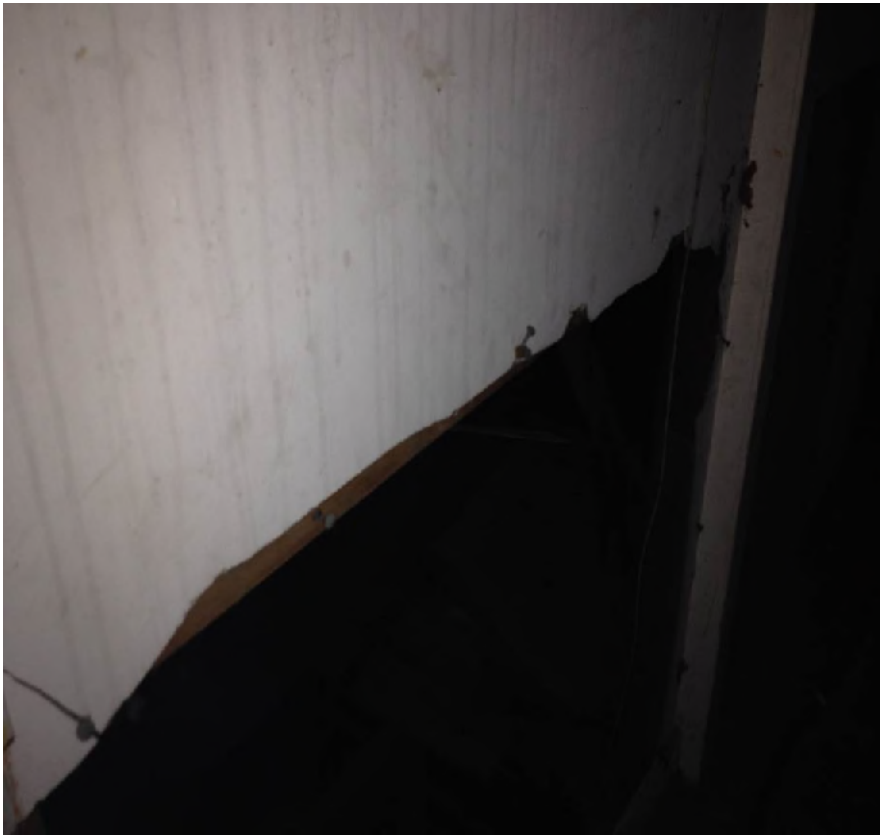
**PHOTOPLATE 241**

First Floor Store

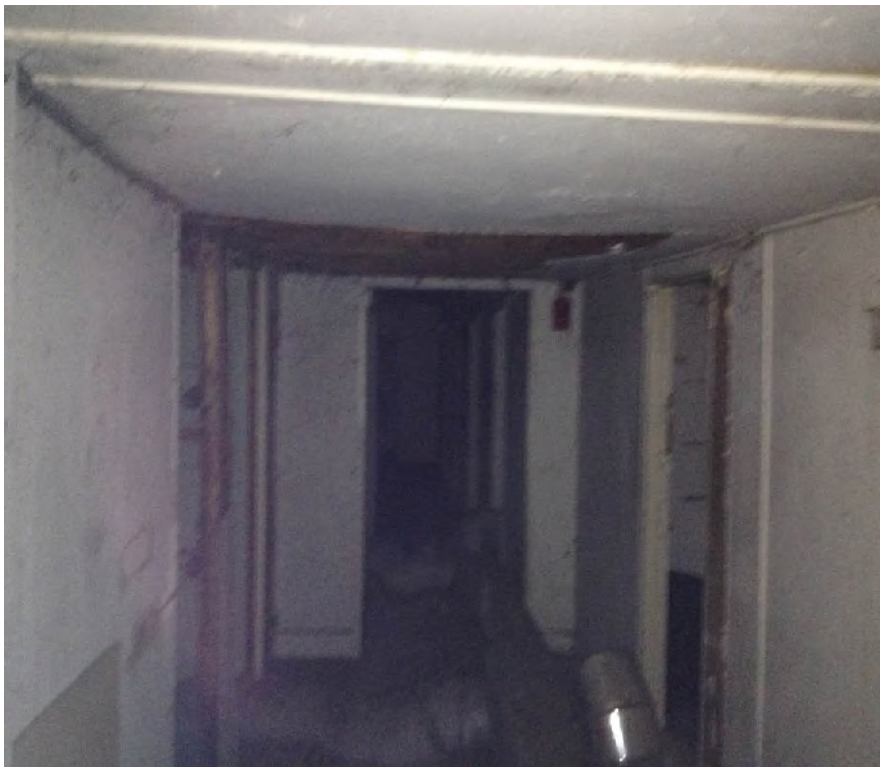
**PHOTOPLATE 242**

First Floor Corridor

Recommendation

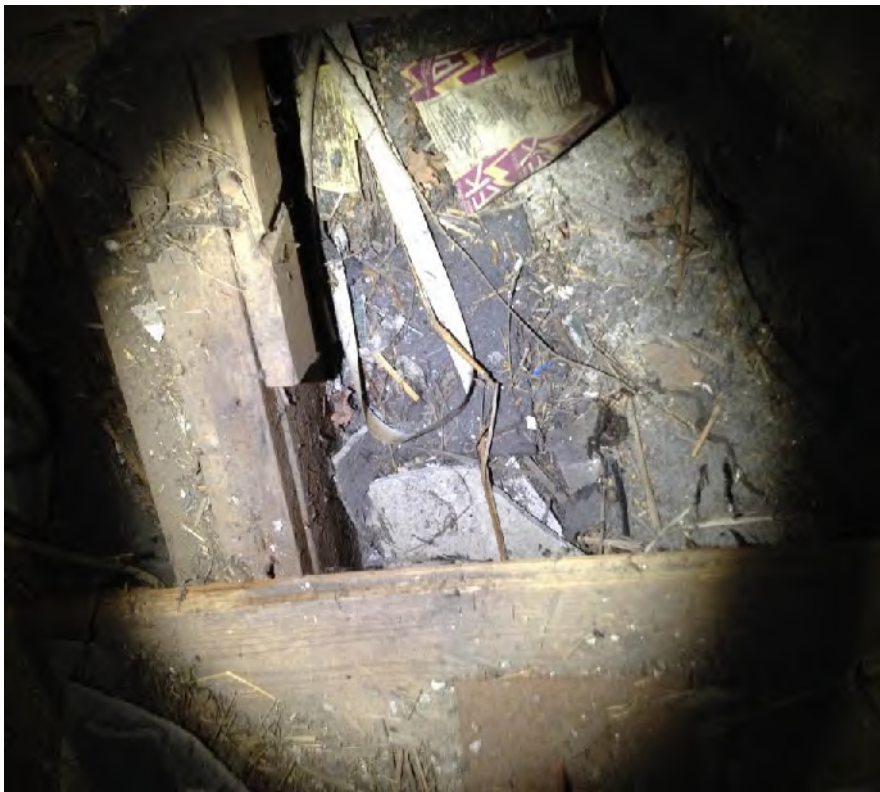
PHOTOPLATE 244

First Floor Hall

Debris to floor and beneath broken floor board

Recommendation

Remove

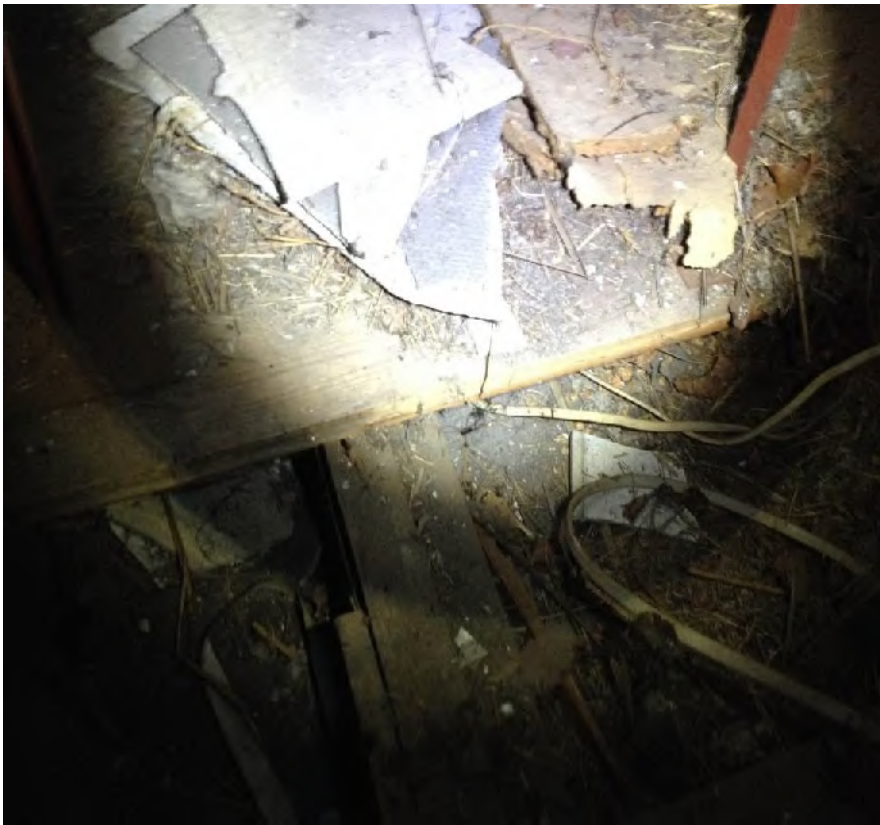
PHOTOPLATE 245

First Floor Void

Recommendation

Remove

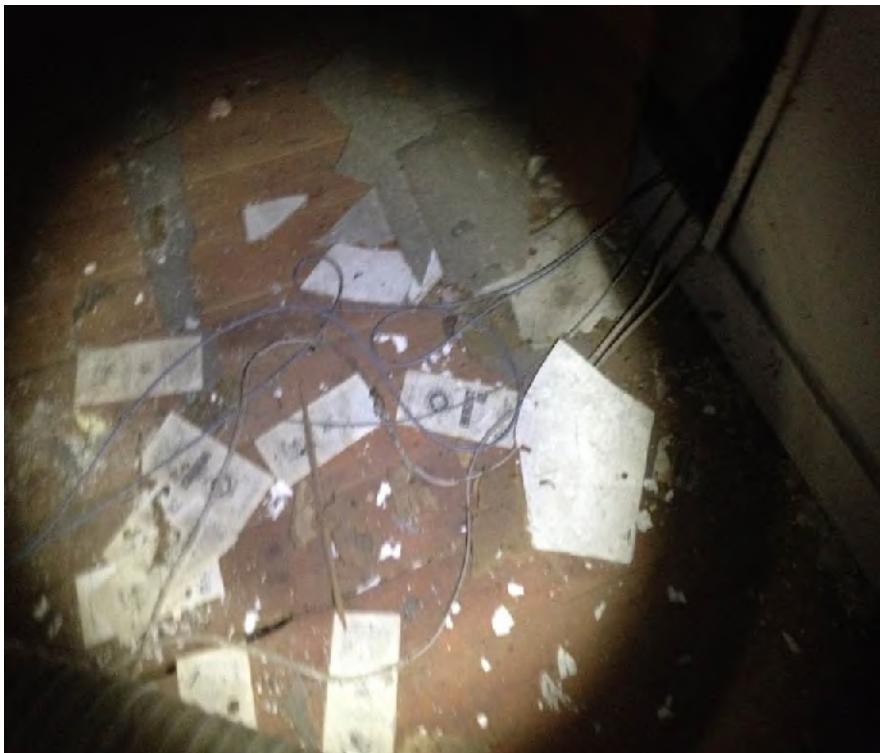
PHOTOPLATE 246

First Floor Store

Recommendation

Remove
