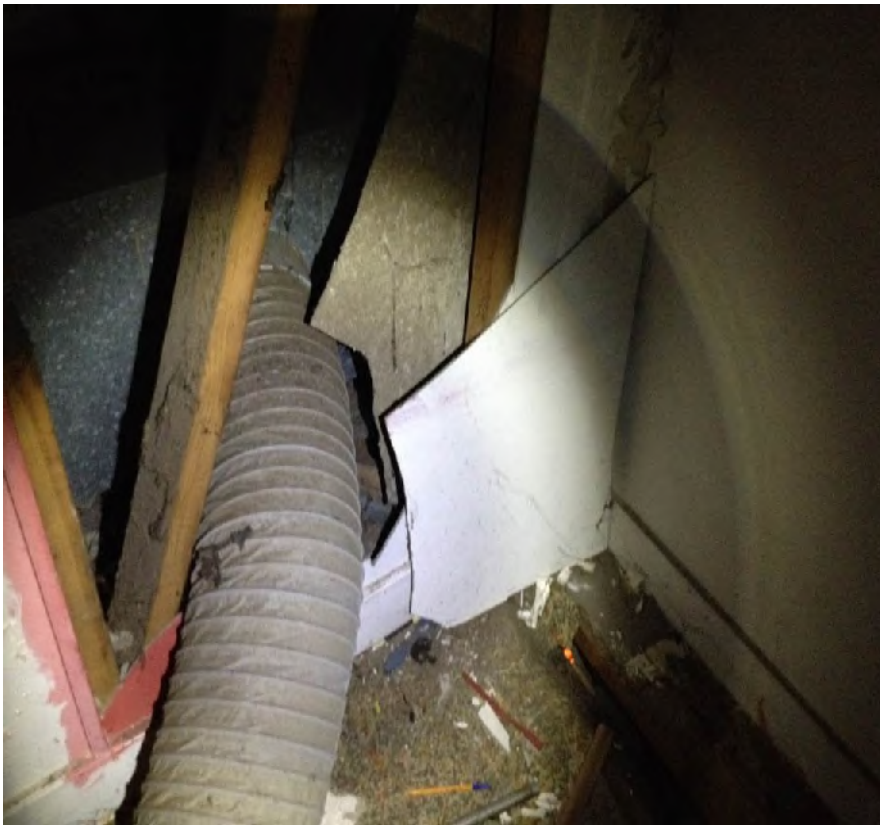
PHOTOPLATE 247

First Floor Corridor

Recommendation

Remove

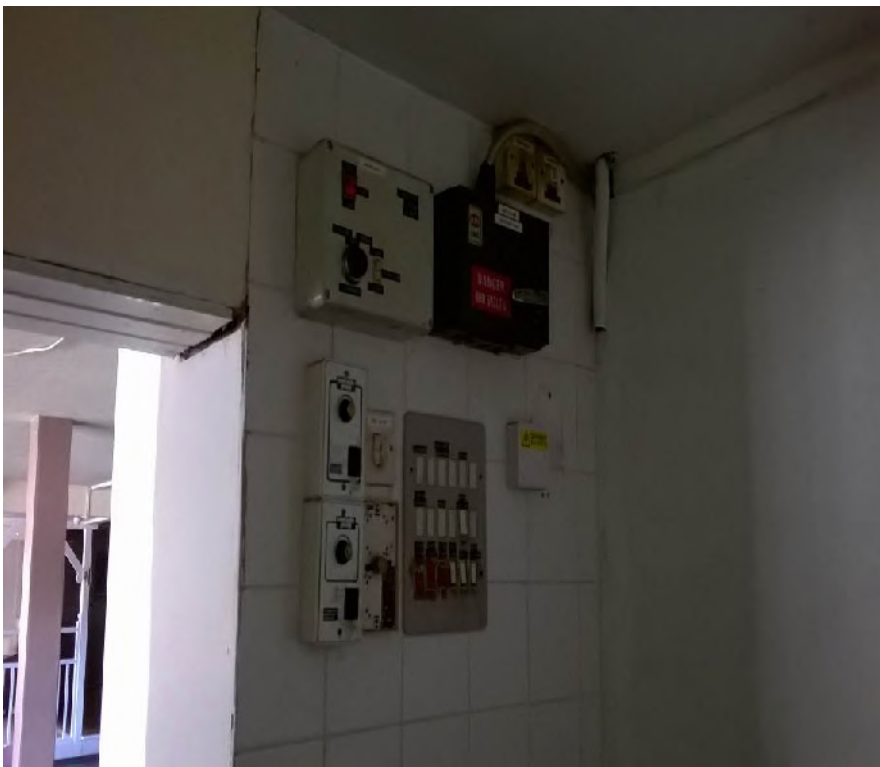
PHOTOPLATE 248

Ground Floor Circulation

Recommendation

Mark and manage

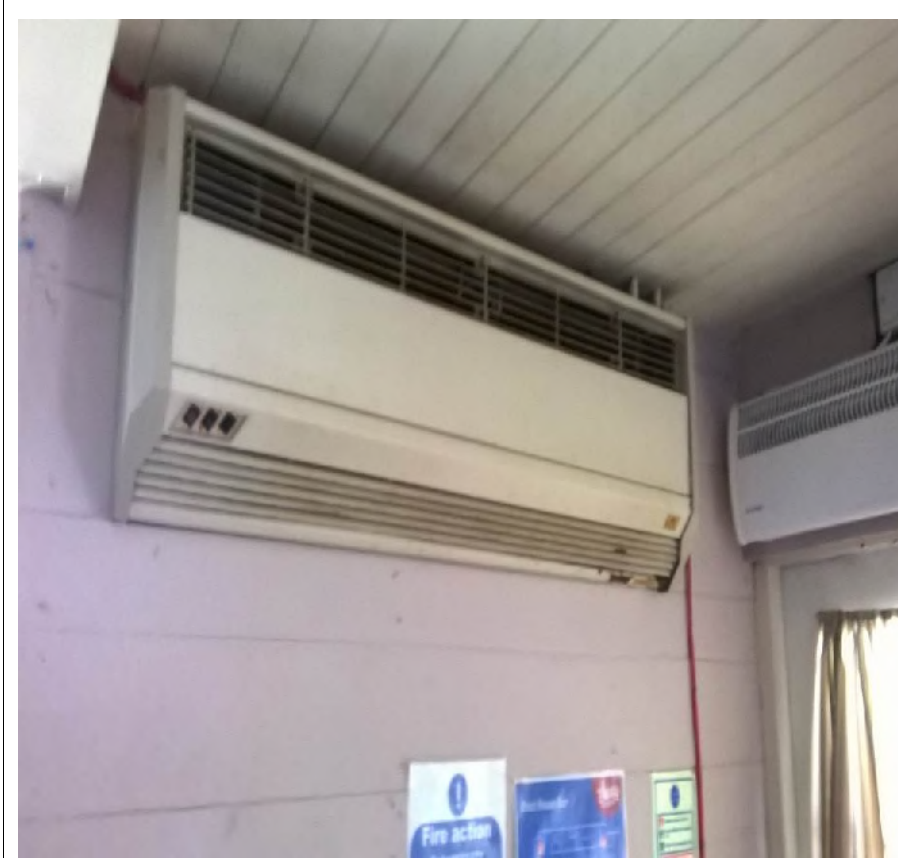
PHOTOPLATE 249

Ground Floor Circulation

Recommendation

Mark and manage

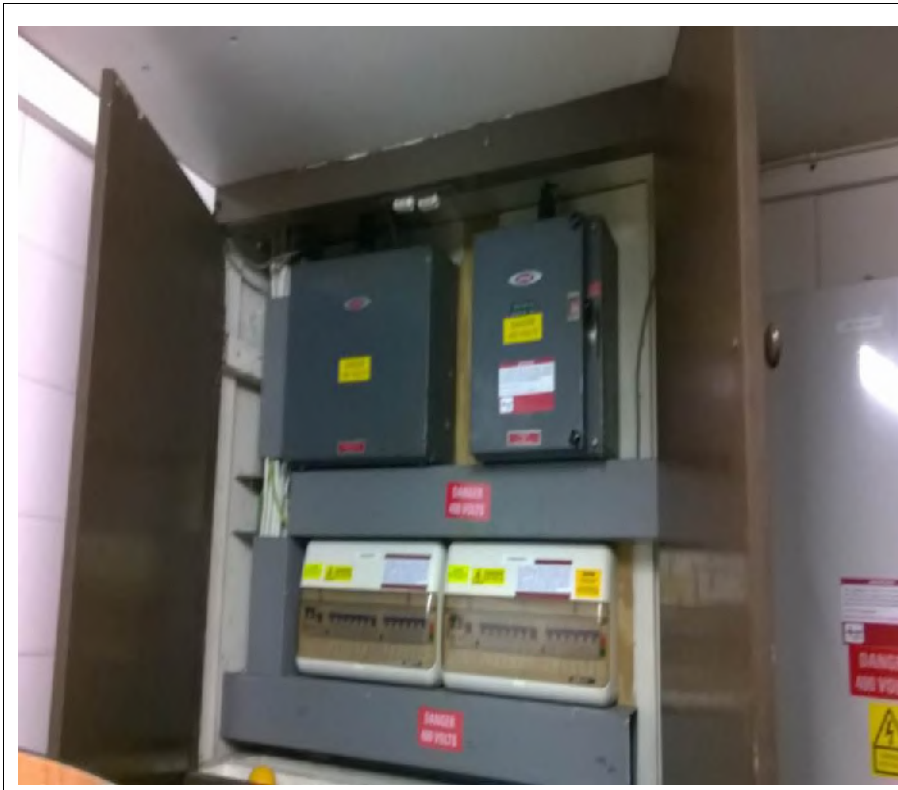
PHOTOPLATE 250

Ground Floor Circulation

Recommendation

Mark and manage

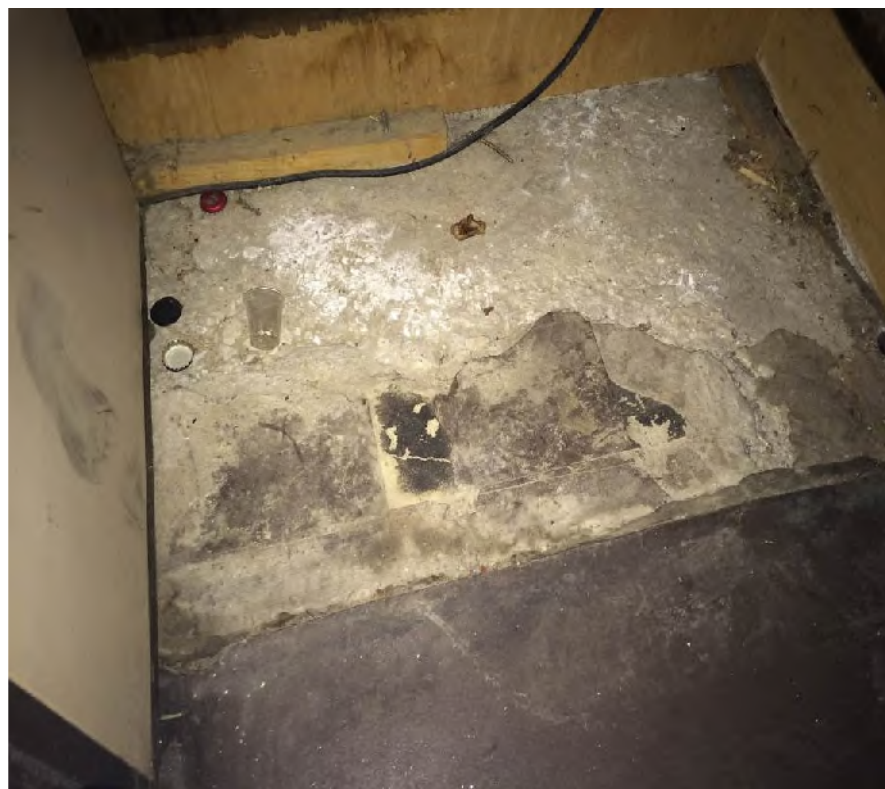
**PHOTOPLATE 252**

Ground Floor Bar

Recommendation

Mark and manage

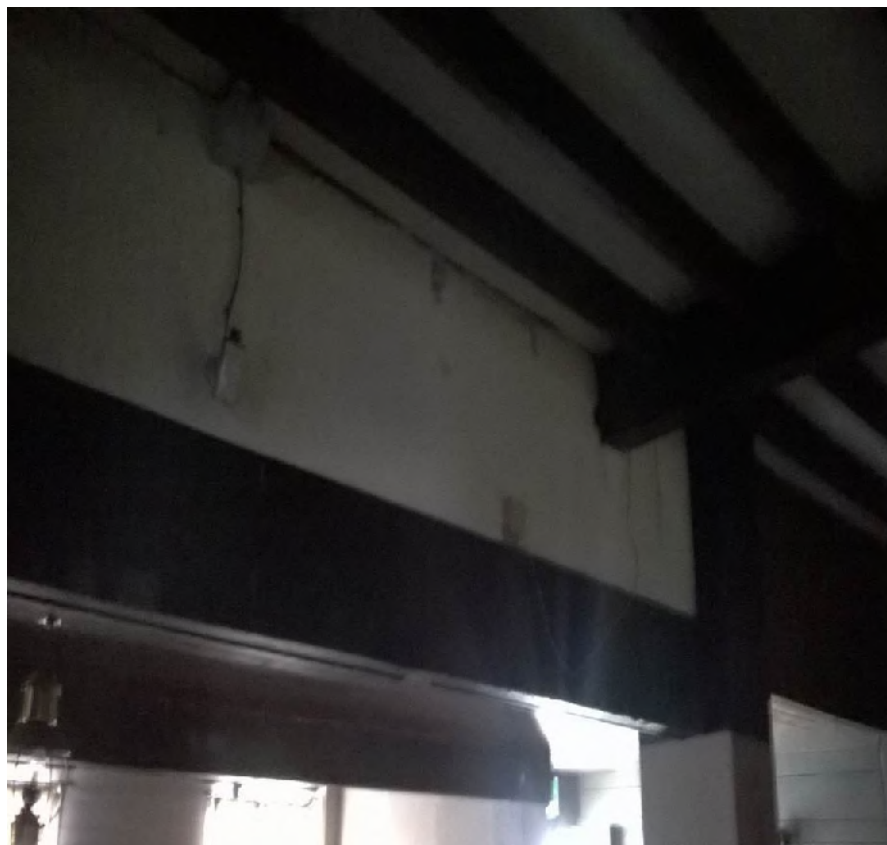
PHOTOPLATE 255

Ground Floor Circulation

Recommendation

Mark and manage

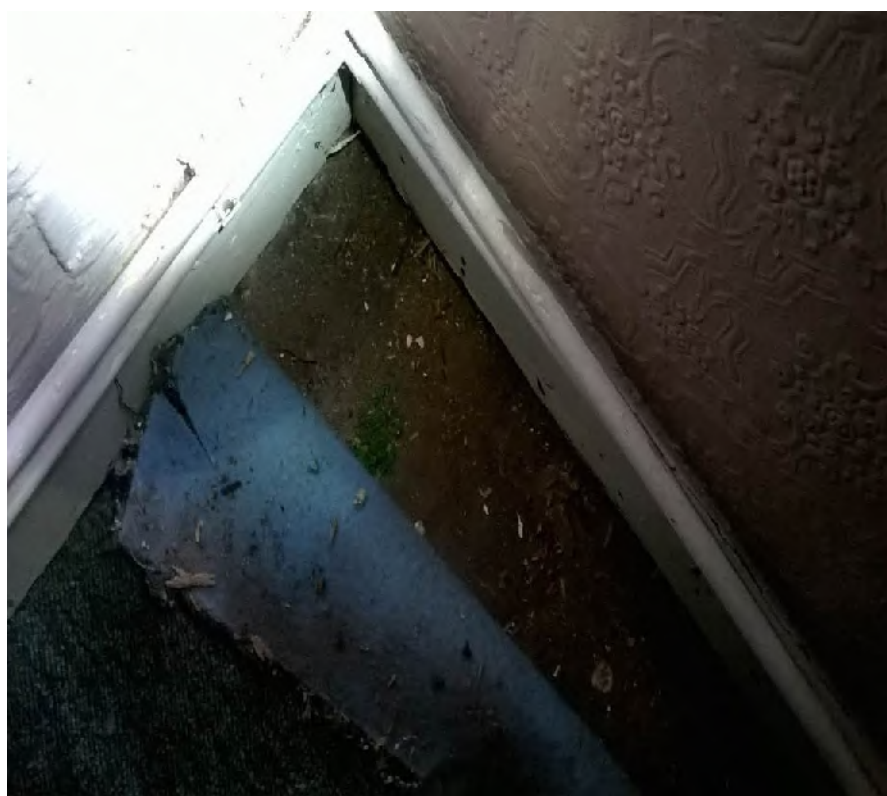
PHOTOPLATE 256

Ground Floor Circulation

Recommendation

Mark and manage

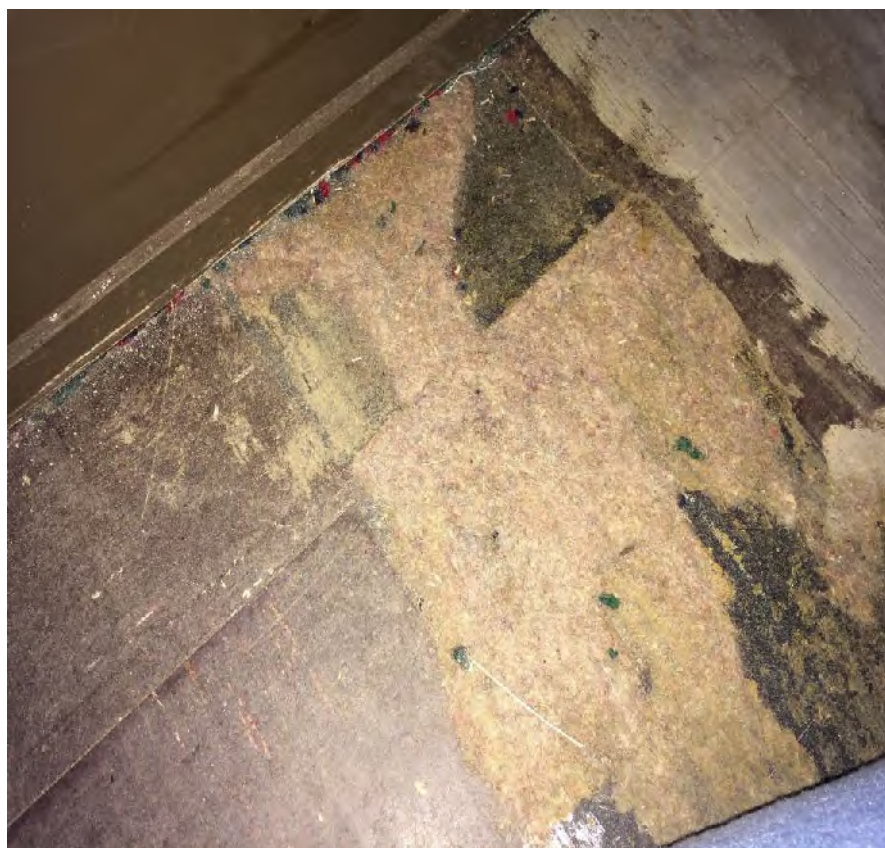
**PHOTOPLATE 257**

Ground Floor Circulation

Recommendation

Mark and manage

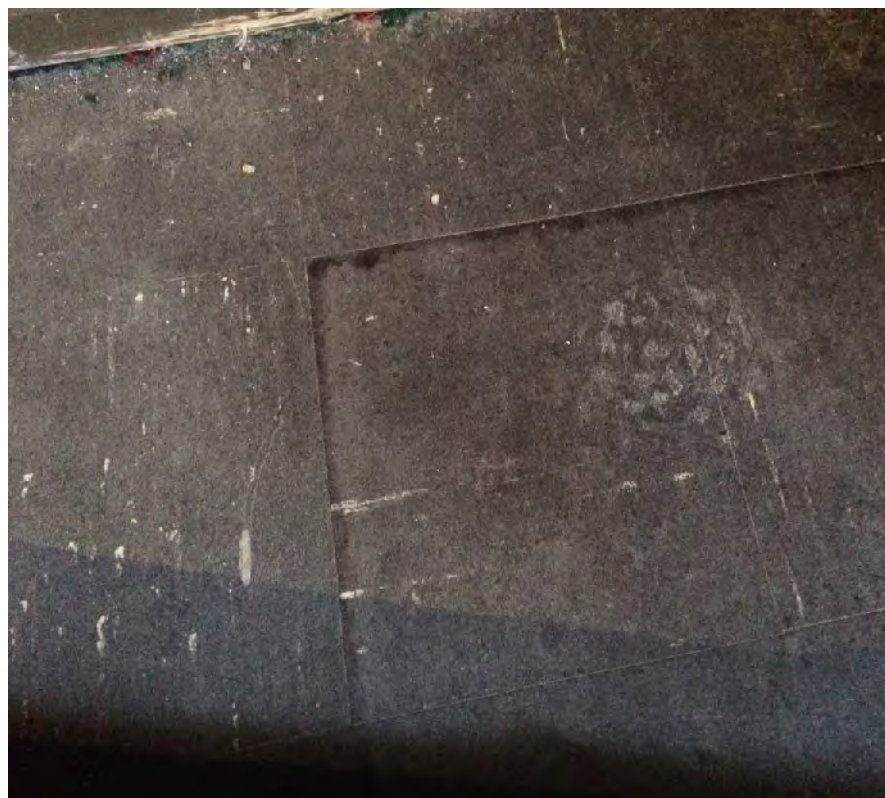
**PHOTOPLATE 258**

Ground Floor Circulation

Recommendation

Mark and manage

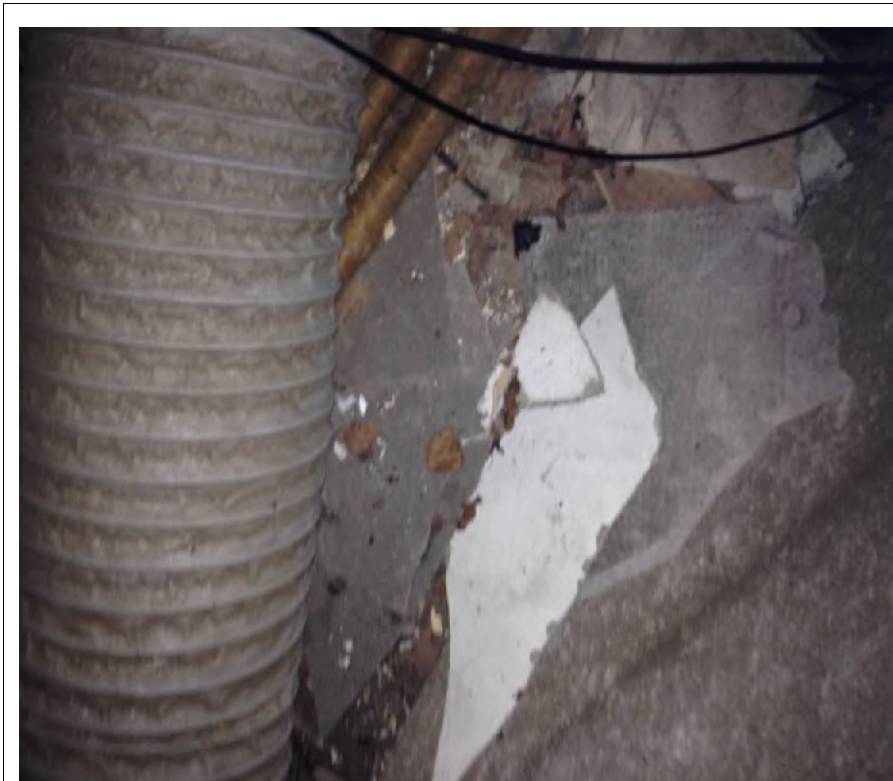
**PHOTOPLATE 260**

| First Floor Void |

| Sample Reference (Bulk ID) |
| - |
| Recommendation |
| Remove |

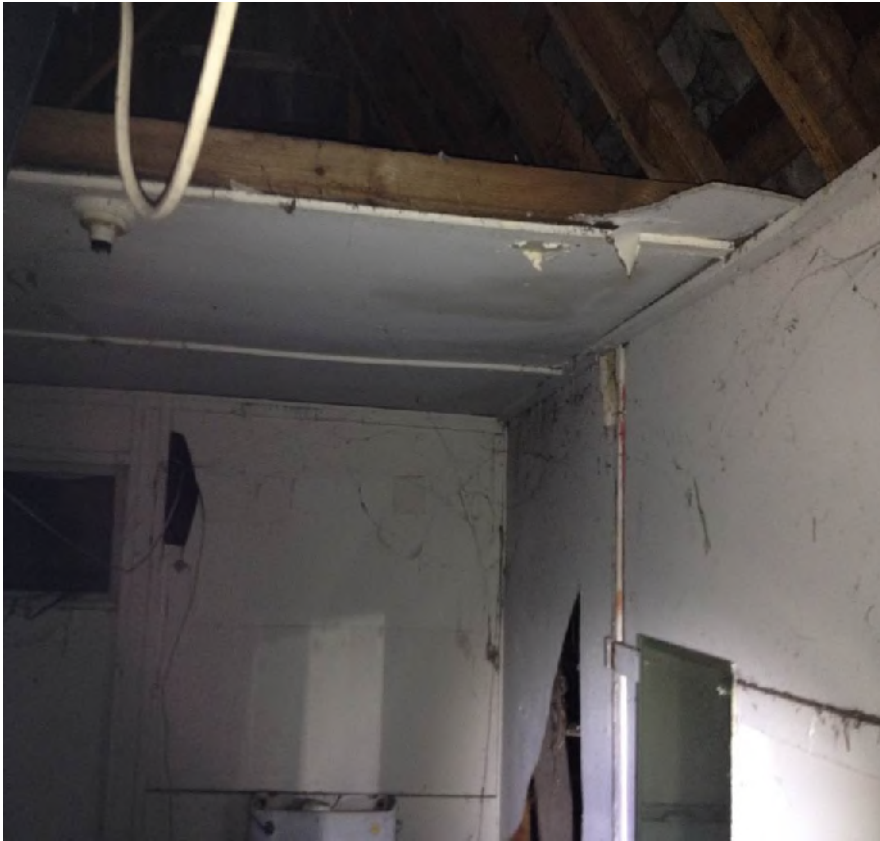
PHOTOPLATE 261

First Floor Toilet

Recommendation

Encapsulate

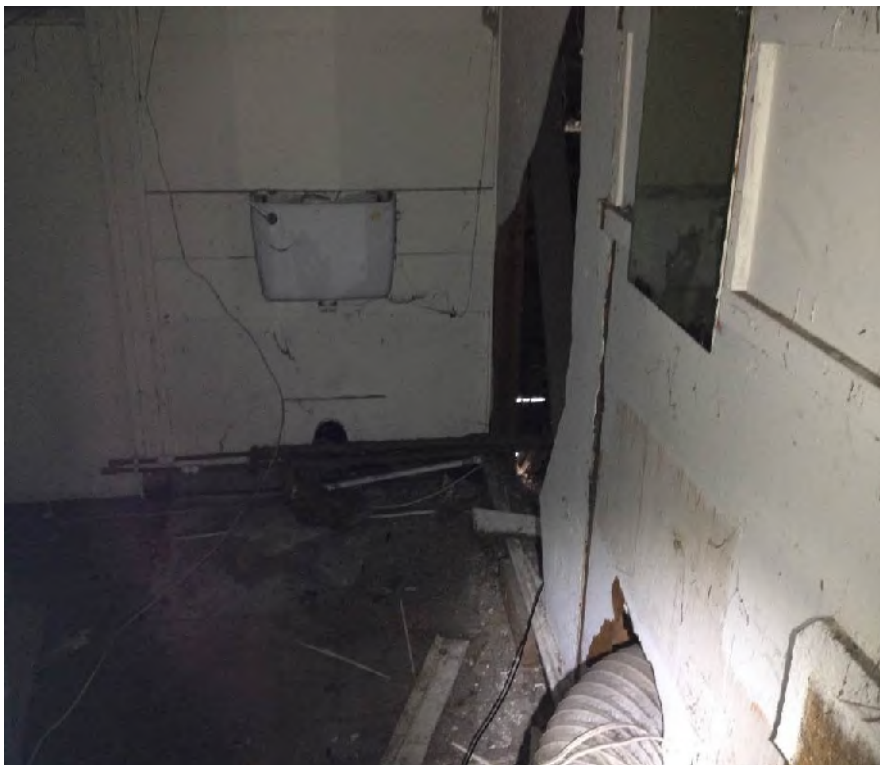
PHOTOPLATE 262

First Floor Toilet

Recommendation

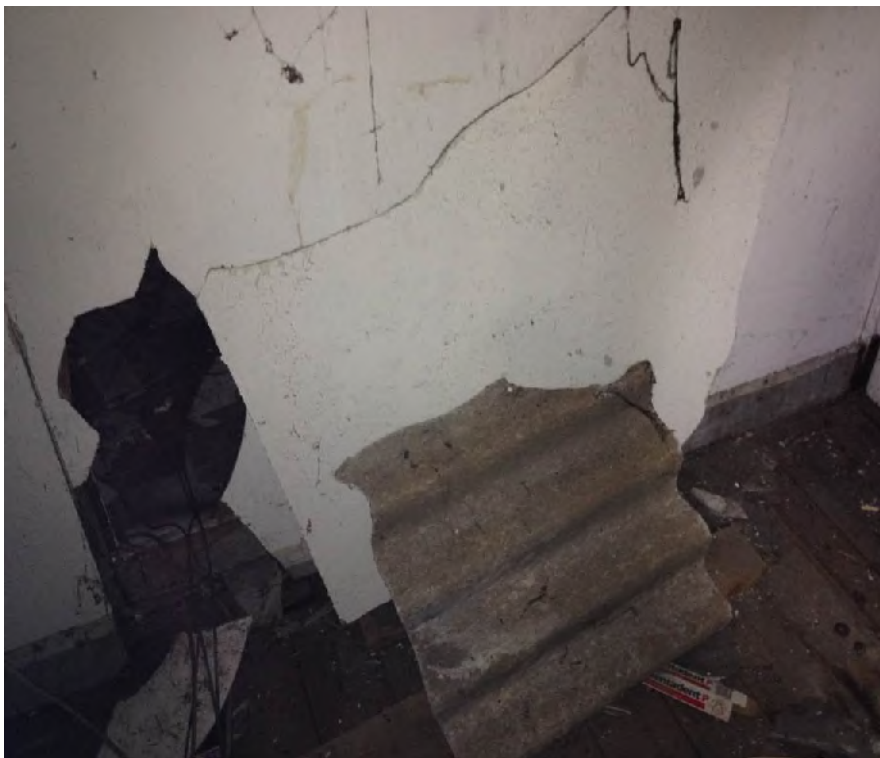
**PHOTOPLATE 264**

| First Floor Toilet |

| Sample Reference (Bulk ID) |
| - |
| Recommendation |
| Remove |

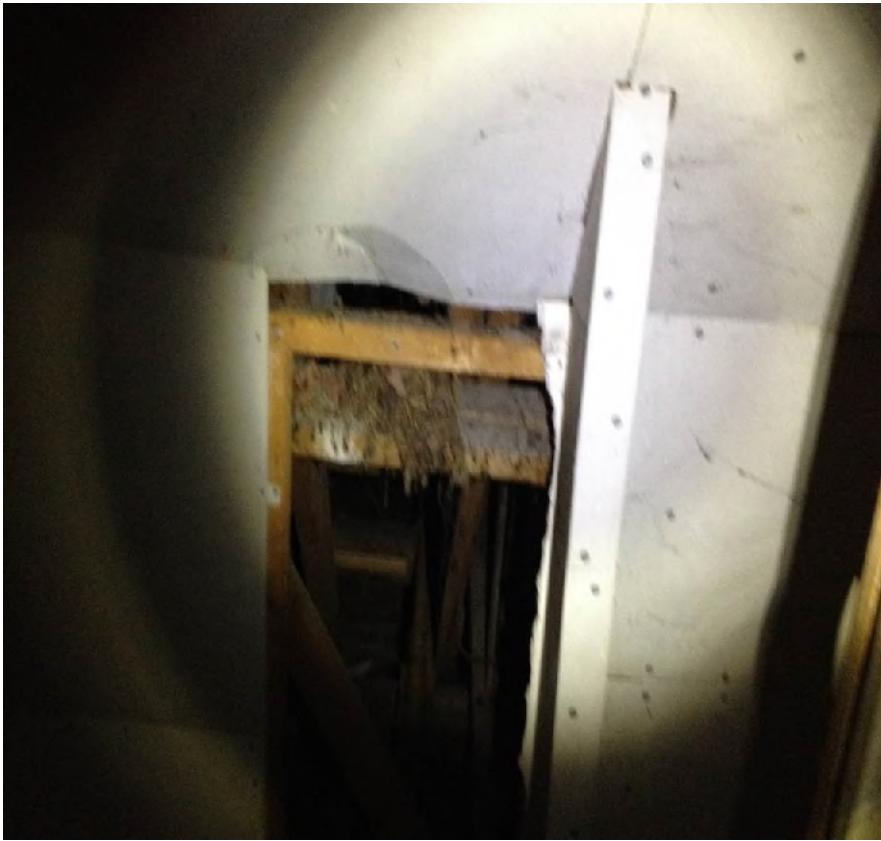
PHOTOPLATE 265

First Floor Void

Recommendation

Encapsulate

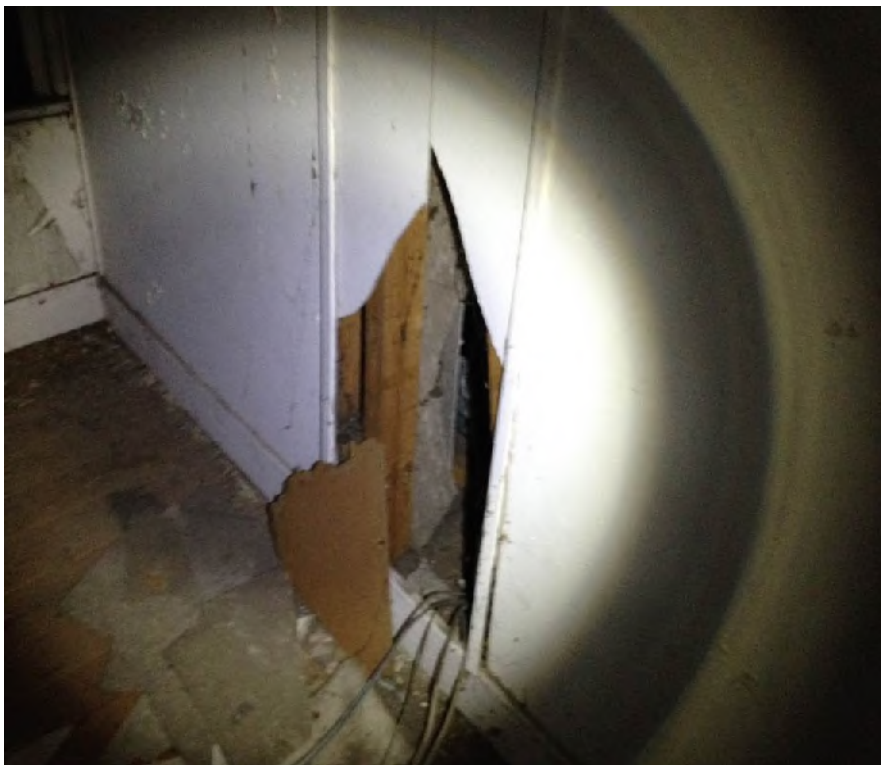
PHOTOPLATE 266

First Floor Store

Recommendation

Encapsulate

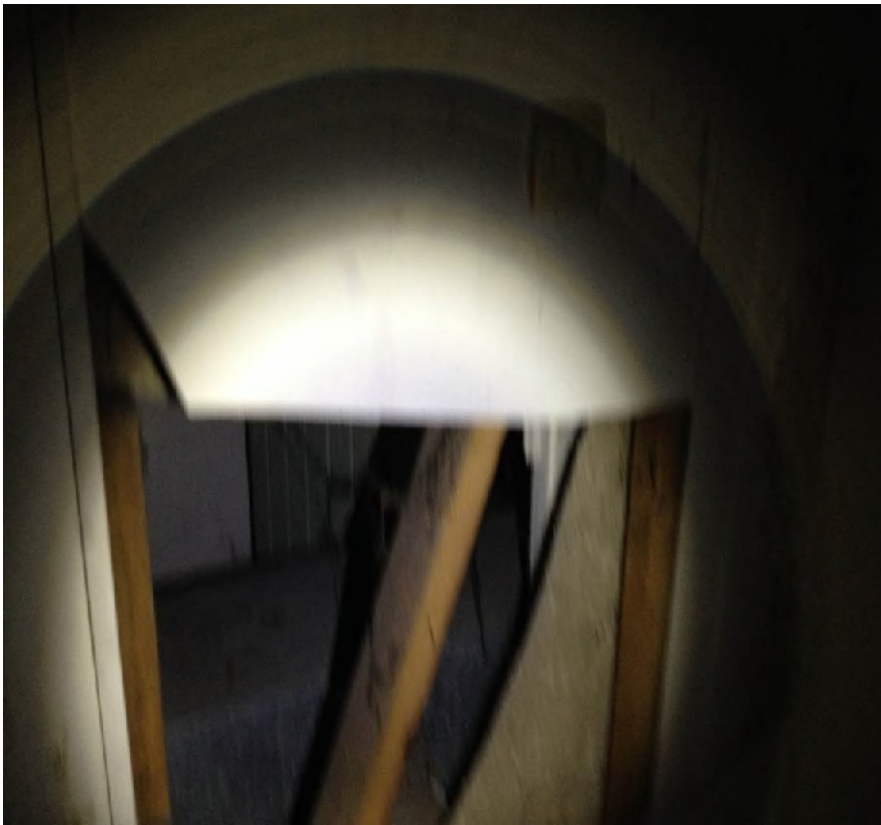
PHOTOPLATE 267

First Floor Store

Recommendation

Encapsulate

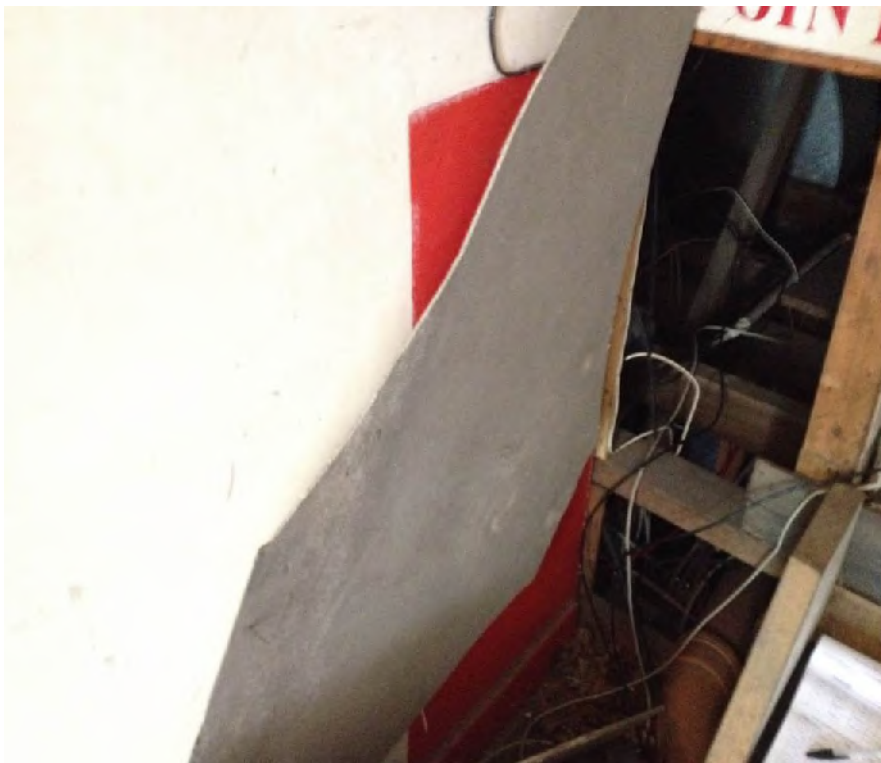
PHOTOPLATE 268

First Floor Corridor

Recommendation

Encapsulate

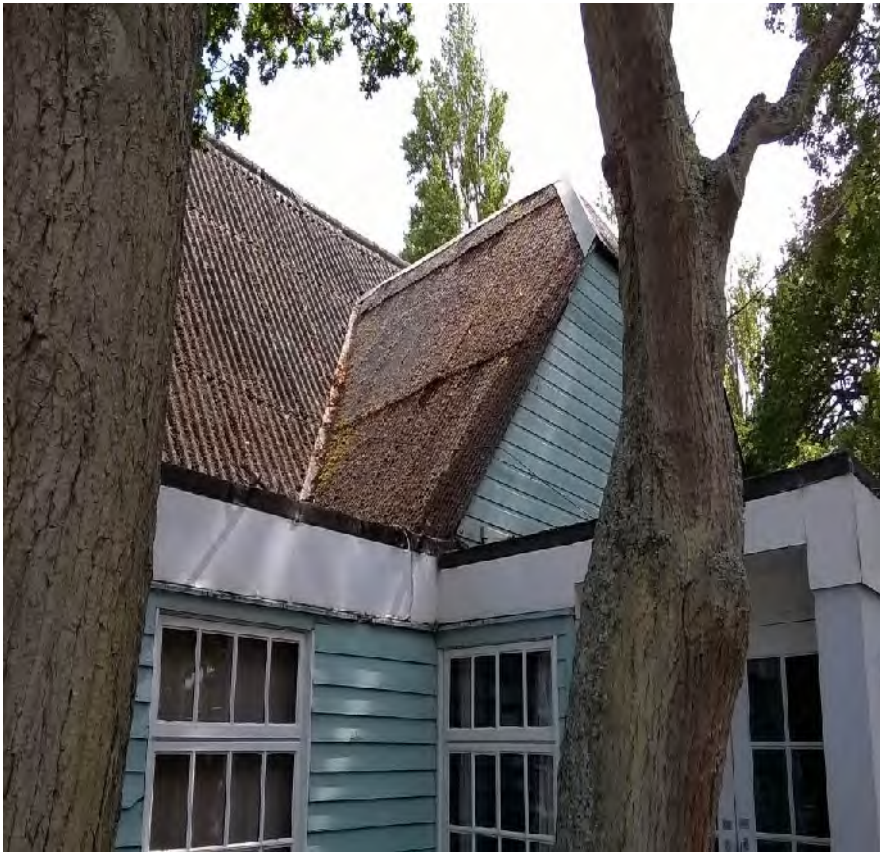
PHOTOPLATE 269

External Circulation

Recommendation

Mark and manage

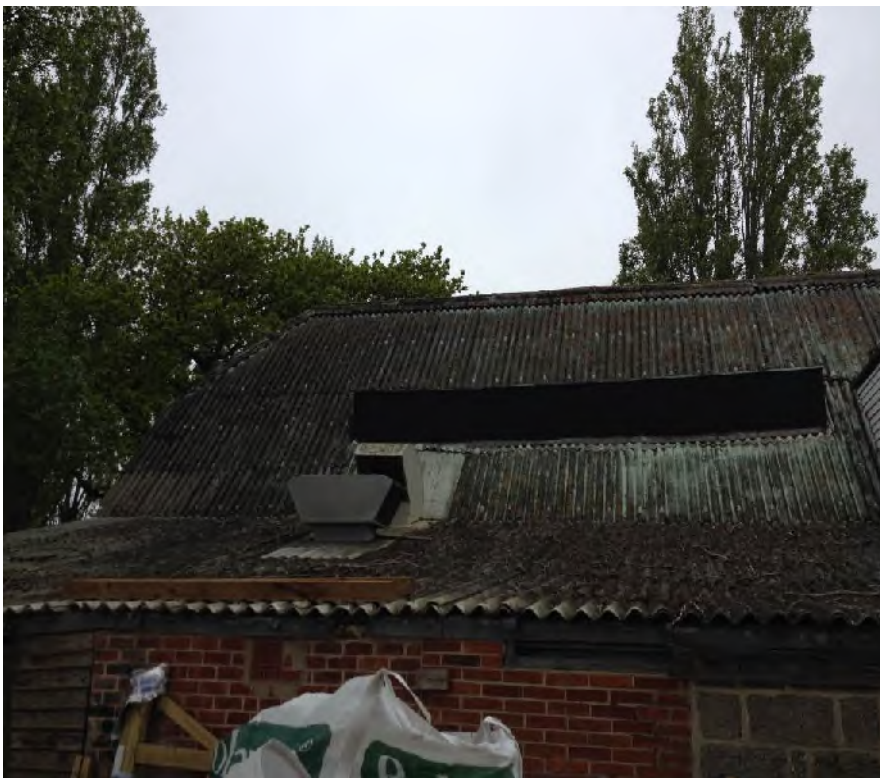
PHOTOPLATE 270

External Circulation

Recommendation

Mark and manage

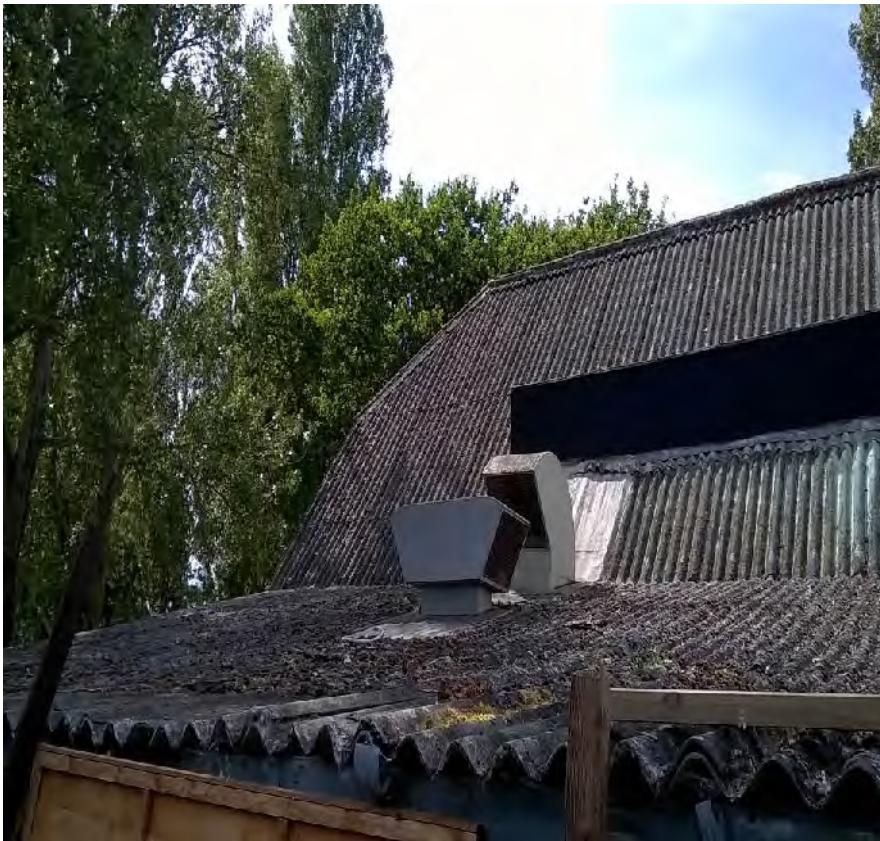
PHOTOPLATE 271

External Circulation

Recommendation

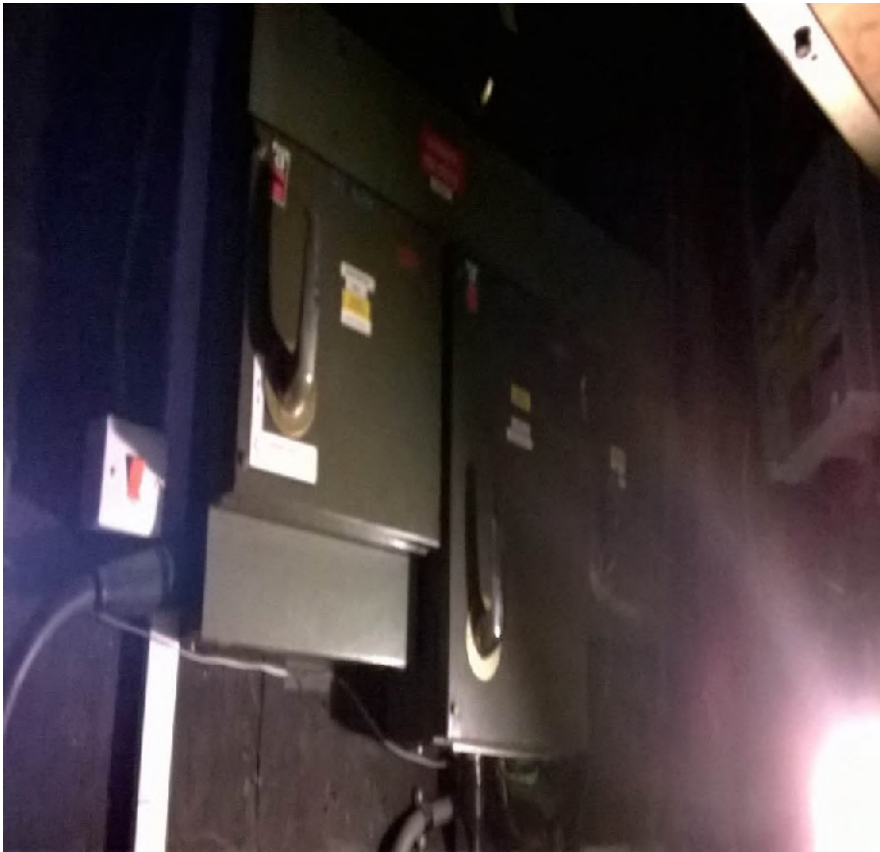
PHOTOPLATE 273

| Ground Floor Stage |

| Item No. |
| - |
| Recommendation |
| Mark and manage |

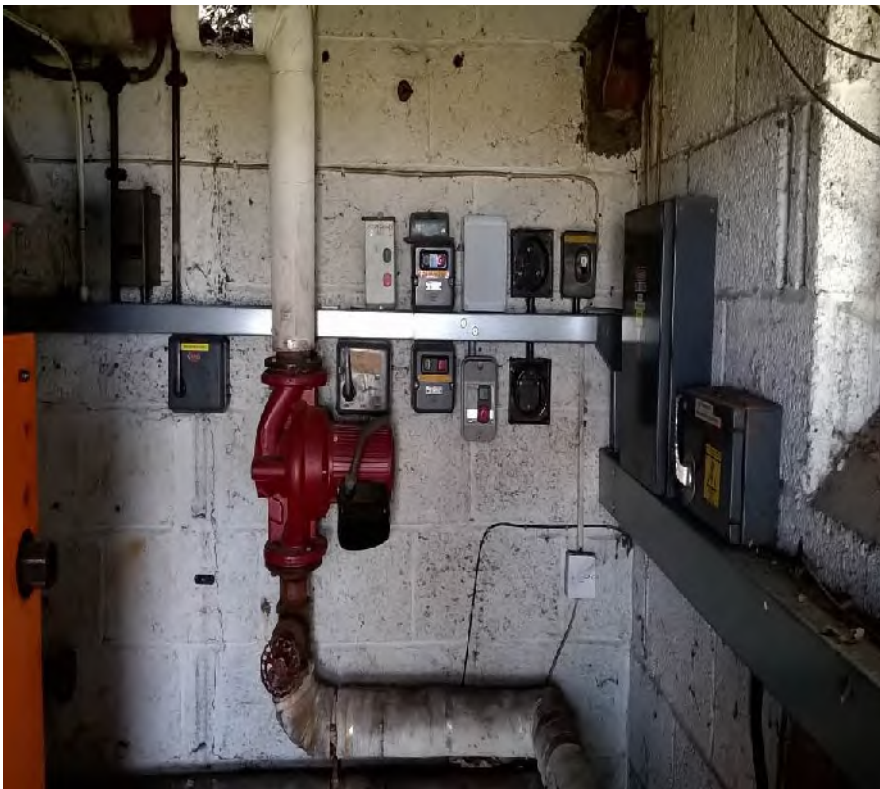
PHOTOPLATE 274

| Boiler Room |

| Item No. |
| - |
| Recommendation |
| Mark and manage |

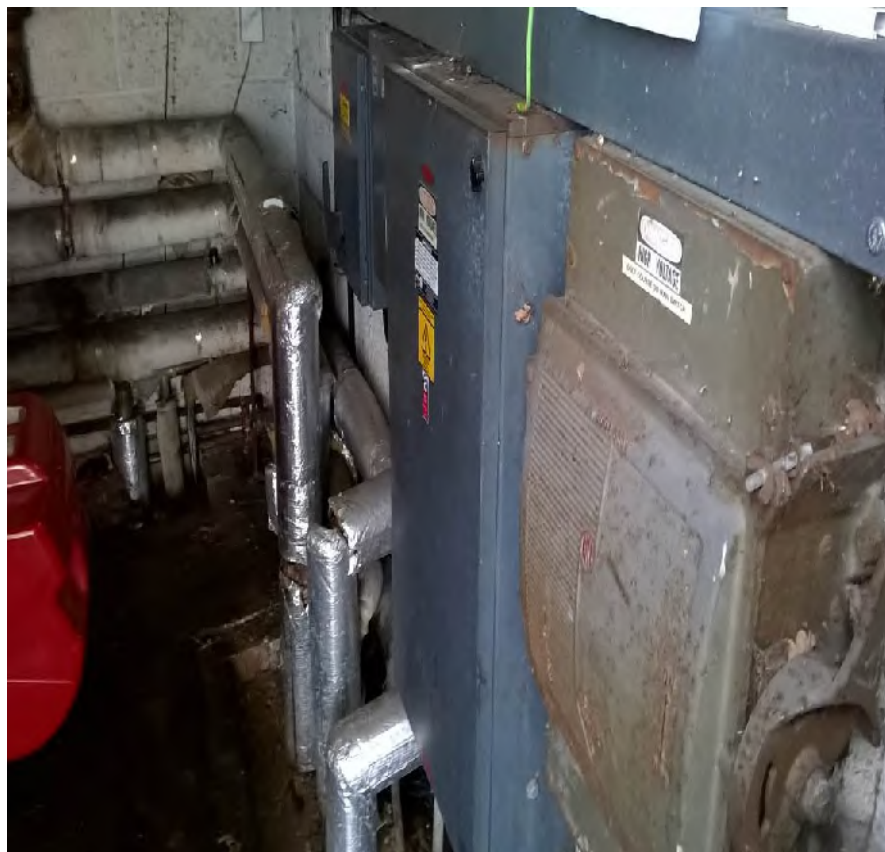
PHOTOPLATE 275

Boiler Room

Recommendation

Mark and manage

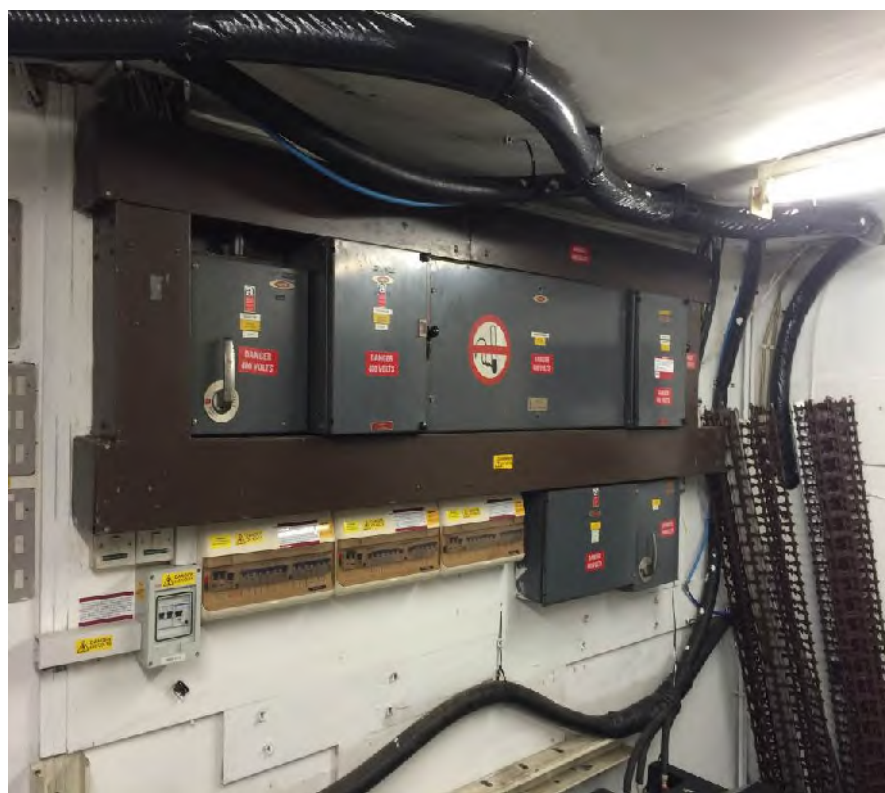
PHOTOPLATE 276

Hudsons Rear Cellar

Recommendation

Mark and manage

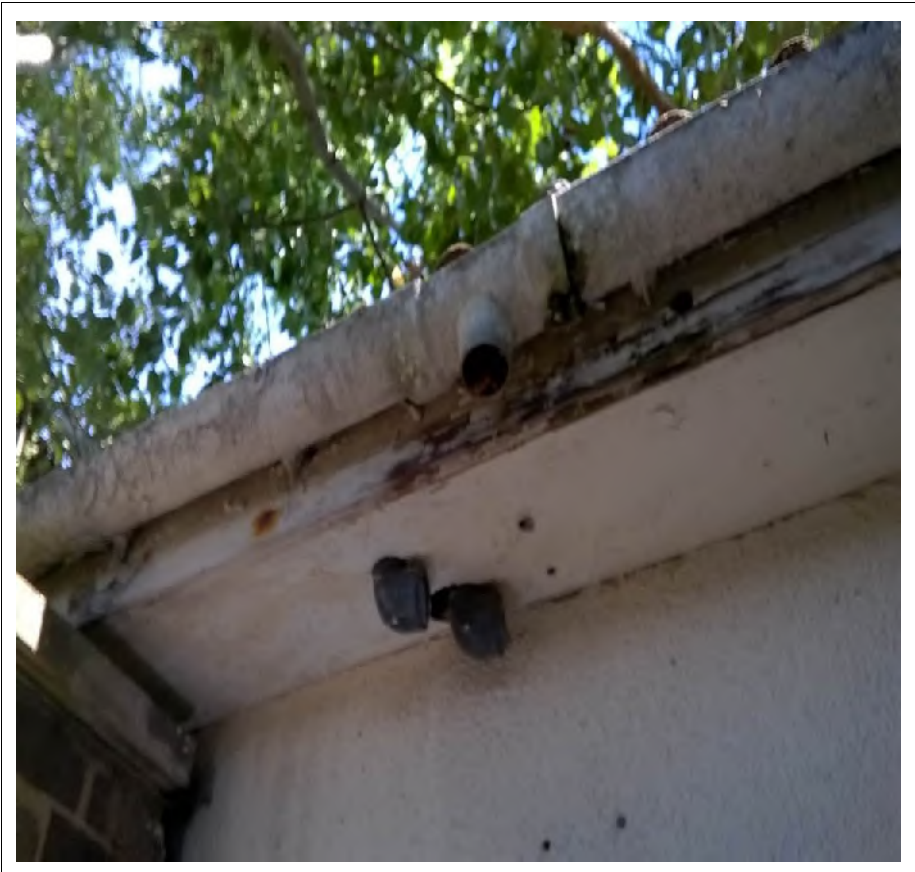
PHOTOPLATE 277

| External |

| Item No. |
| - |
| Recommendation |
