### Asbestos Survey

### MANAGEMENT RE-INSPECTION SURVEY REPORT

**Report Number:** J4850  
**On behalf of** Away Resorts  
Mill Rythe Holiday Village, 16 Havant Road,  
Hayling Island, Hampshire PO11 0PB

**Mill Rythe Holiday Village**  
**16 Havant Road**  
**Hayling Island**  
**Hampshire**  
**PO11 0PB**

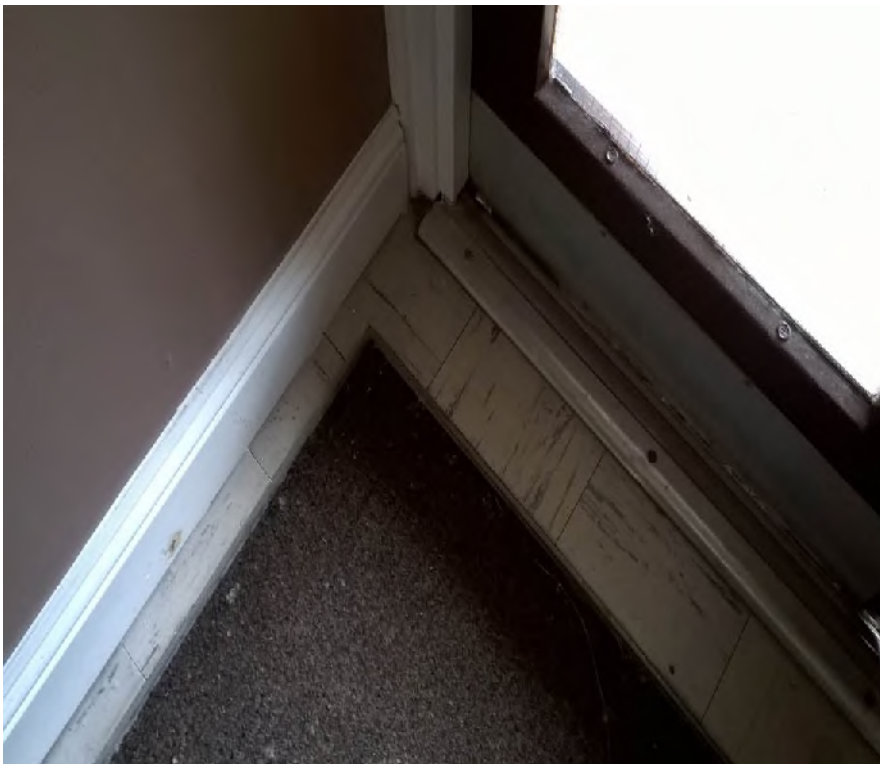
PHOTOPLATE 002

| Building: <b>Main</b> | | | | | |
|---|---|---|---|---|---|
| Ground Floor Corridor | 449 | 02 | Floor tiles (Grey) | Was found to contain Chrysotile (White Asbestos) | Mark and manage |

| Ground Floor Corridor |

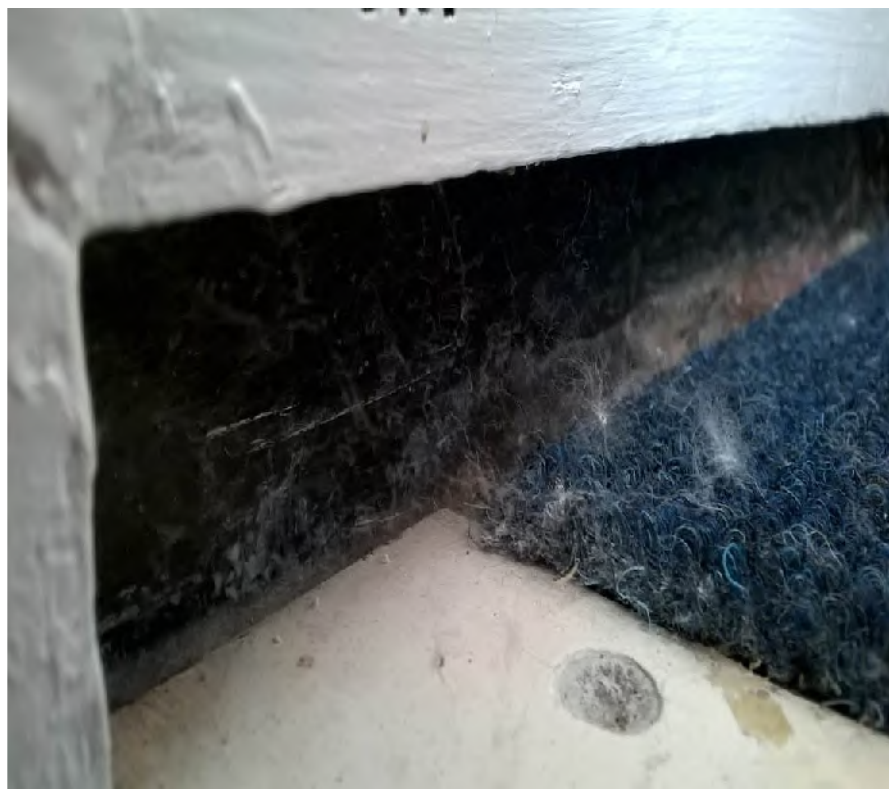
PHOTOPLATE 004

| Building: <b>Main</b> | | | | | |
|---|---|---|---|---|---|
| First Floor Stairwell | 453 | 04 | Stair skirting to the stair area behind timber skirting | Was found to contain Chrysotile (White Asbestos) | Mark and manage |

First Floor Stairwell

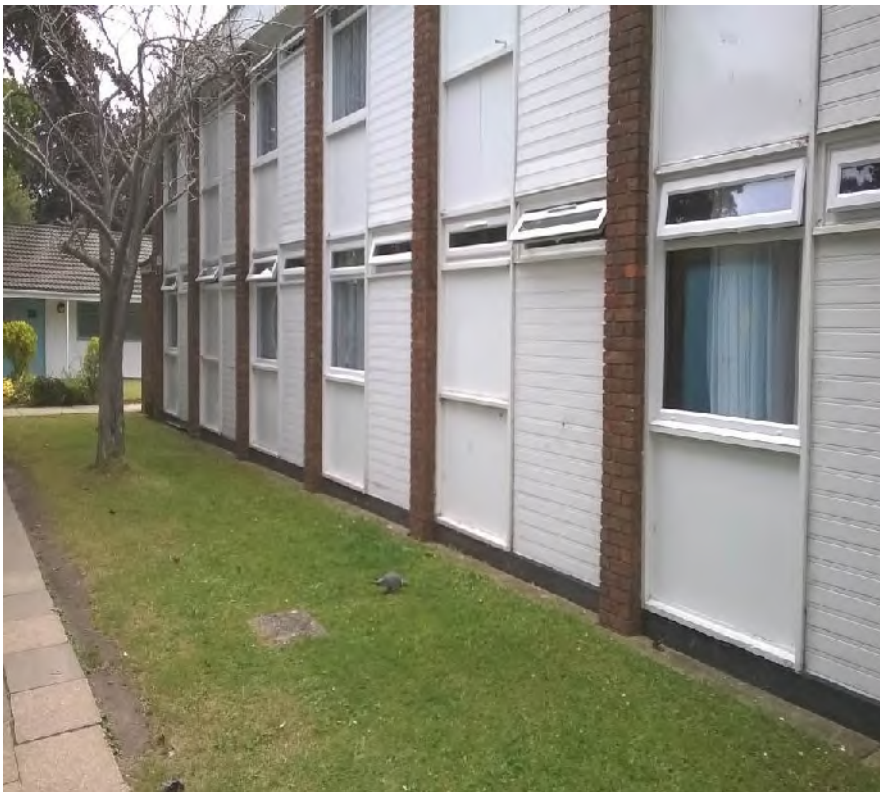
**PHOTOPLATE 008**

| Building: <b>Main</b> | | | | | |
|---|---|---|---|---|---|
| External Side Elevations | 464 | 08 | Panels beneath windows partially covered with UPVC | Was found to contain Chrysotile (White Asbestos) | Mark and manage |

External Side Elevations

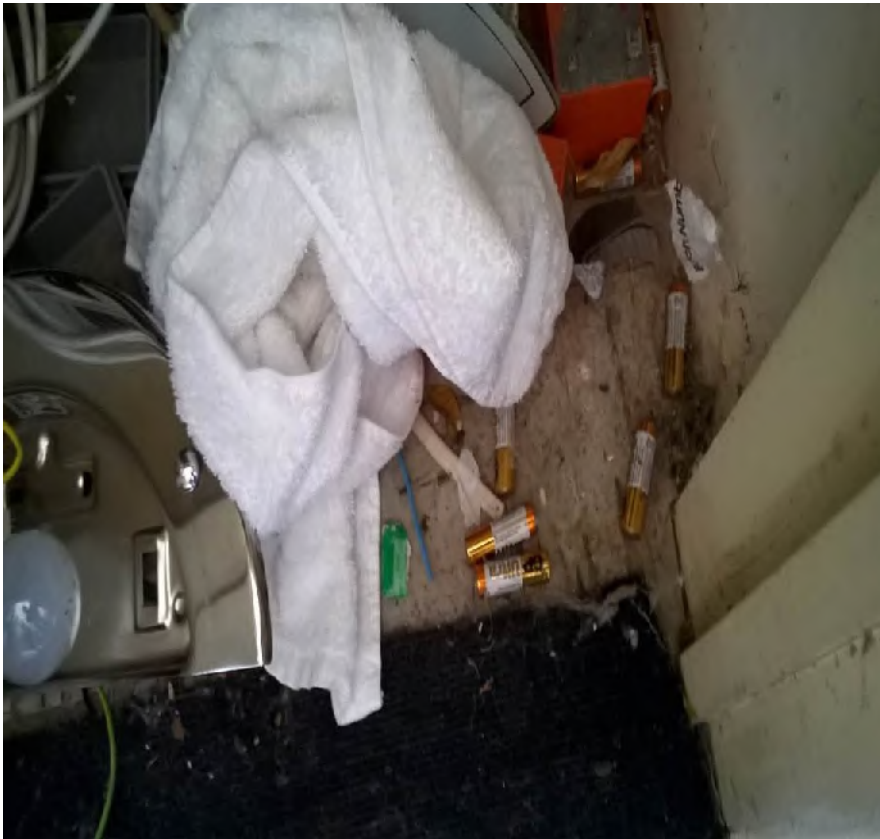
PHOTOPLATE 009

| Building: <b>Main</b> | | | | | |
|---|---|---|---|---|---|
| Ground Floor Electrical Cupboard | 548 | 09 | Floor tiles | Was found to contain Chrysotile (White Asbestos) | Mark and manage |

Ground Floor Electrical Cupboard

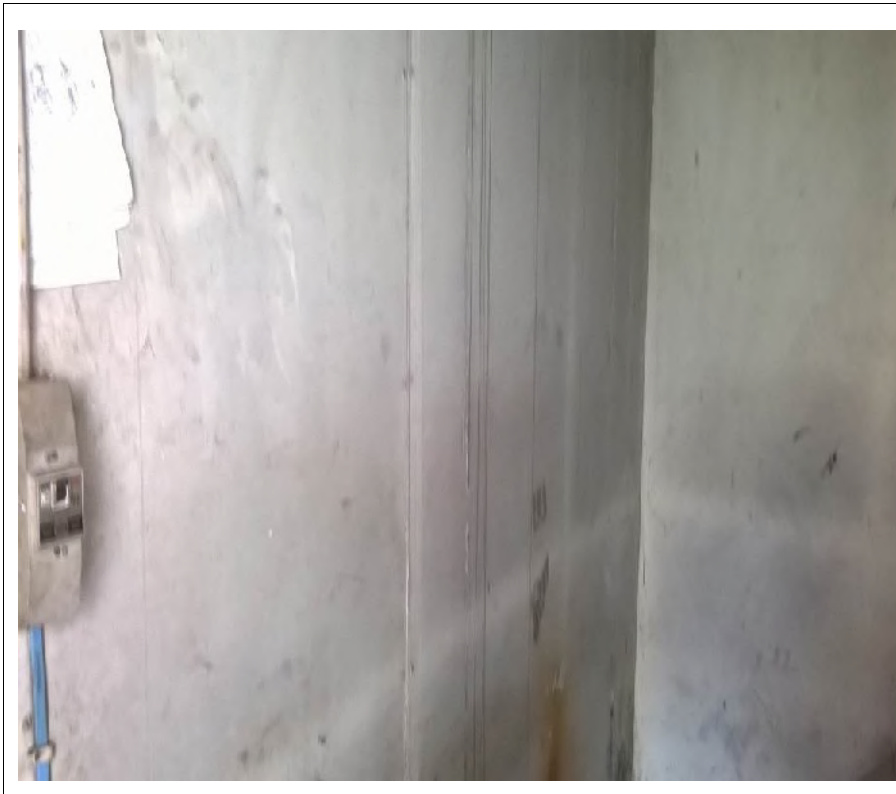
**PHOTOPLATE 018**

| Building: <b>Main</b> | | | | | |
|---|---|---|---|---|---|
| Ground Floor Boiler House | 483 | 18 | Lining panels to walls | Was found to contain Amosite (Brown Asbestos) | Mark and manage |

| Ground Floor Boiler House |

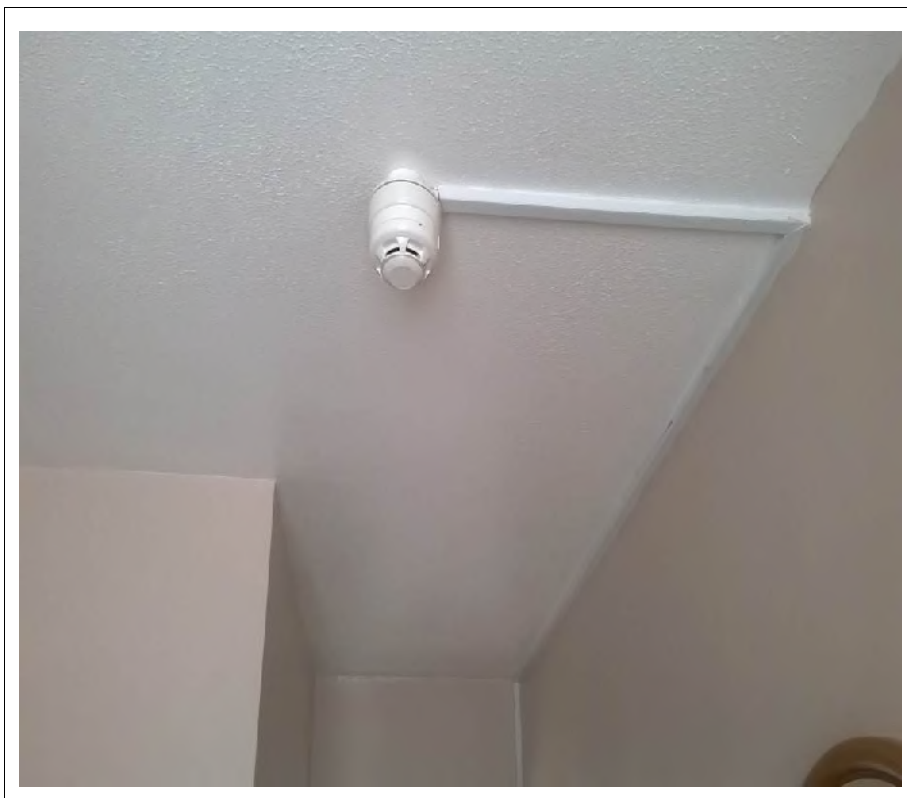
| Accommodation Block 21 (Tenby) | | | | | |
|---|---|---|---|---|---|
| Ground Floor Bedroom | 431 | 20 | Textured coating to ceiling | Was found to contain Chrysotile (White Asbestos) | Mark and manage |

**Ground Floor Bedroom**

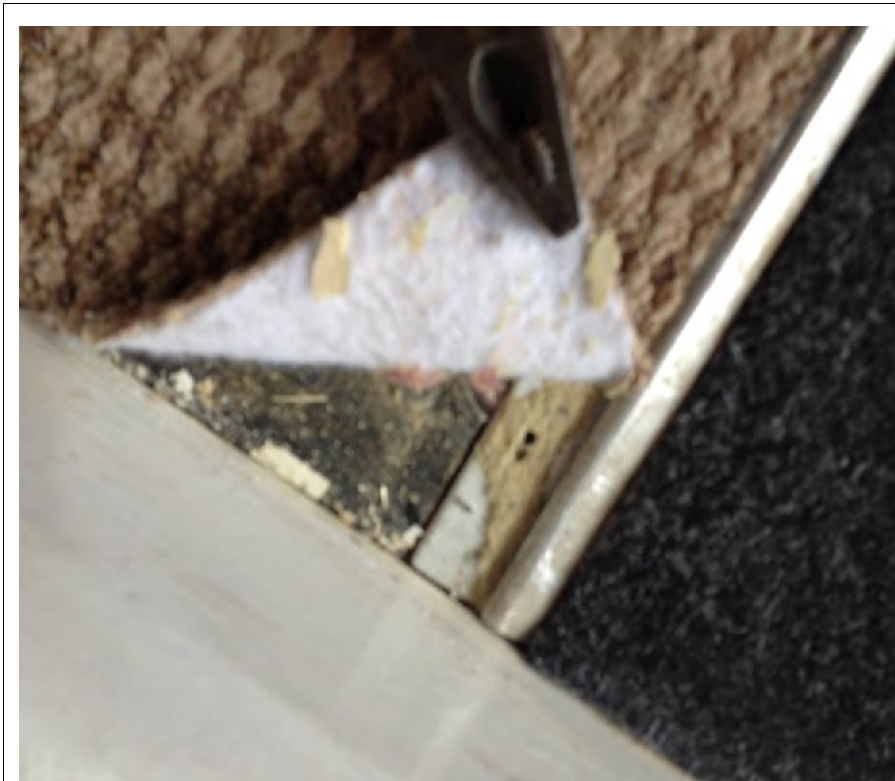
**PHOTOPLATE 022**

| Accommodation Block 21 (Tenby) | | | | | |
|---|---|---|---|---|---|
| First Floor Bedroom | 434 | 22 | Floor tiles beneath carpet | Was found to contain Chrysotile (White Asbestos) | Mark and manage |

First Floor Bedroom

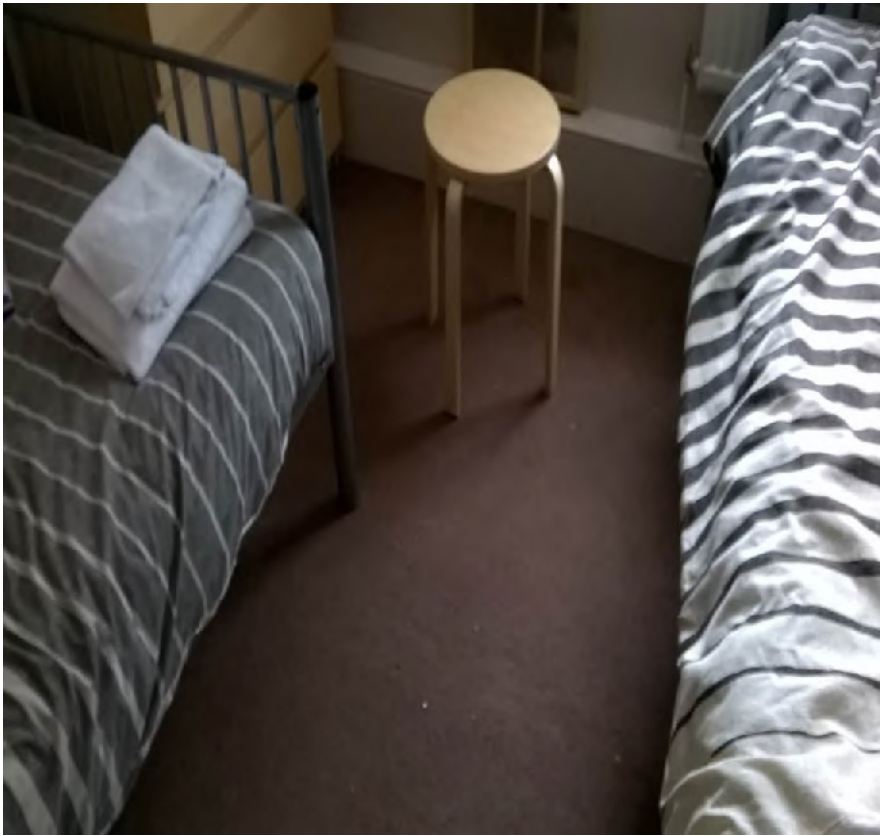
PHOTOPLATE 025

| Accommodation Block 21 (Tenby) | | | | | |
|---|---|---|---|---|---|
| Ground Floor Bedroom | 342 | 25 | Screed beneath carpet | Was found to contain Chrysotile (White Asbestos) | Mark and manage |

| Ground Floor Bedroom |

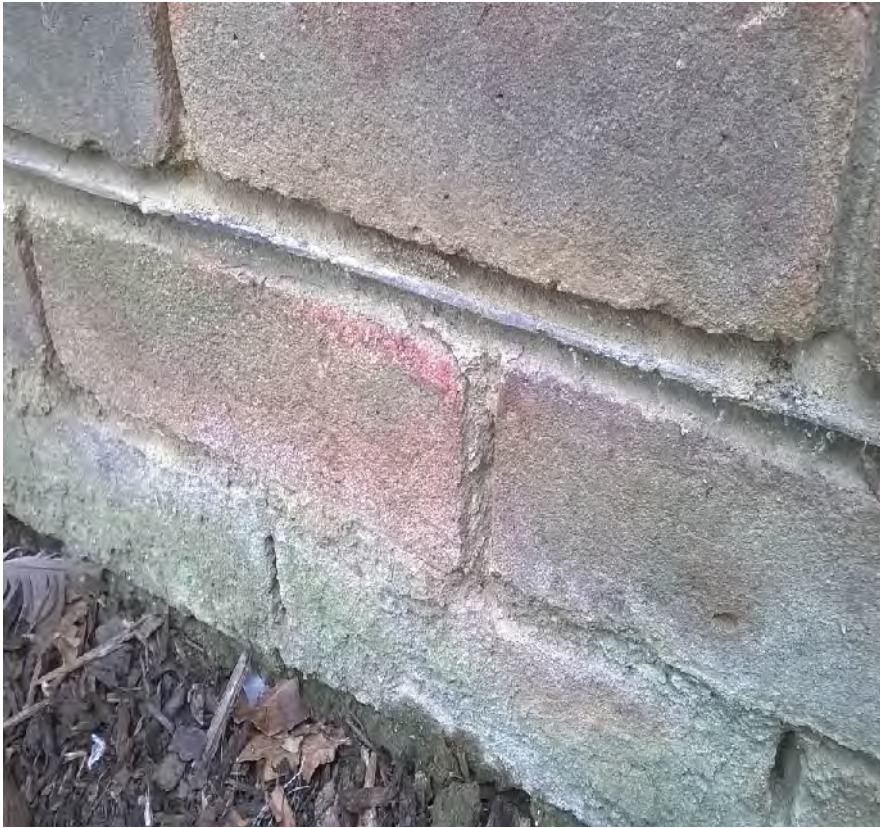
**PHOTOPLATE 027**

| Accommodation Block 21 (Tenby) | | | | | |
|---|---|---|---|---|---|
| External Elevations | 358 | 27 | Damp proof course | Was found to contain Chrysotile (White Asbestos) | Mark and manage |

| External Elevations |

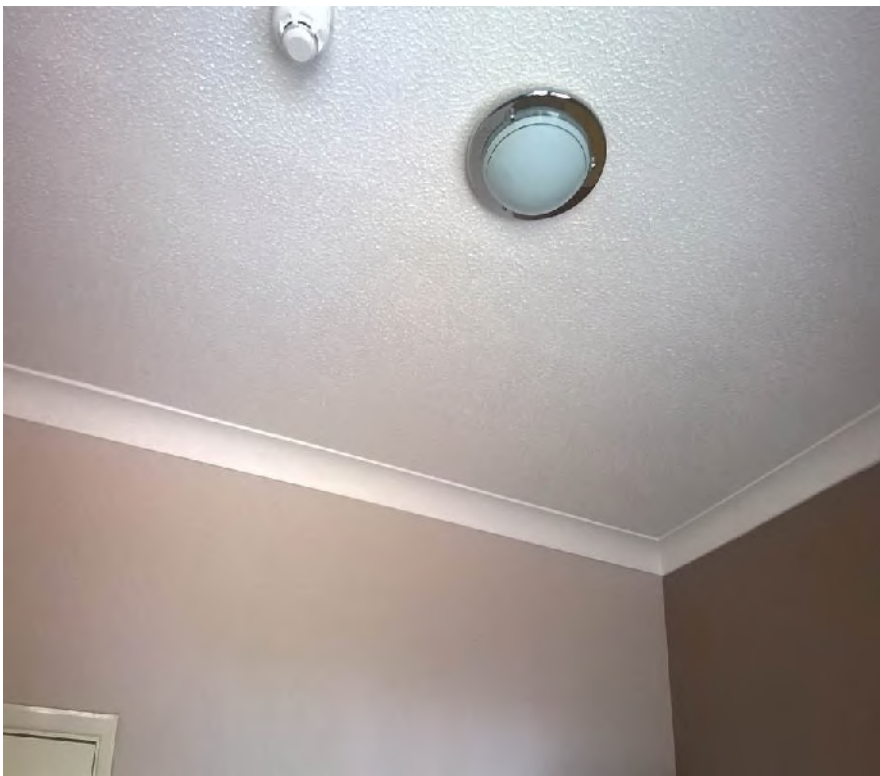
**PHOTOPLATE 028**

| Accommodation Block 21 (Tenby) | | | | | |
|---|---|---|---|---|---|
| Ground Floor Bedroom | 324 | 28 | Textured coating to ceiling | Was found to contain Chrysotile (White Asbestos) | Mark and manage |

| Ground Floor Bedroom |

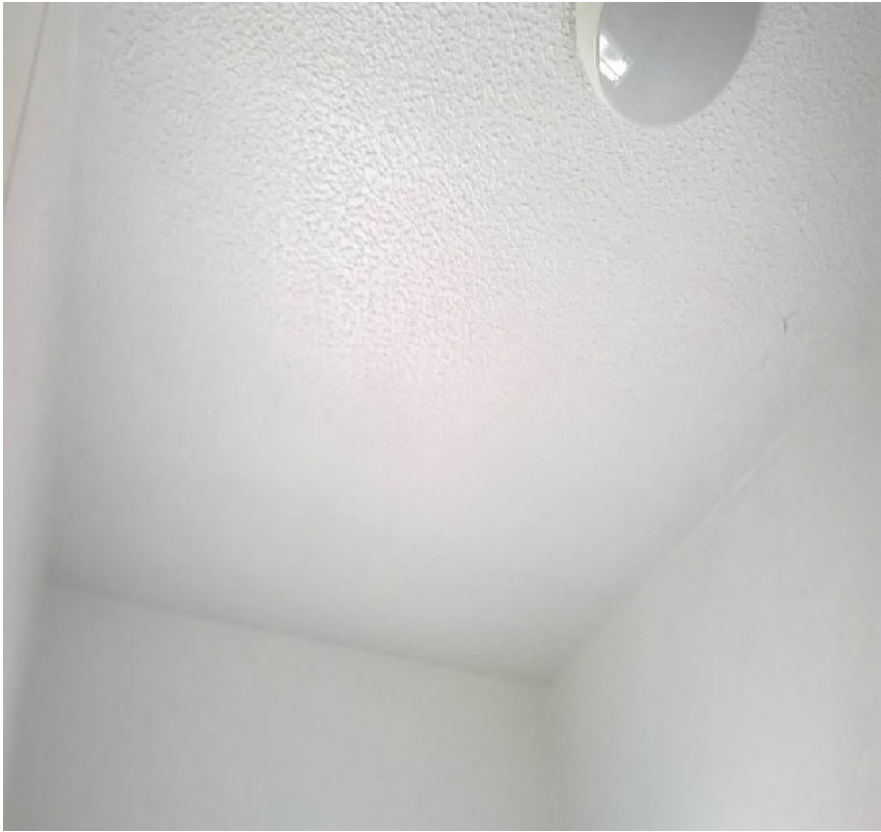
**PHOTOPLATE 029**

| Accommodation Block 21 (Tenby) | | | | | |
|---|---|---|---|---|---|
| Ground Floor Bathroom | 325 | 29 | Textured coating to ceiling | Was found to contain Chrysotile (White Asbestos) | Mark and manage |

| Ground Floor Bathroom |

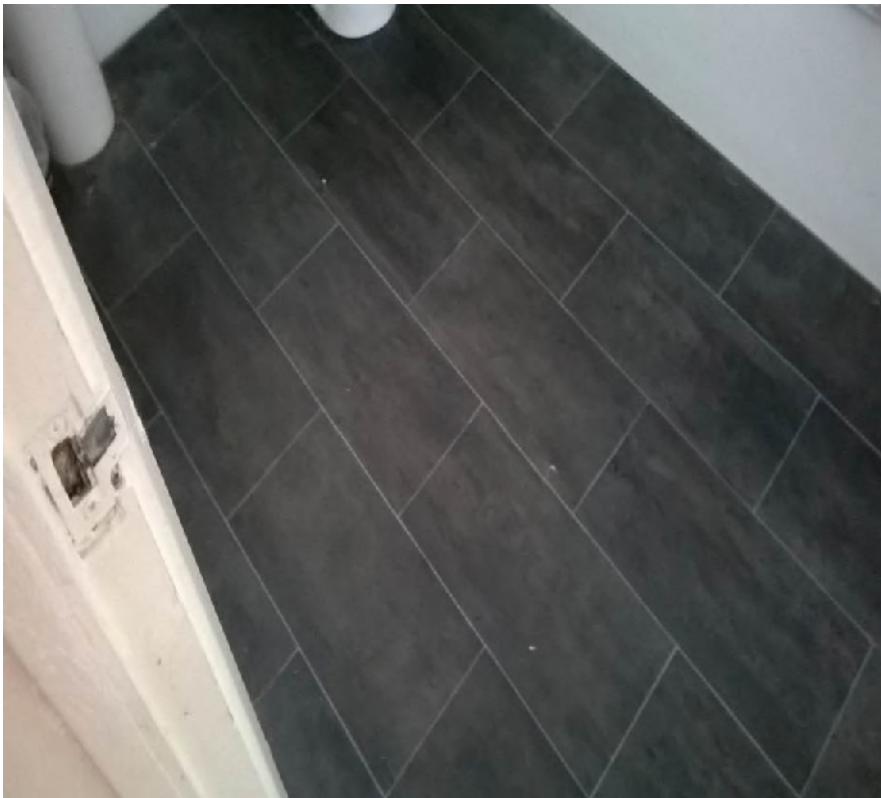
**PHOTOPLATE 030**

| Accommodation Block 21 (Tenby) | | | | | |
|---|---|---|---|---|---|
| Ground Floor Bathroom | 326 | 30 | Beneath glued down modern vinyl floor covering | Was found to contain Chrysotile (White Asbestos) | Mark and manage |

| Ground Floor Bathroom |

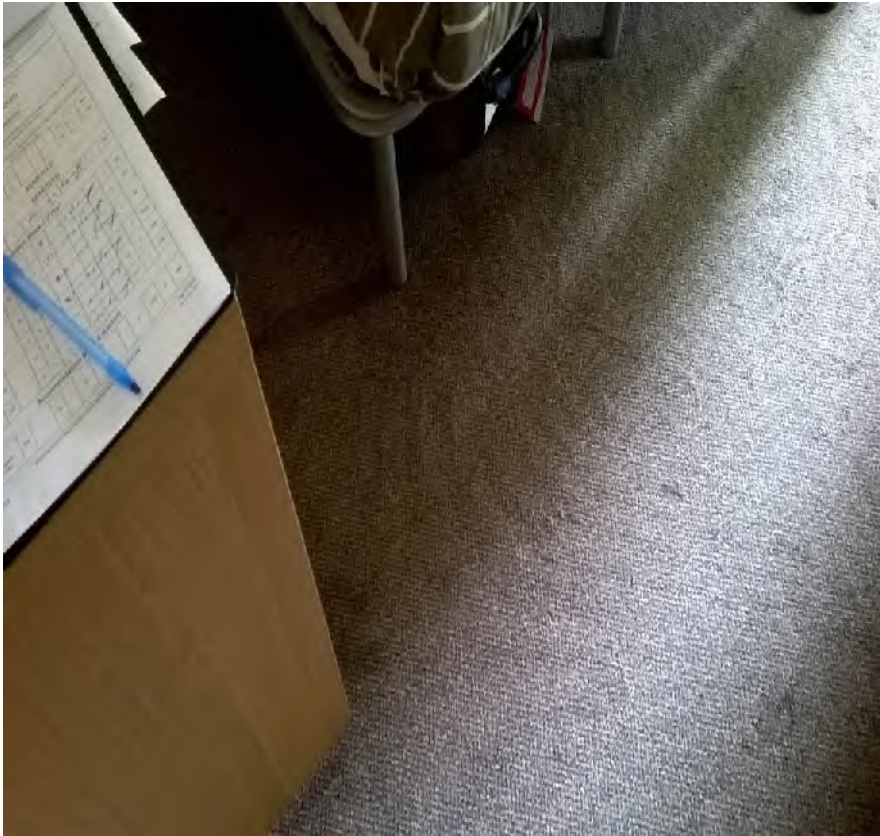
PHOTOPLATE 031

| Accommodation Block 21 (Tenby) | | | | | |
|---|---|---|---|---|---|
| Ground Floor Bedroom | 327 | 31 | Bitumen adhesive beneath carpet | Was found to contain Chrysotile (White Asbestos) | Mark and manage |

Ground Floor Bedroom

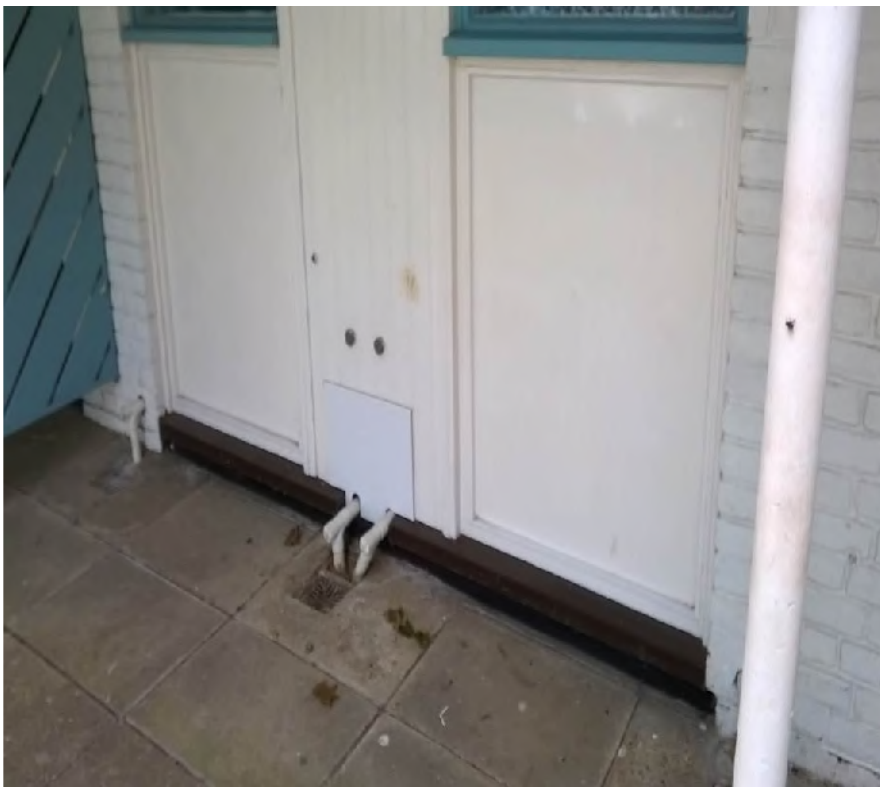
PHOTOPLATE 032

| Accommodation Block 21 (Tenby) | | | | | |
|---|---|---|---|---|---|
| External Bedroom | 328 | 32 | Infill panel beneath window encapsulated with plastic sheet | Was found to contain Chrysotile (White Asbestos) | Mark and manage |

External Bedroom

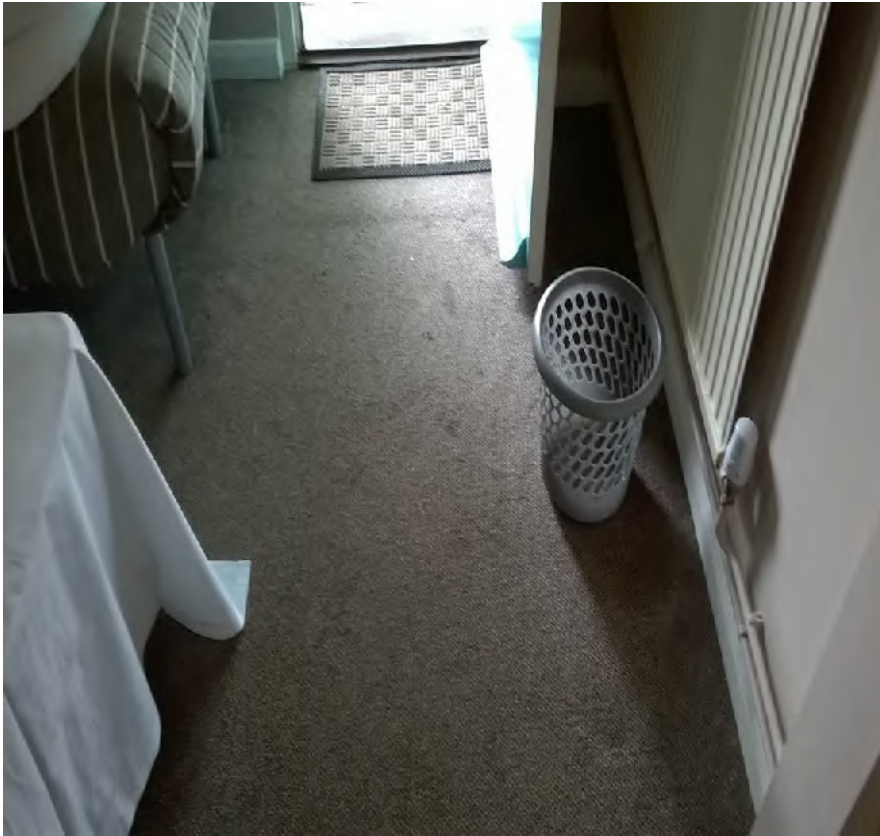
**PHOTOPLATE 035**

| Accommodation Block 21 (Tenby) | | | | | |
|---|---|---|---|---|---|
| Ground Floor Bedroom | 337 | 35 | Beneath the carpet | Was found to contain Chrysotile (White Asbestos) | Mark and manage |

Ground Floor Bedroom

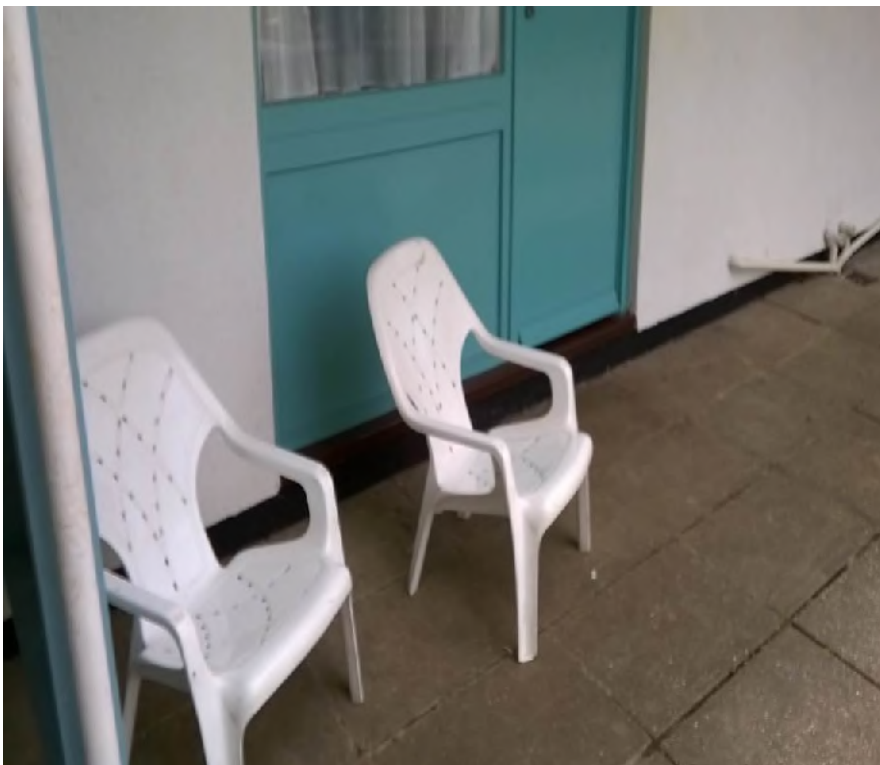
**PHOTOPLATE 036**

| Accommodation Block 21 (Tenby) | | | | | |
|---|---|---|---|---|---|
| External Bedroom | 339 | 36 | Infill panels beneath window | Was found to contain Chrysotile (White Asbestos) | Mark and manage |

External Bedroom

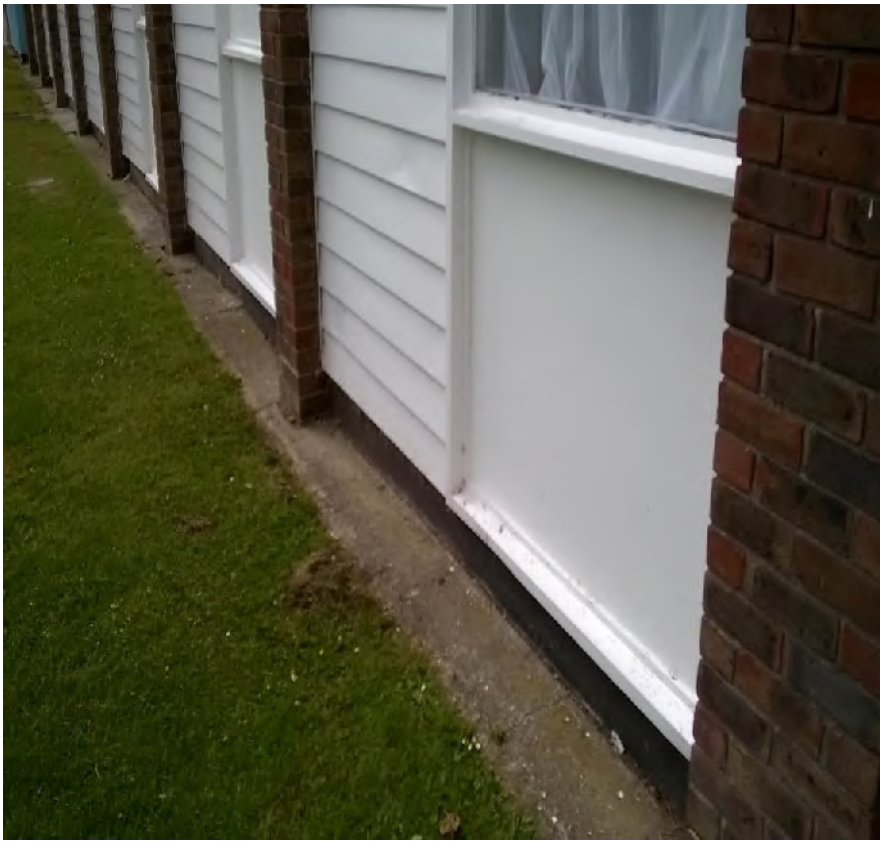
PHOTOPLATE 059

External Side Elevations

| Sample Reference (Bulk ID) |
| - |
| Mark and manage |

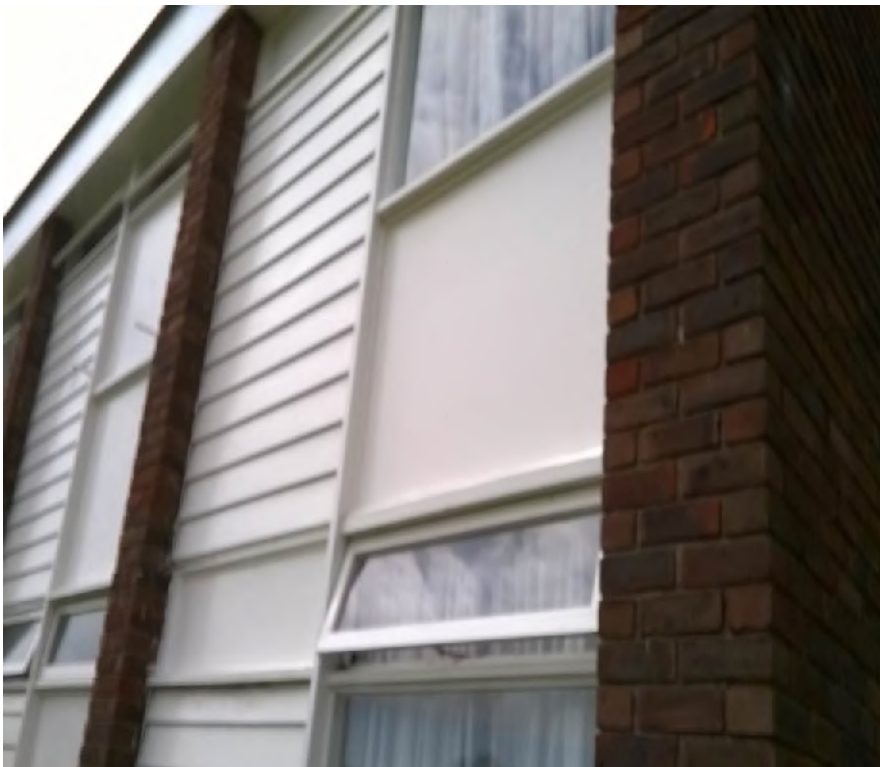
PHOTOPLATE 060

External Side Elevations

Mark and manage

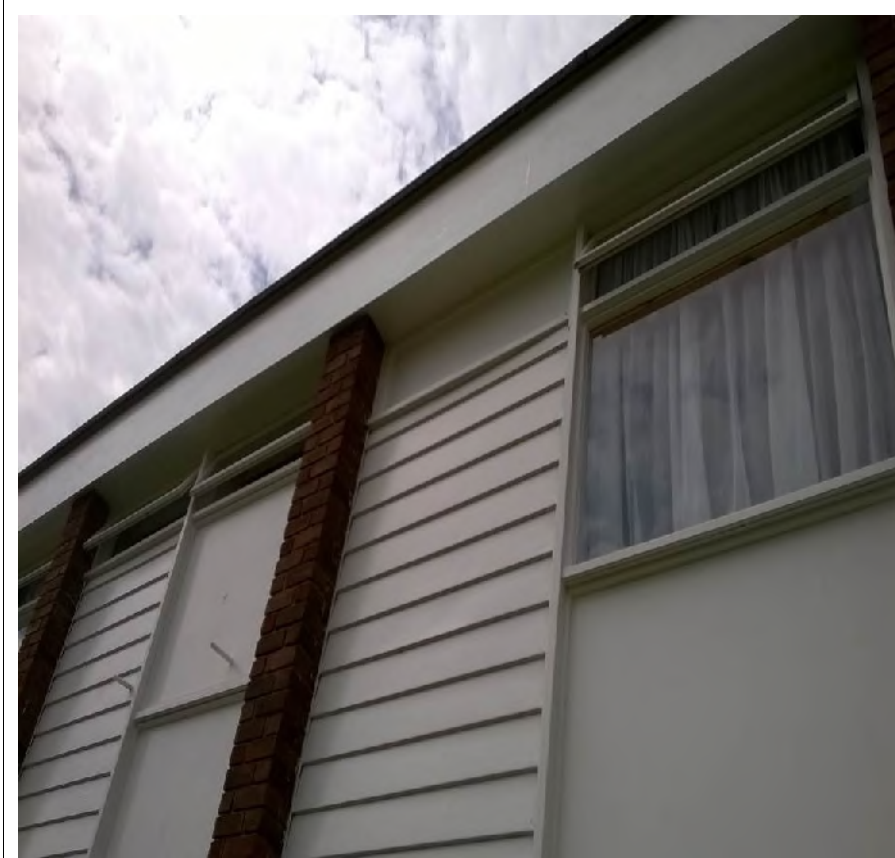
PHOTOPLATE 061

External Side Elevations

Mark and manage

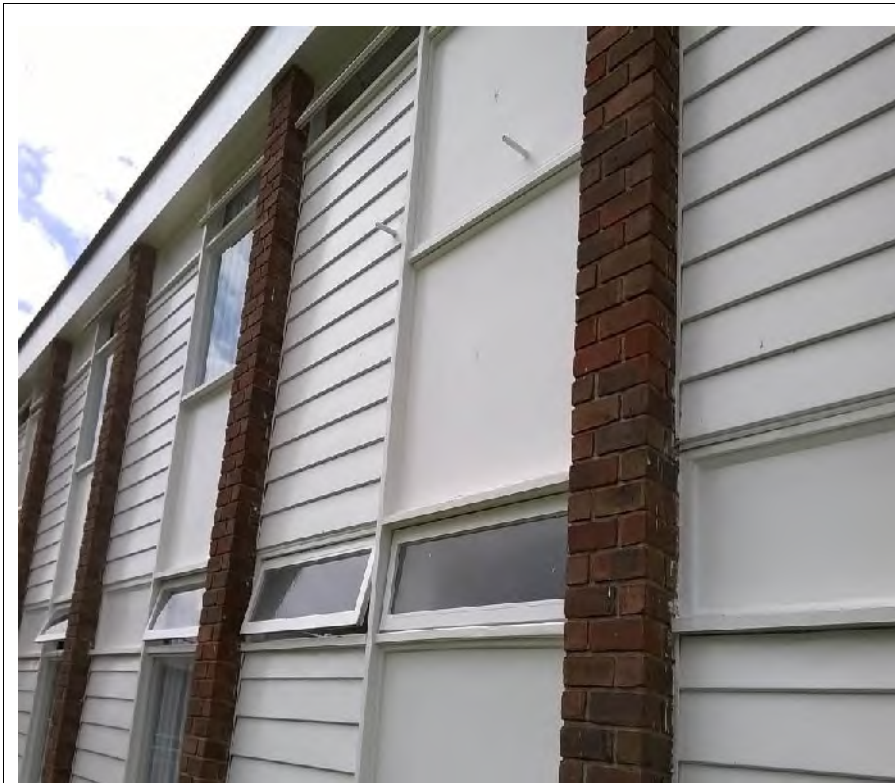
PHOTOPLATE 062

External Side Elevations

Mark and manage

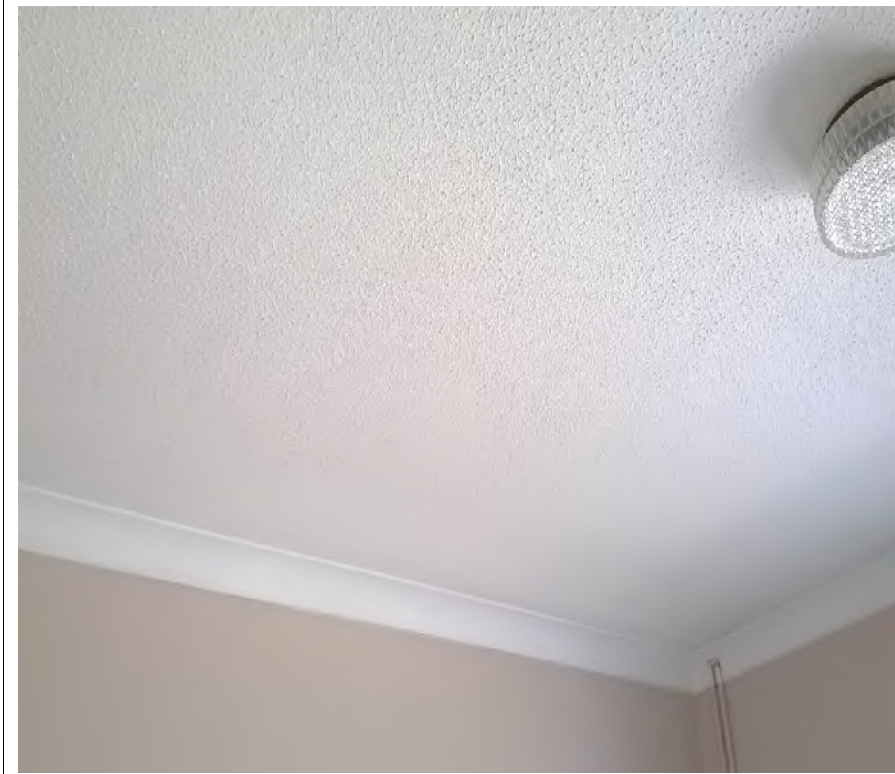
**PHOTOPLATE 064**

| Ground Floor Bedroom 2 |

| Item No. |
| - |
| Mark and manage |

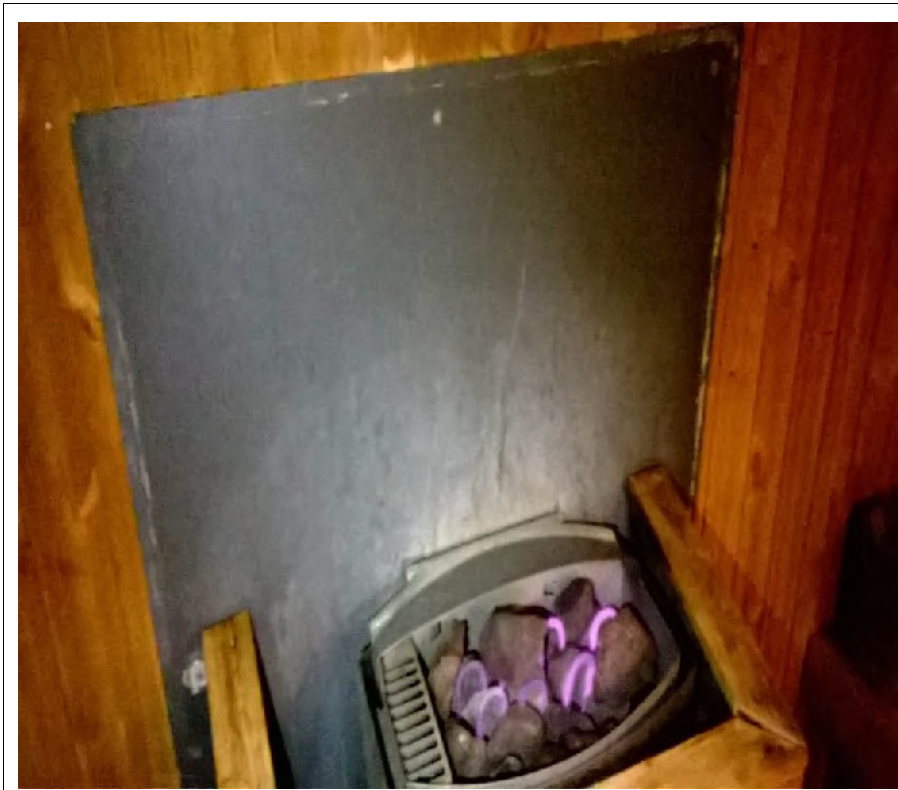
**PHOTOPLATE 068**

Ground Floor Sauna

Mark and manage

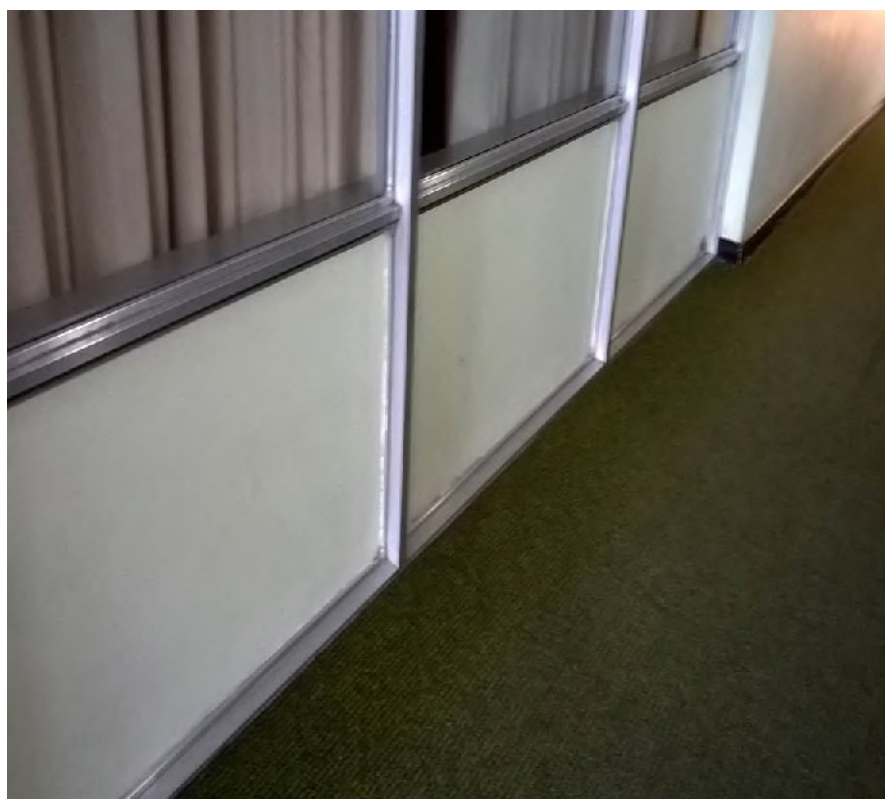
**PHOTOPLATE 070**

Ground Floor Corridor

Mark and manage

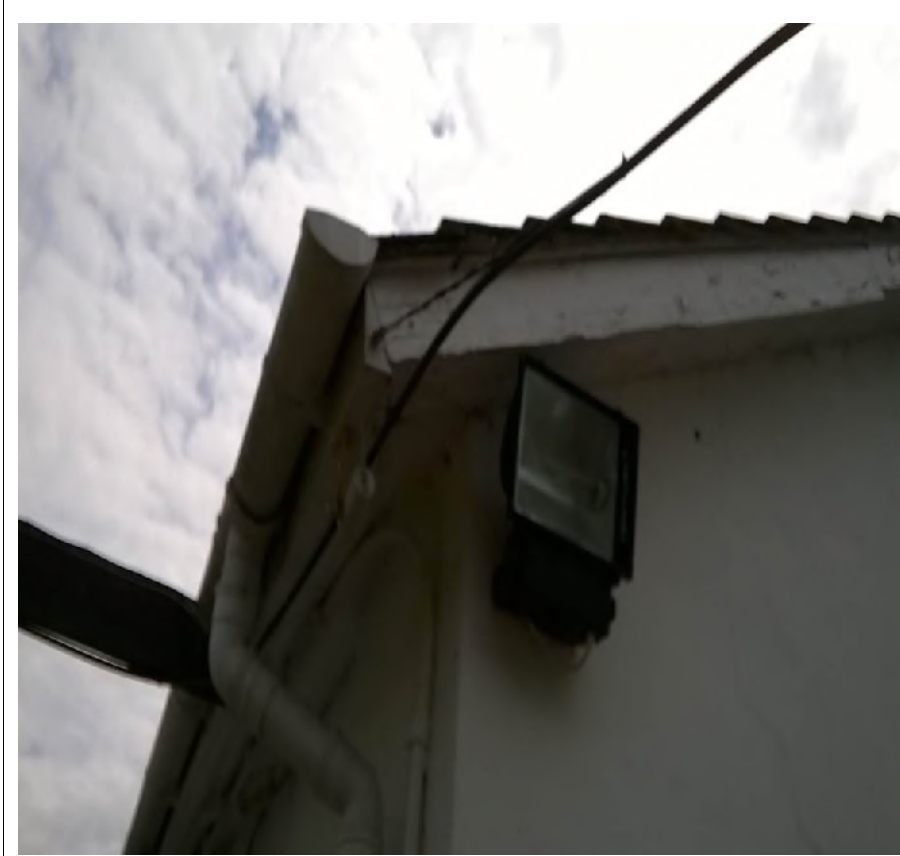
PHOTOPLATE 071

| External Games Room |

Mark and manage

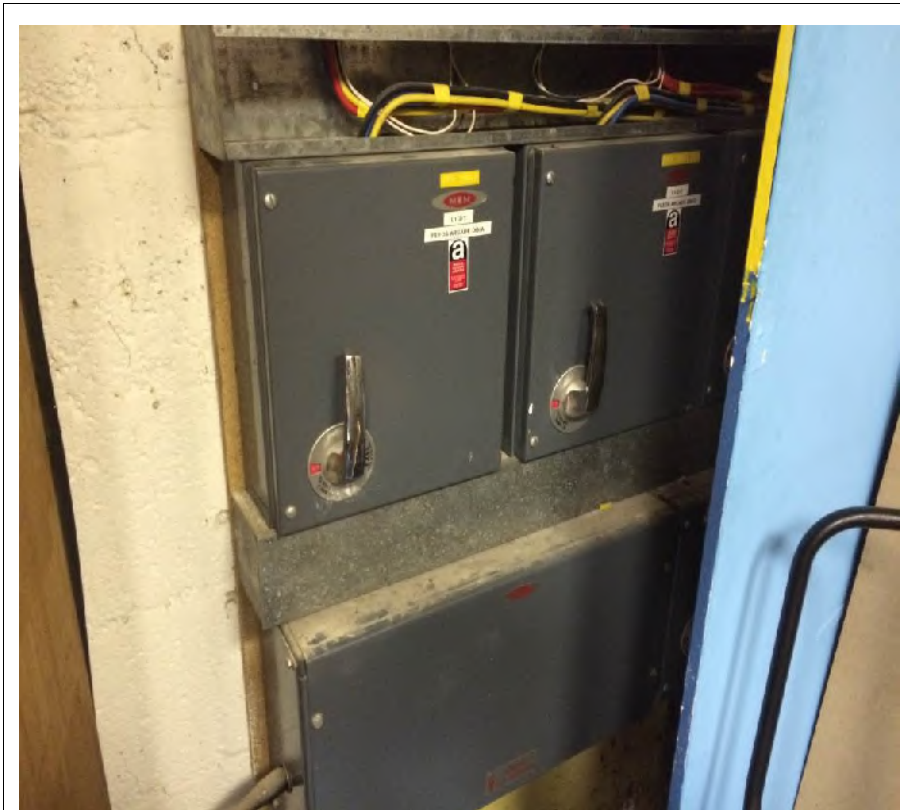
PHOTOPLATE 072

| Ground Floor Office |

| Item No. |
| - |
| Mark and manage |

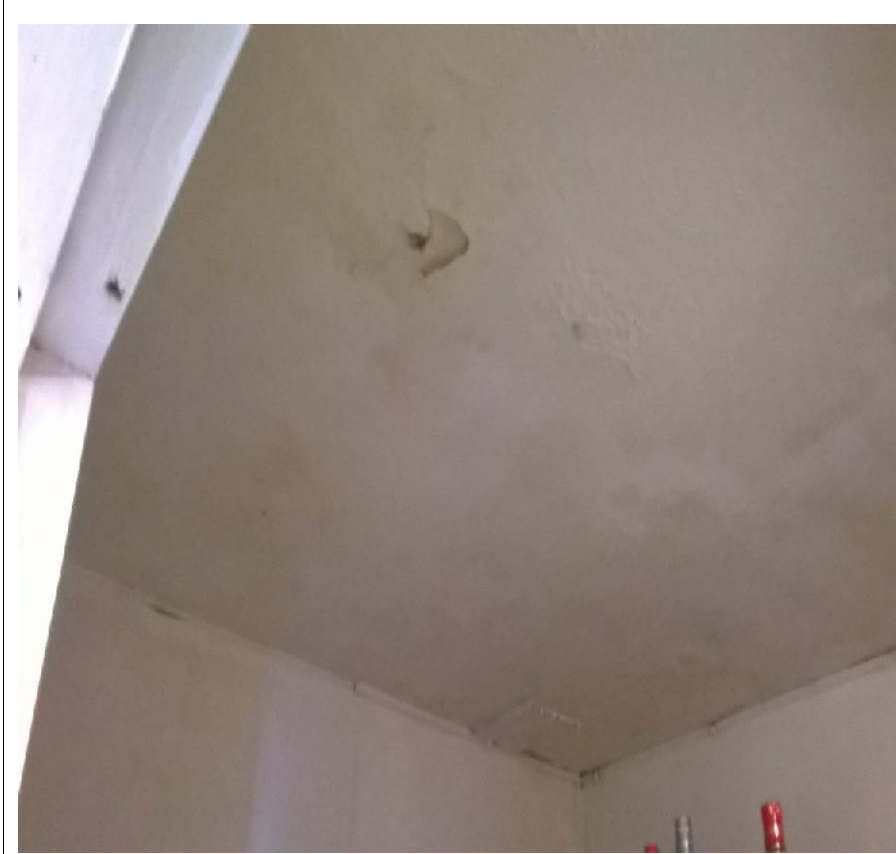
**PHOTOPLATE 075**

Ground Floor Cellar

Encapsulate

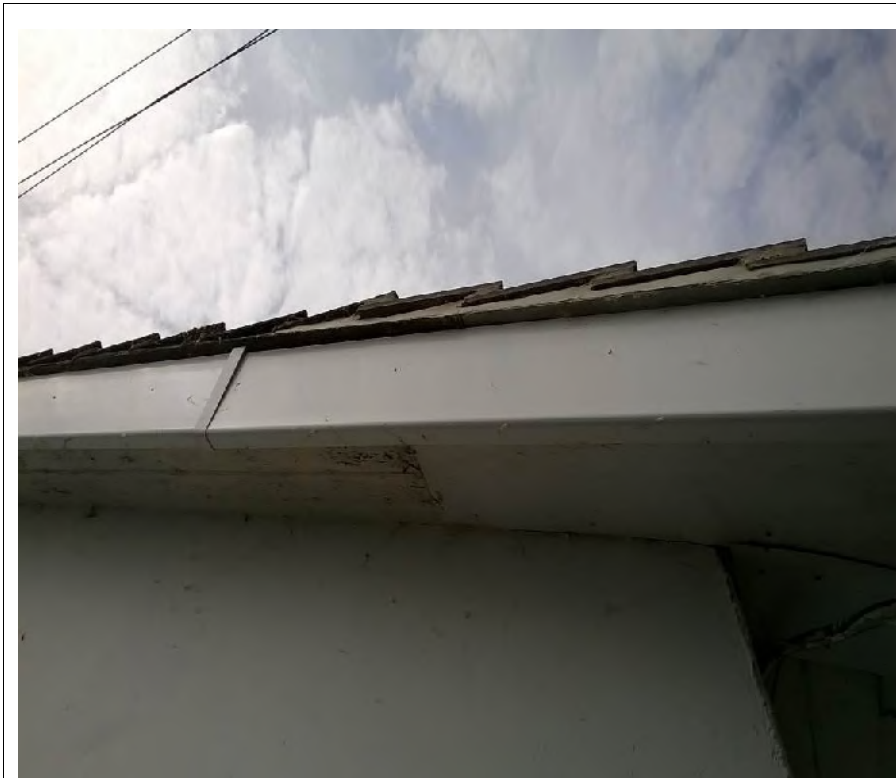
**PHOTOPLATE 076**

External Games Room

Encapsulate

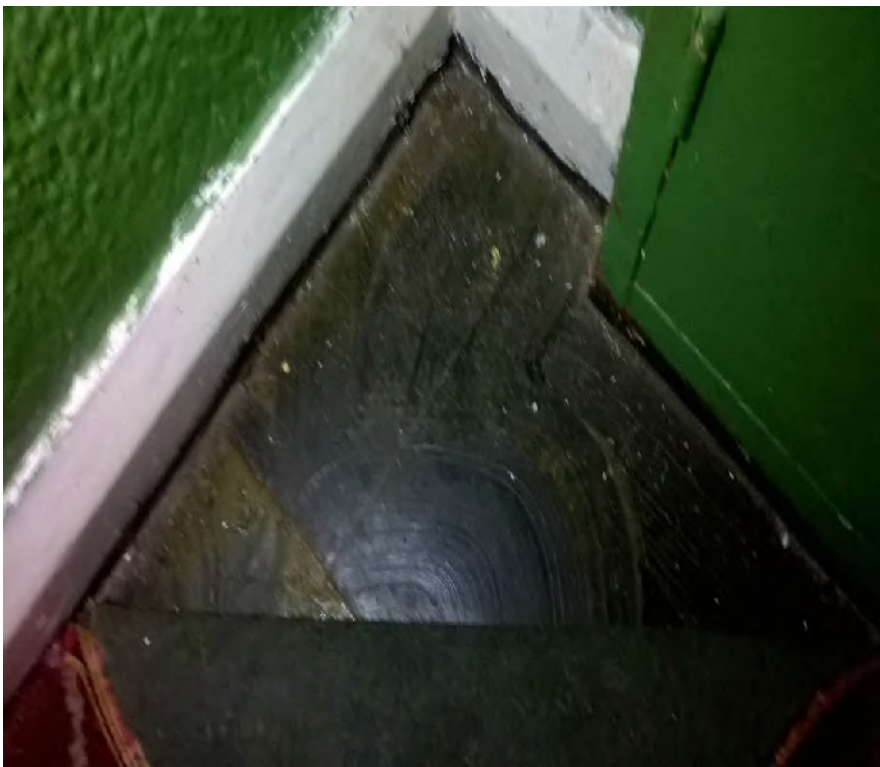
**PHOTOPLATE 078**

| Ground Floor Snooker Room |

| Item No. |
| - |
| Mark and manage |

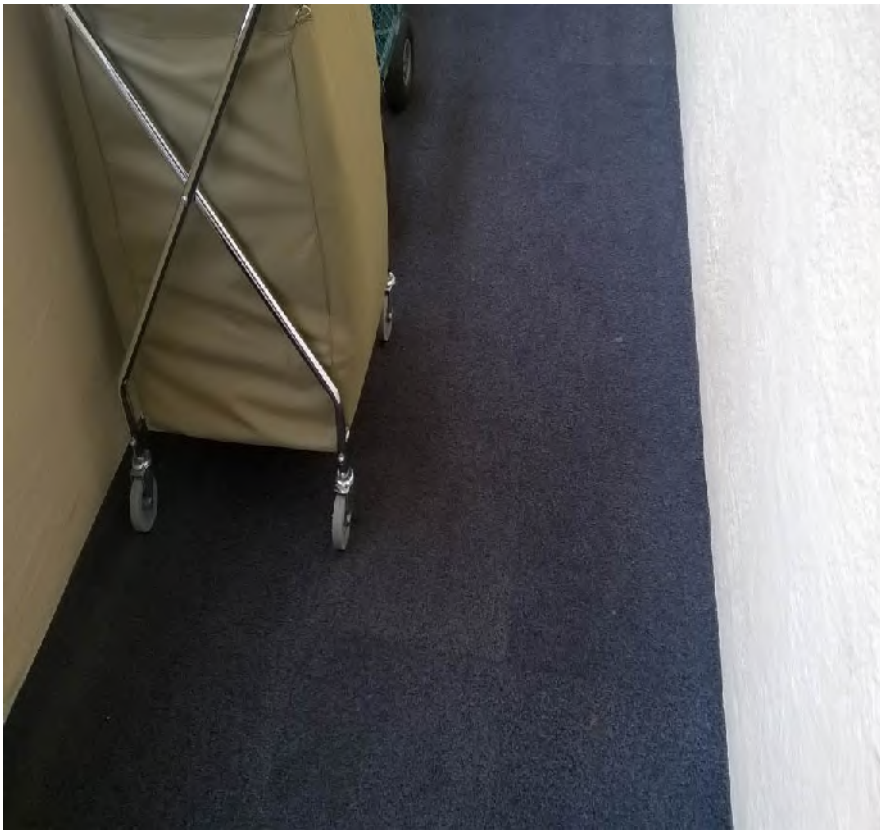
PHOTOPLATE 079

| Ground Floor Circulation |

| Sample Reference (Bulk ID) |
| - |
| Mark and manage |

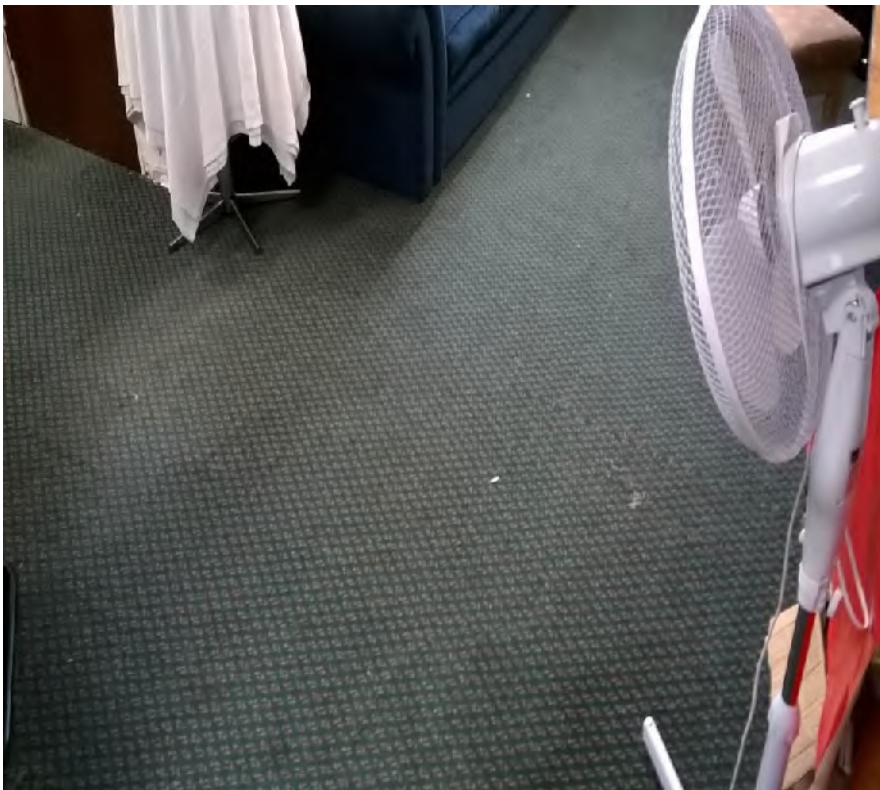
PHOTOPLATE 080

| Ground Floor Office |

| Sample Reference (Bulk ID) |
| - |
| Mark and manage |
