### Asbestos Survey

### MANAGEMENT RE-INSPECTION SURVEY REPORT

**Report Number:** J4850  
**On behalf of** Away Resorts  
Mill Rythe Holiday Village, 16 Havant Road,  
Hayling Island, Hampshire PO11 0PB

**Mill Rythe Holiday Village**  
**16 Havant Road**  
**Hayling Island**  
**Hampshire**  
**PO11 0PB**

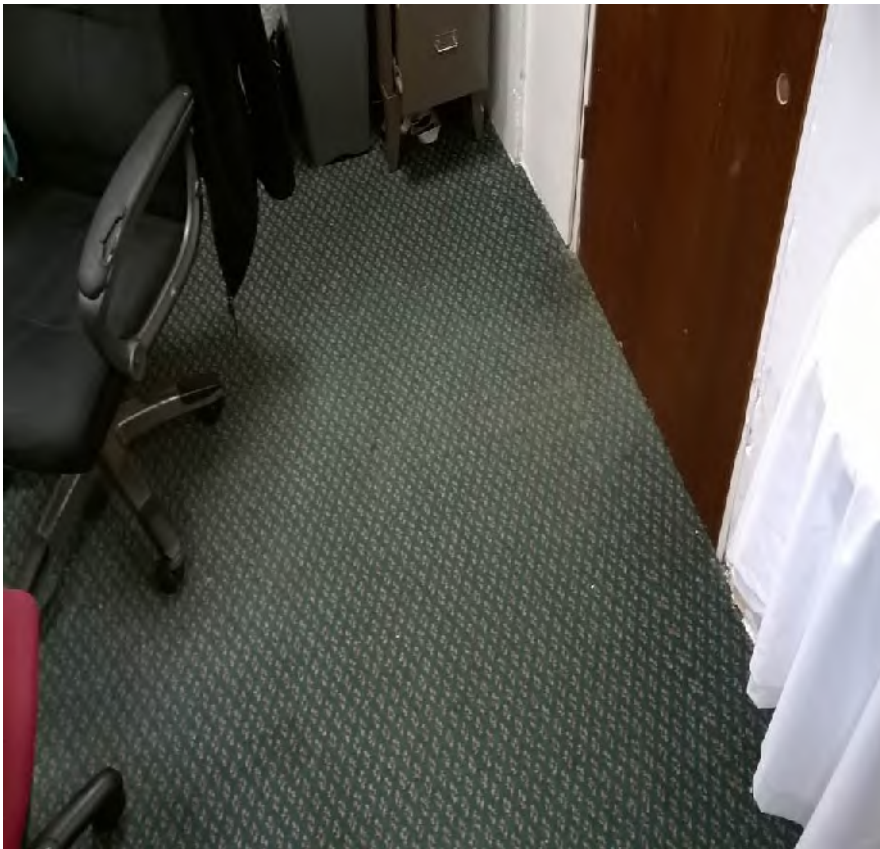
**PHOTOPLATE 081**

Ground Floor Office

| Sample Reference (Bulk ID) |
| - |
| Mark and manage |

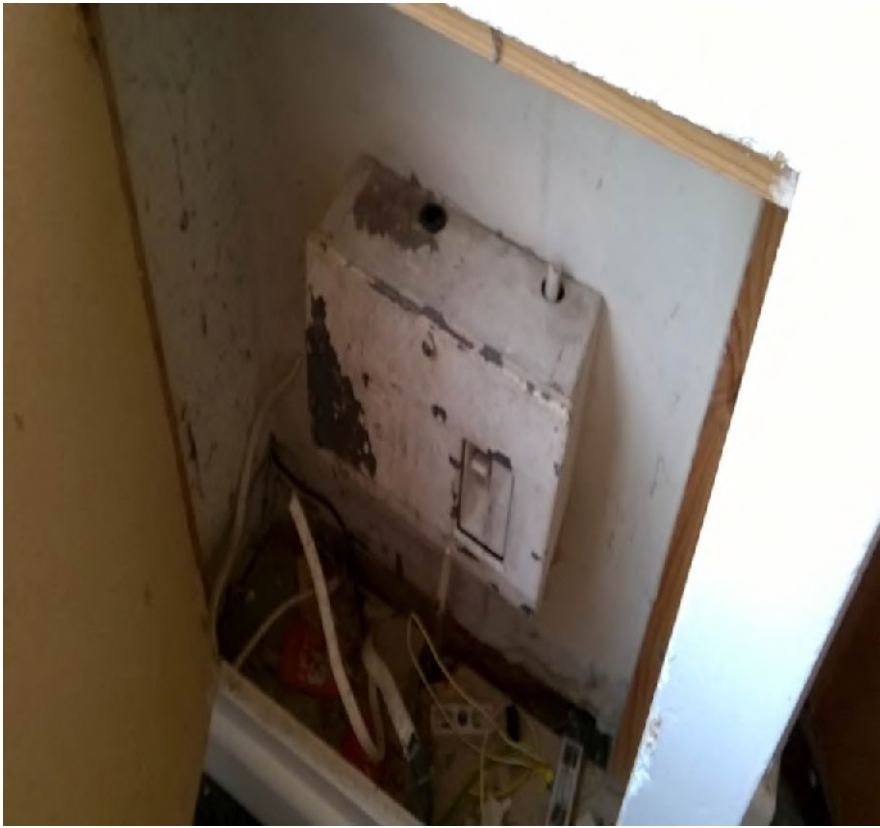
**PHOTOPLATE 083**

| Ground Floor Circulation |

Mark and manage

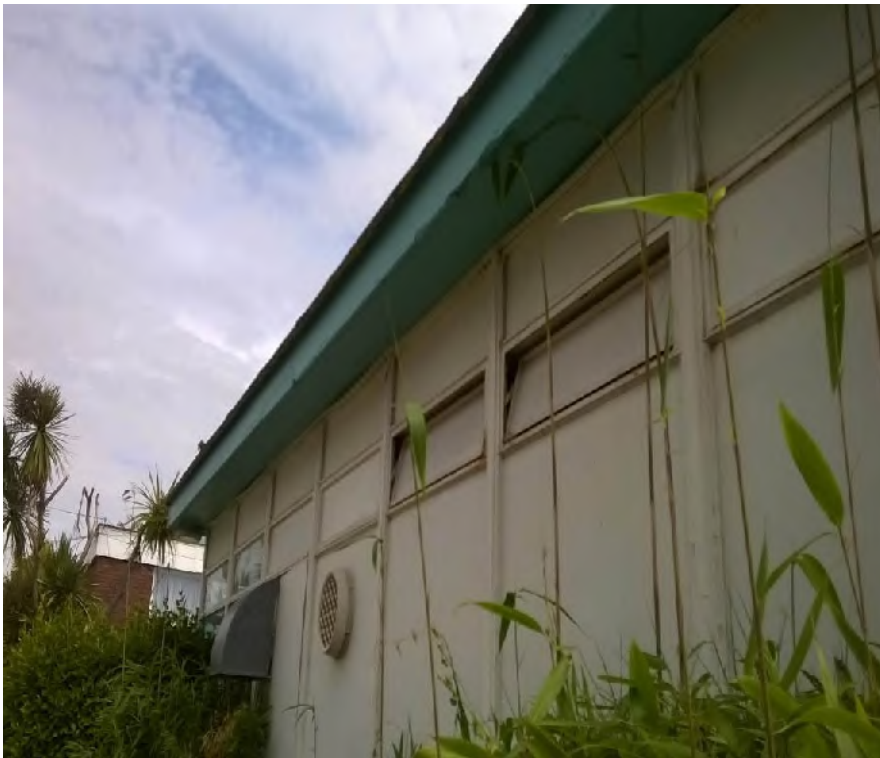
**PHOTOPLATE 084**

| External Circulation |

| Sample Reference (Bulk ID) |
| - |
| Mark and manage |

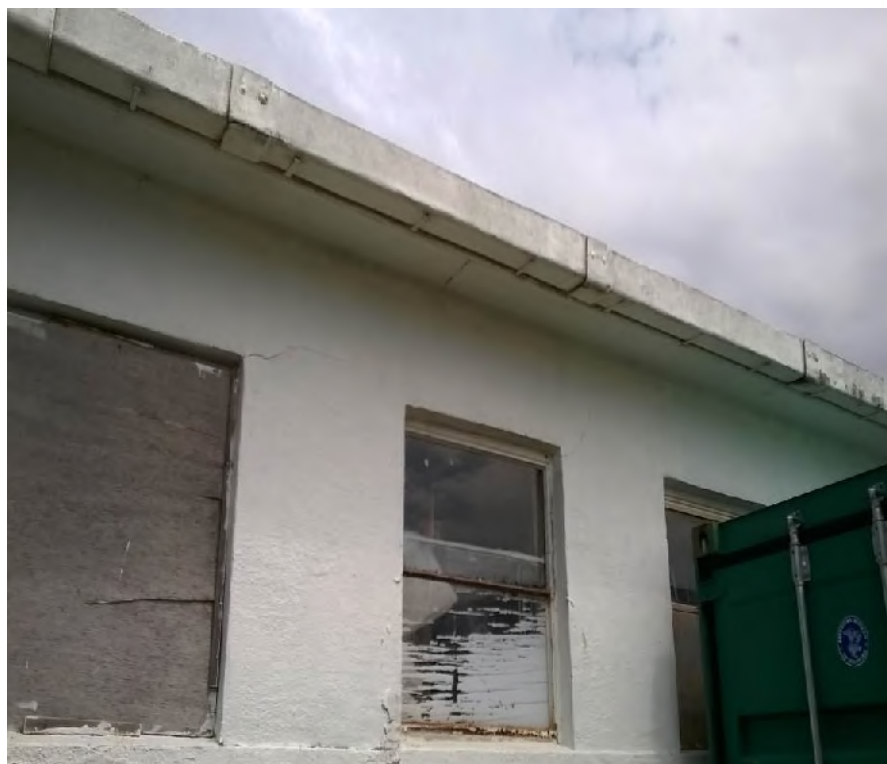
**PHOTOPLATE 086**

External Circulation

Mark and manage

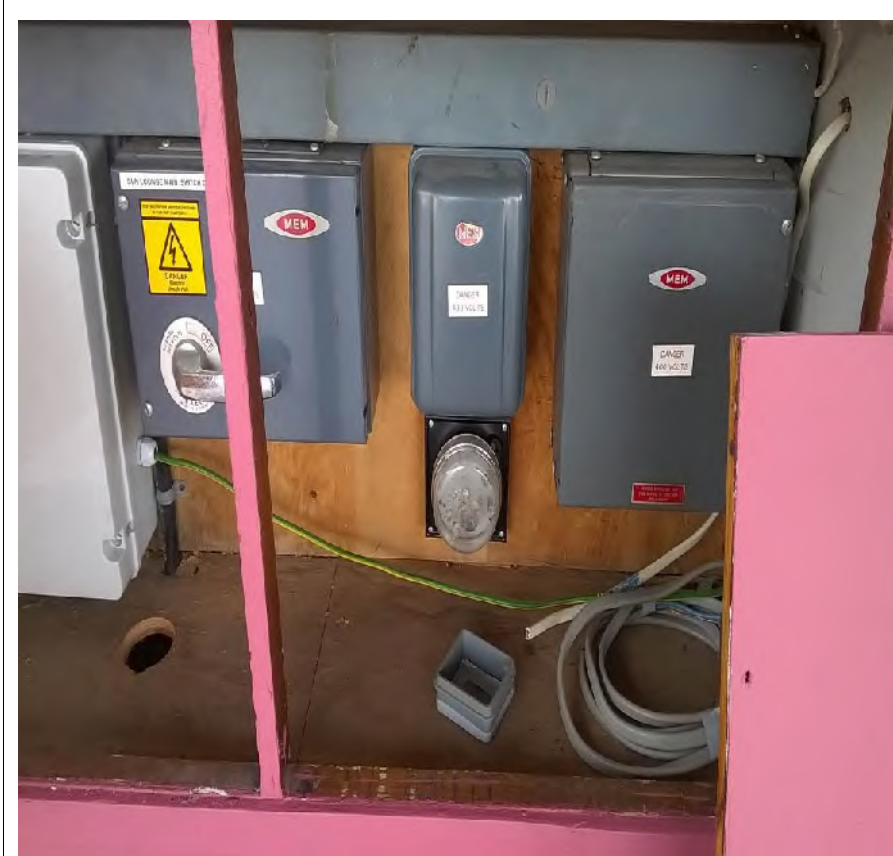
**PHOTOPLATE 087**

| Ground Floor Stores |

Mark and manage

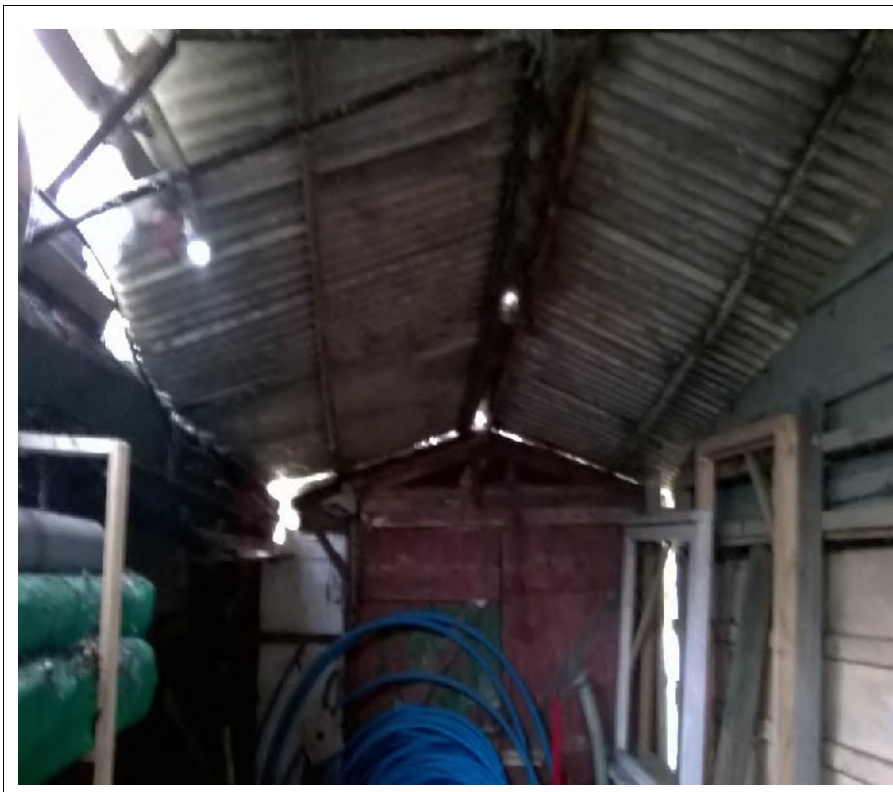
**PHOTOPLATE 088**

| External Store |

| Item No. |
| - |
| Mark and manage |

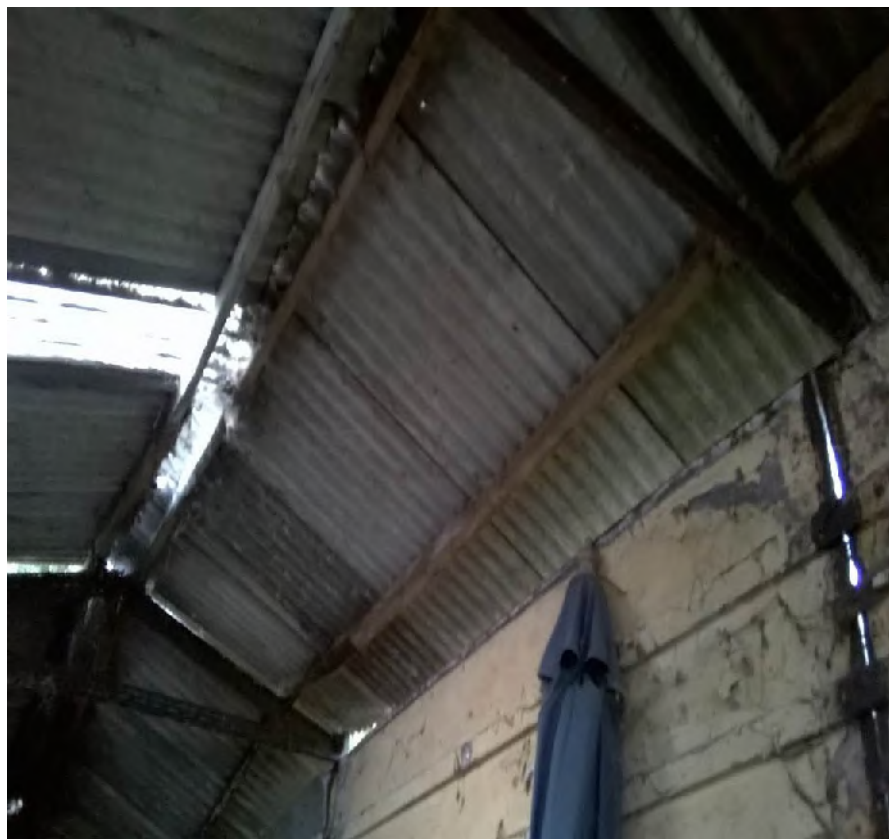
PHOTOPLATE 089

External Store

| Sample Reference (Bulk ID) |
| - |
| Mark and manage |

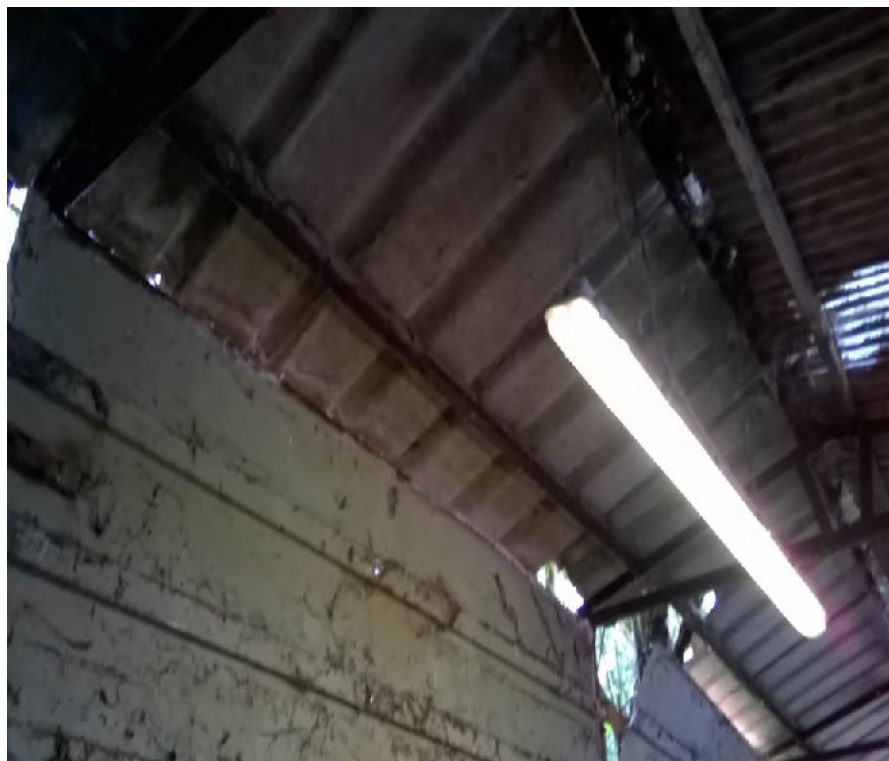
PHOTOPLATE 090

External Store

Mark and manage

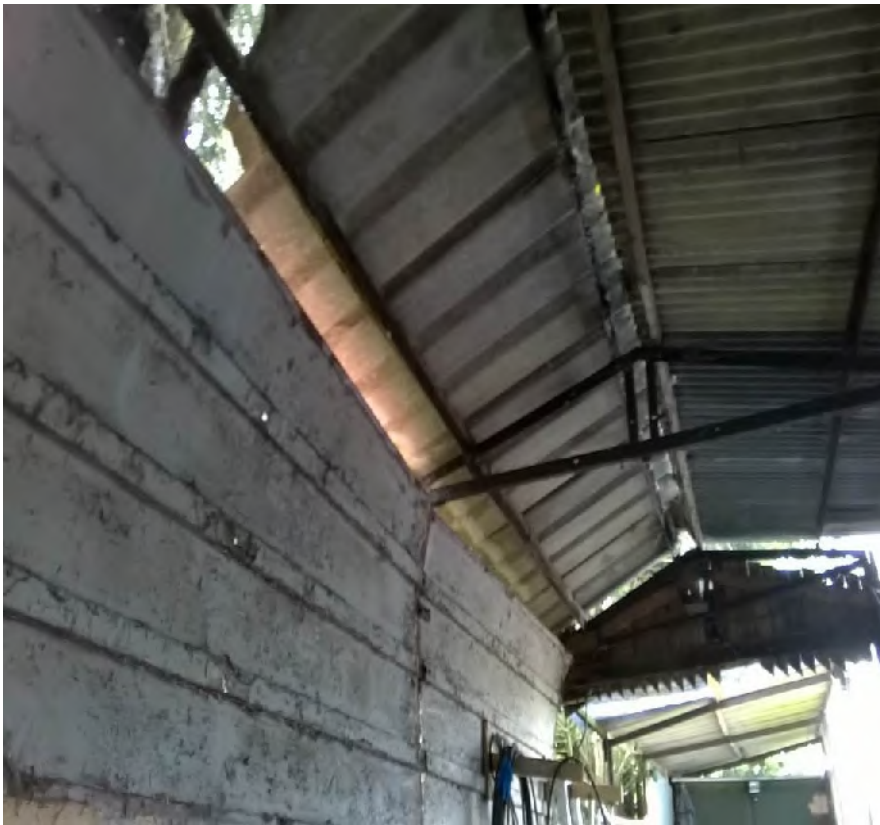
**PHOTOPLATE 091**

| External Store |

Mark and manage

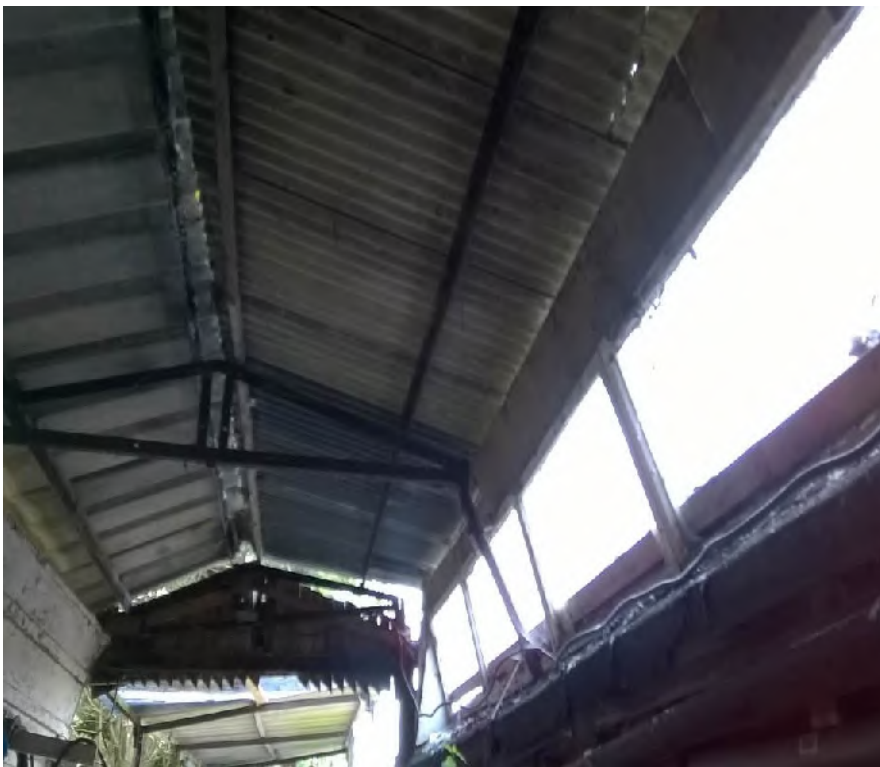
**PHOTOPLATE 092**

| External Store |

| Sample Reference (Bulk ID) |
| - |
| Mark and manage |

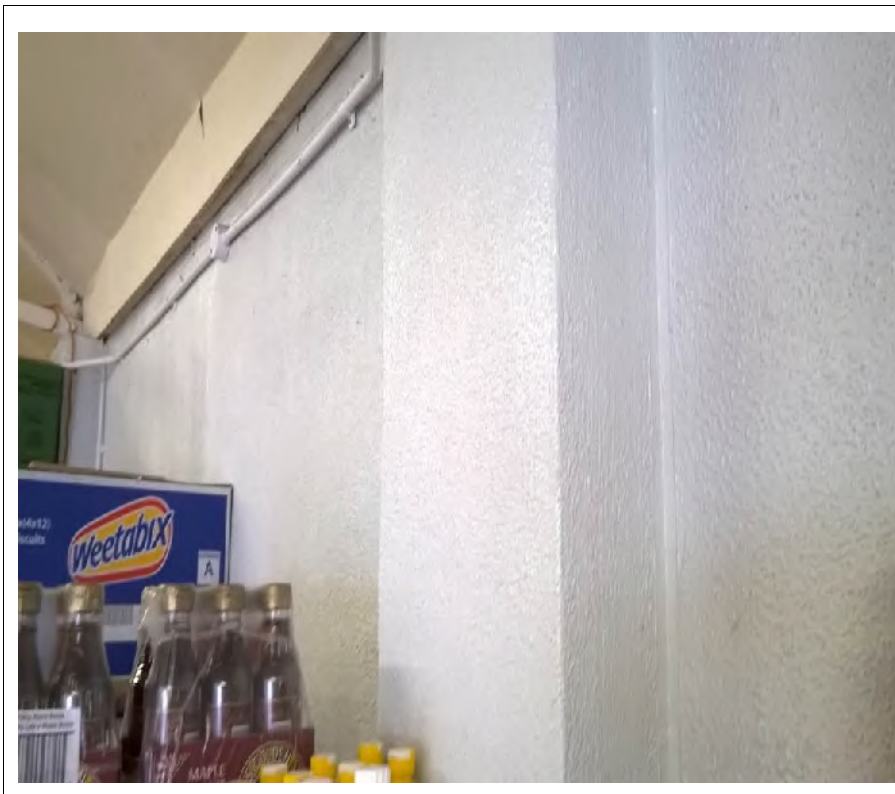
**PHOTOPLATE 094**

| Ground Floor Stores |

| Sample Reference (Bulk ID) |
| - |
| Mark and manage |

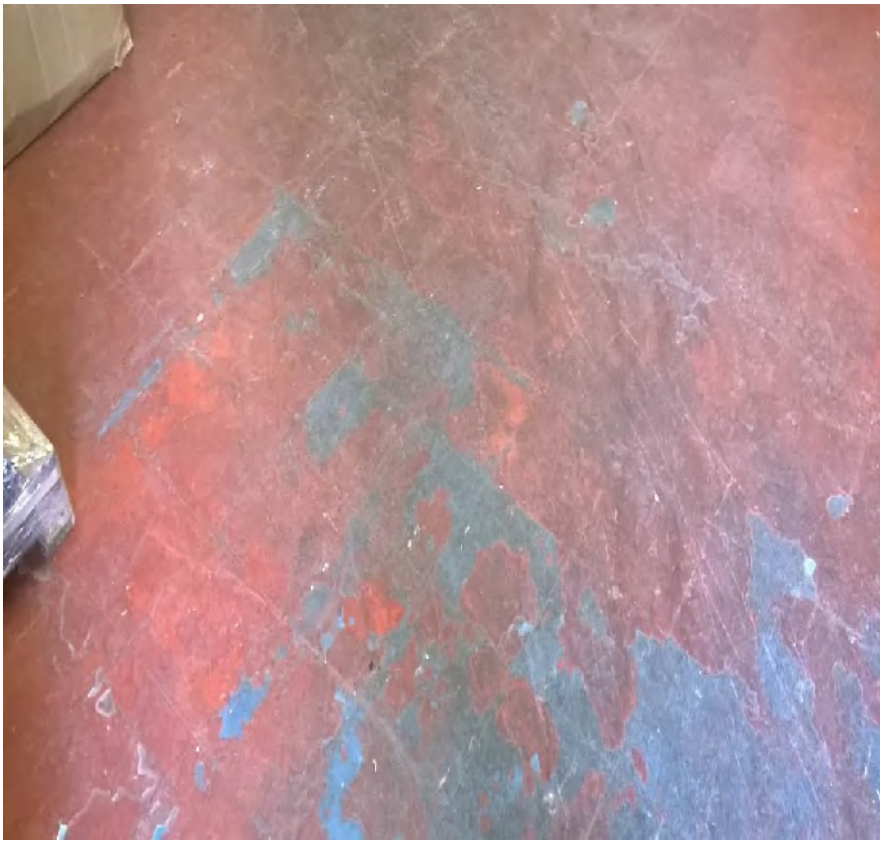
PHOTOPLATE 095

Ground Floor Stores

| Sample Reference (Bulk ID) |
| - |
| Mark and manage |

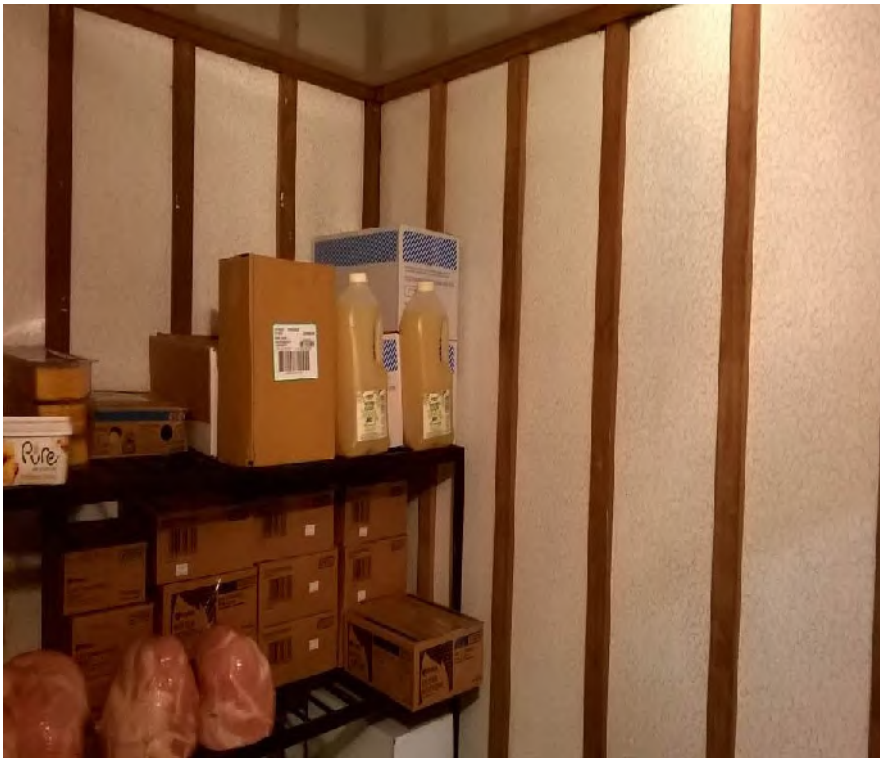
PHOTOPLATE 096

Ground Floor Fridge 3

Mark and manage

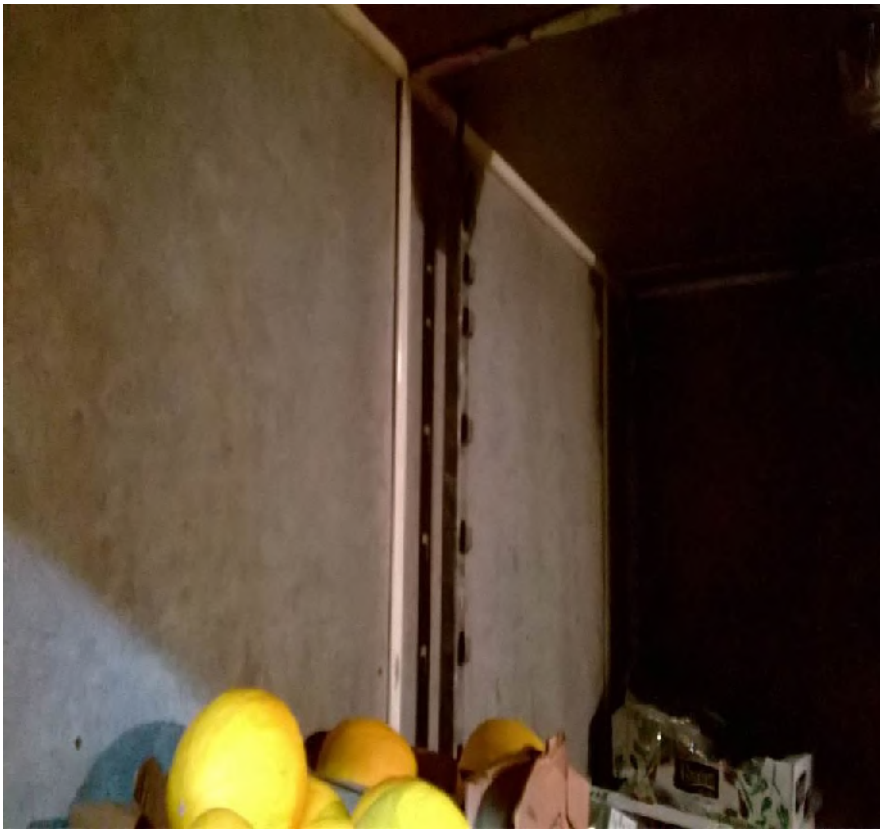
**PHOTOPLATE 097**

Ground Floor Fridge 4

Mark and manage

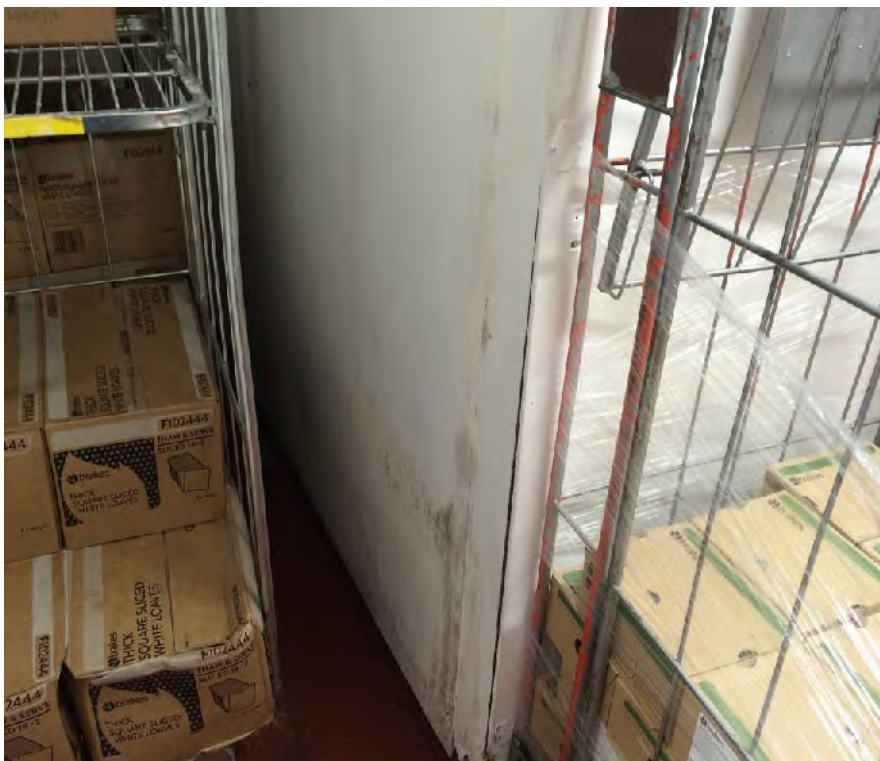
**PHOTOPLATE 098**

Ground Floor Freezer 2

Mark and manage

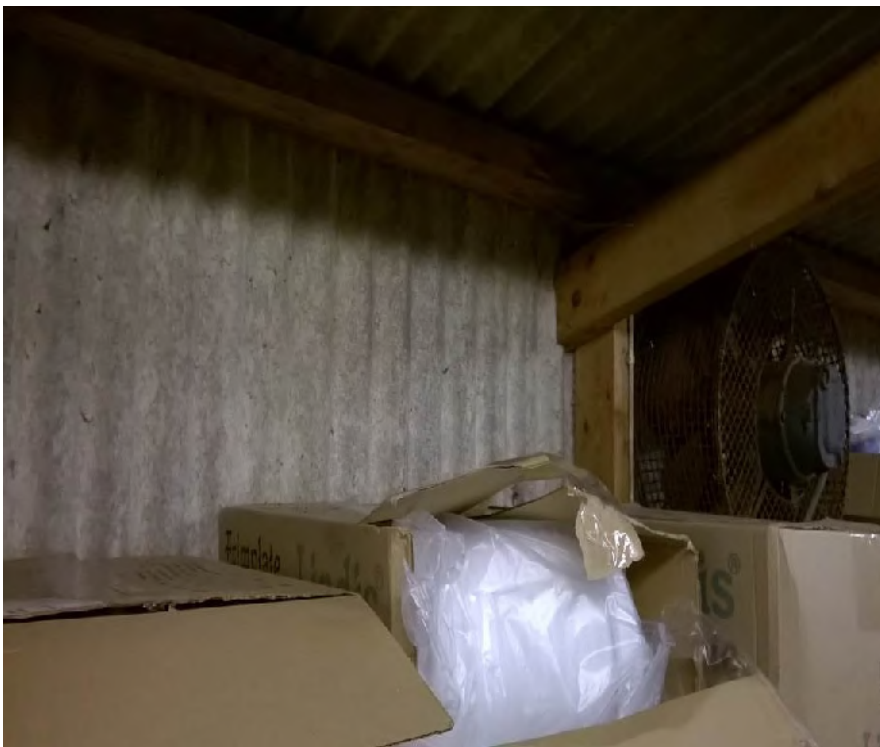
**PHOTOPLATE 100**

| Ground Floor Stores |

| Sample Reference (Bulk ID) |
| - |
| Mark and manage |

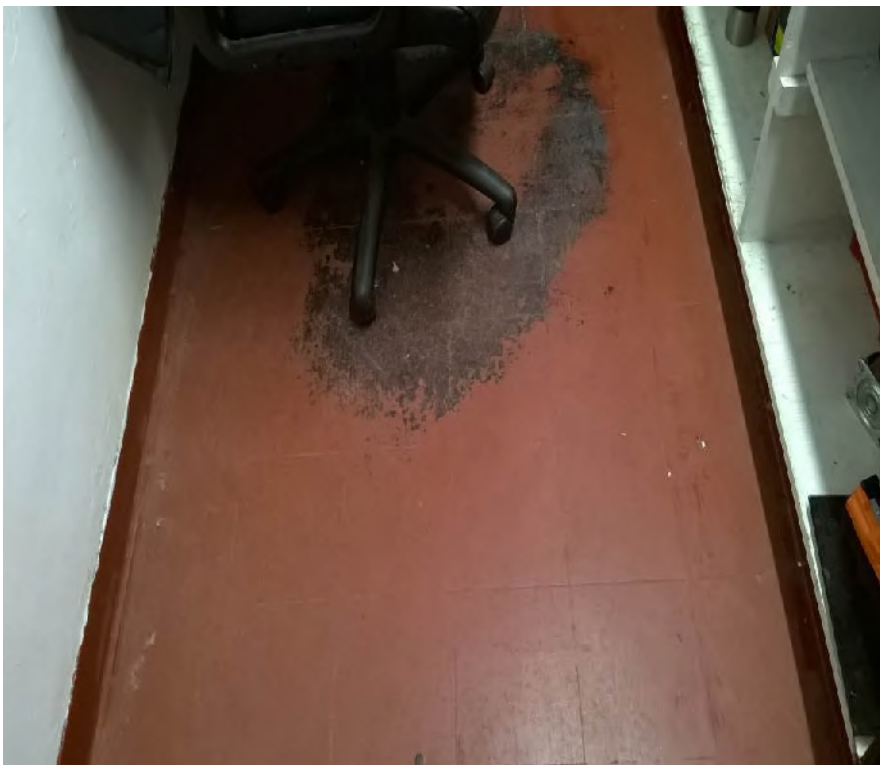
**PHOTOPLATE 102**

Ground Floor Office

Mark and manage

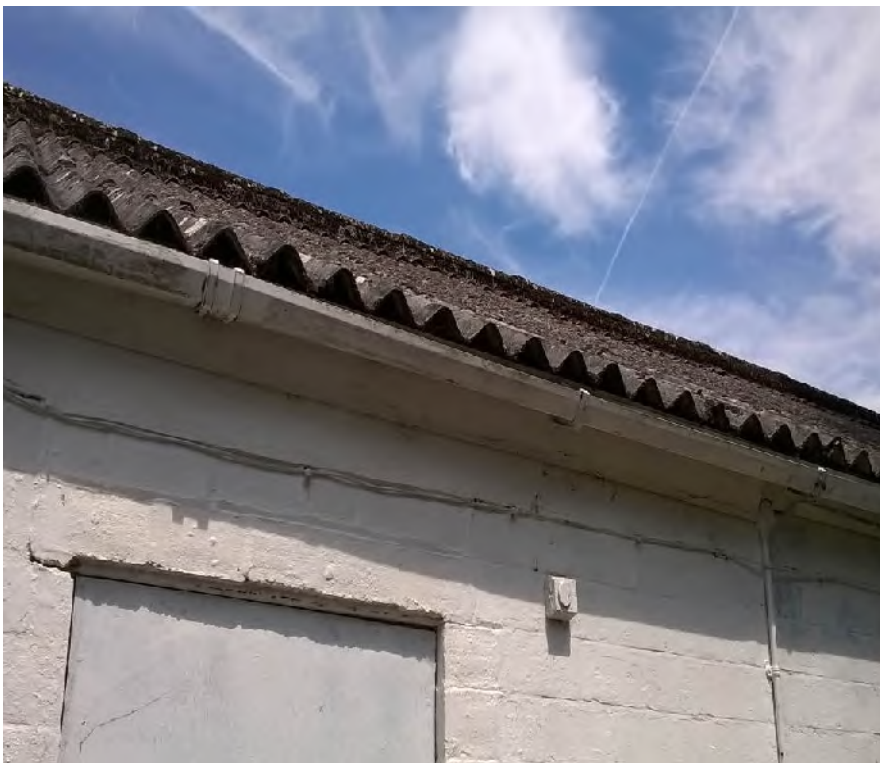
**PHOTOPLATE 104**

External Roof Area

Mark and manage

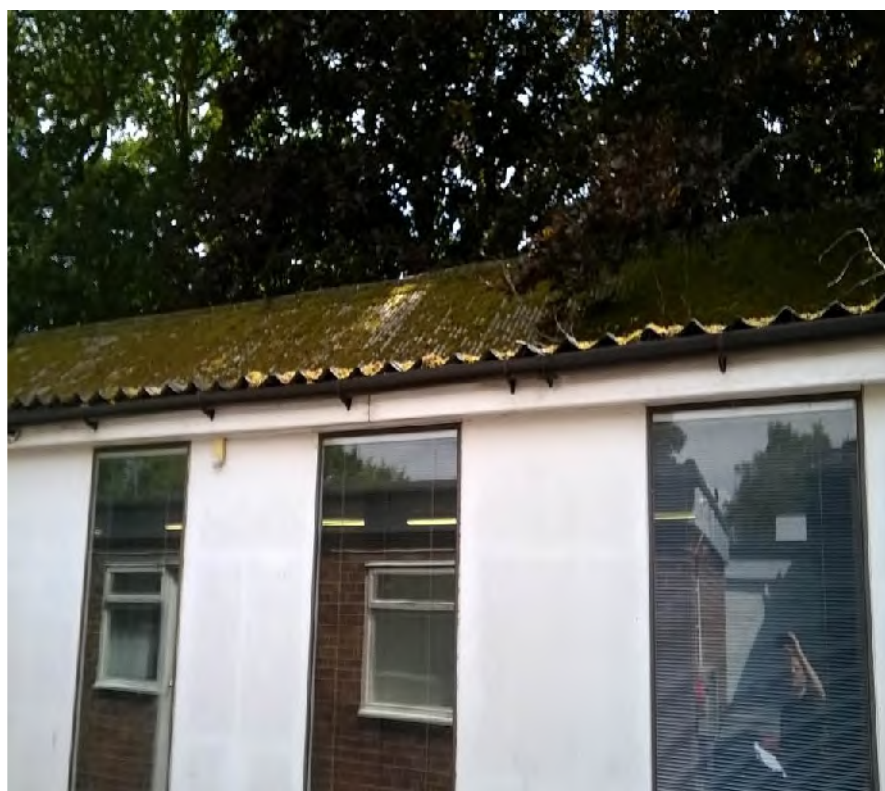
PHOTOPLATE 106

External Team Diner

Mark and manage

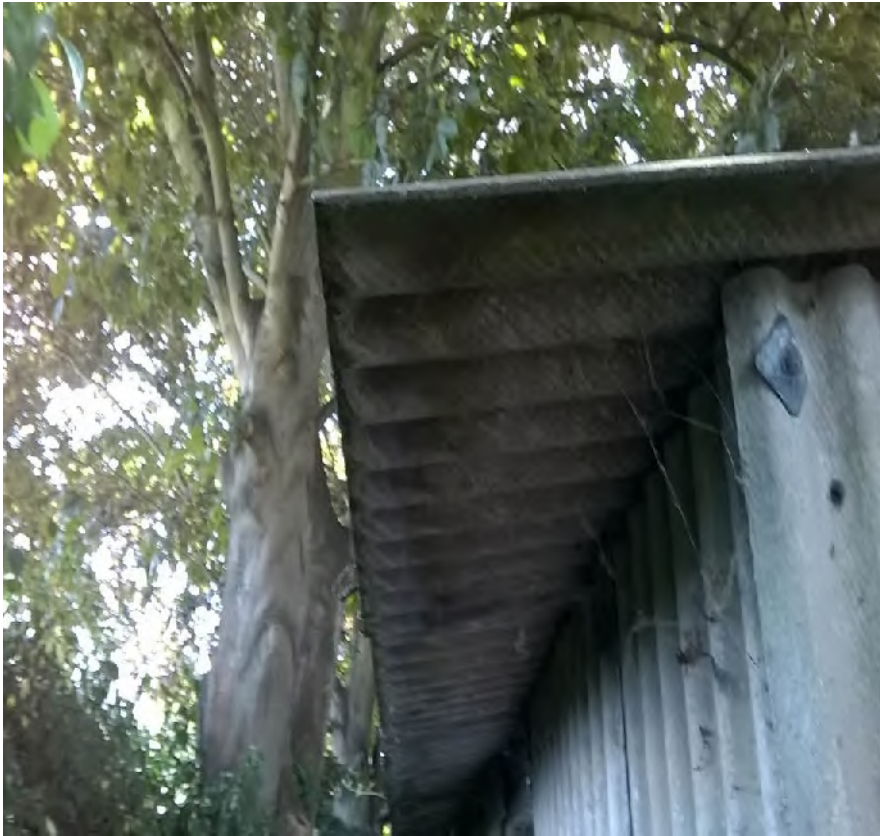
**PHOTOPLATE 107**

| Location<br><b>External Stores</b> |
| Item No.<br><b>272</b> |

| Recommendation<br><b>Mark and manage</b> |

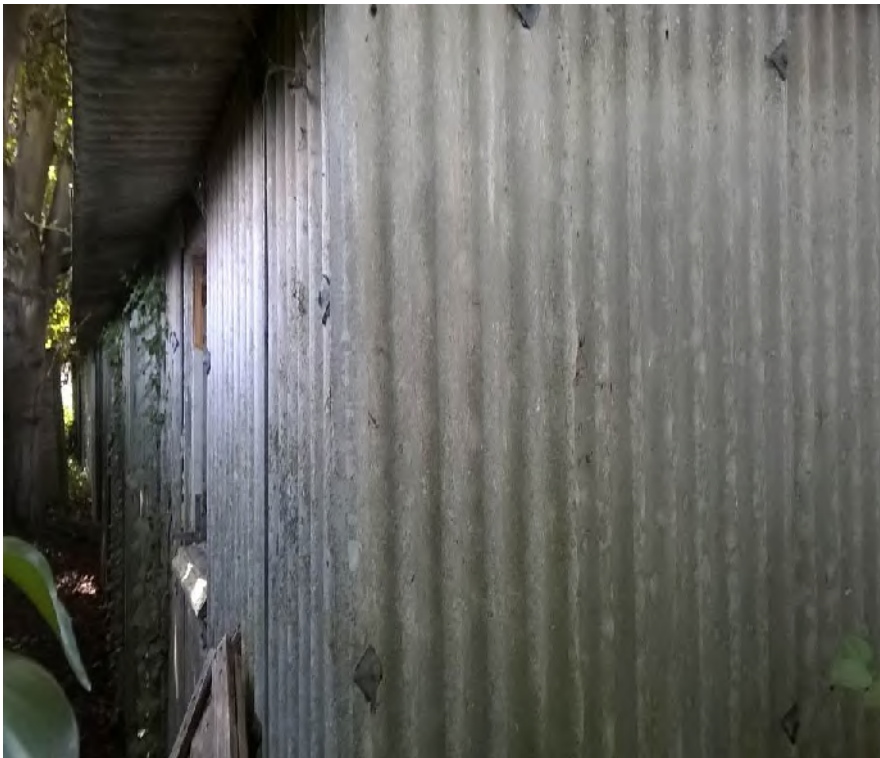
**PHOTOPLATE 108**

| Location<br><b>External Stores</b> |
| Item No.<br><b>273</b> |

| Recommendation<br><b>Mark and manage</b> |

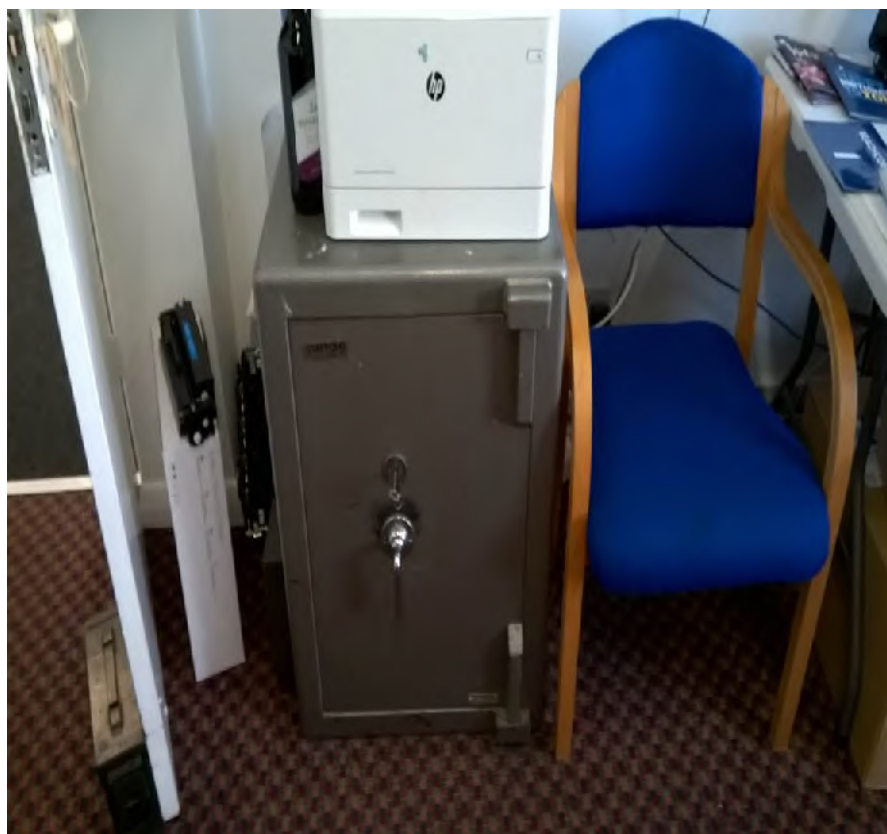
**PHOTOPLATE 109**

First Floor Office

Mark and manage

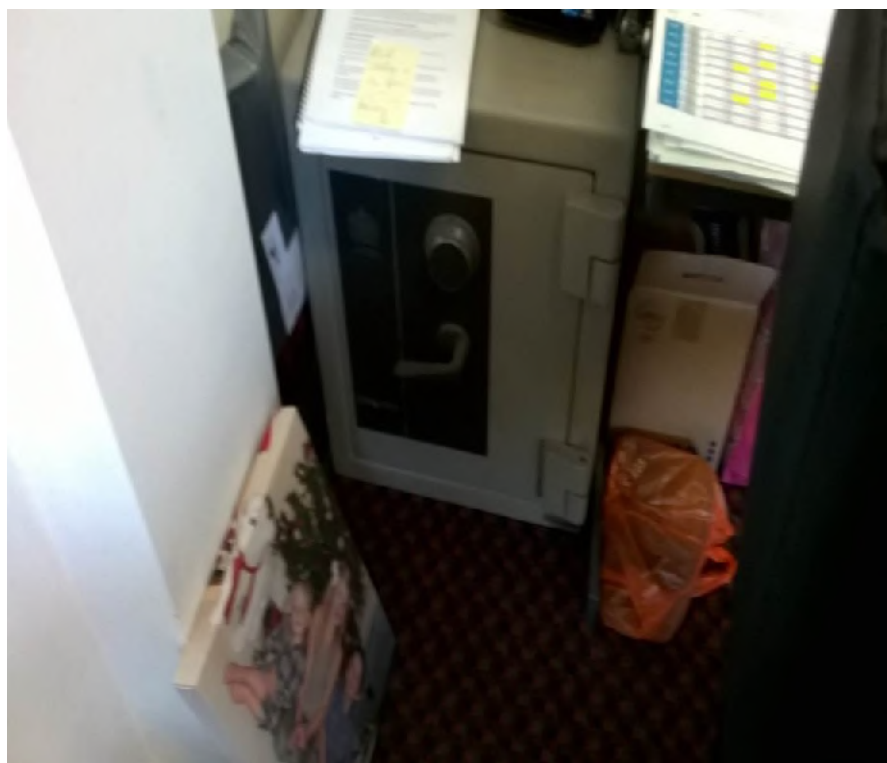
**PHOTOPLATE 110**

First Floor Office

Mark and manage

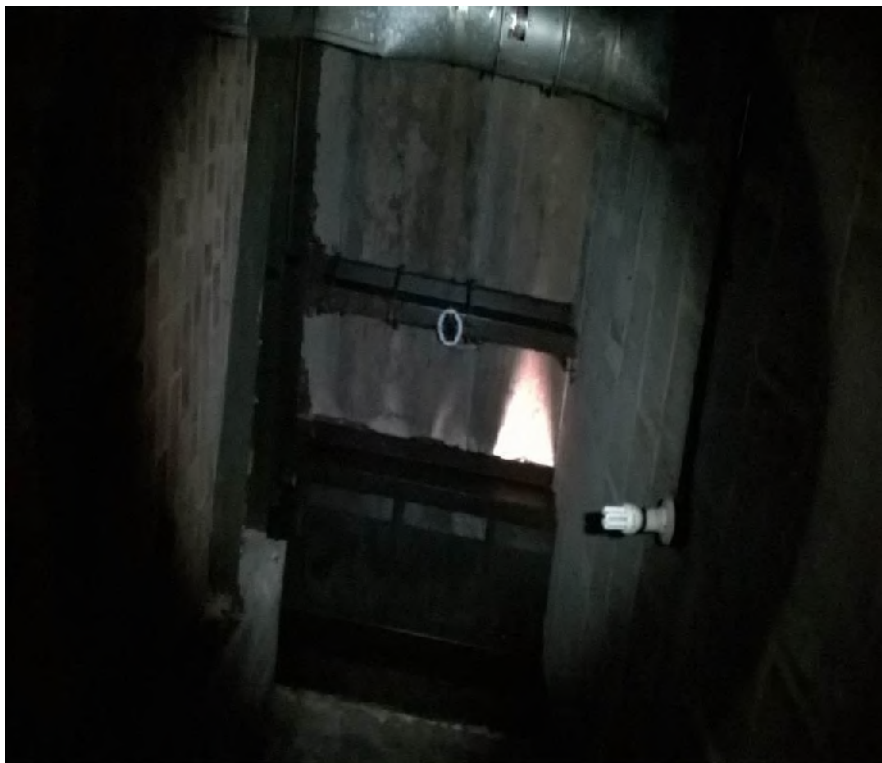
**PHOTOPLATE 112**

Ground Floor Store

Mark and manage

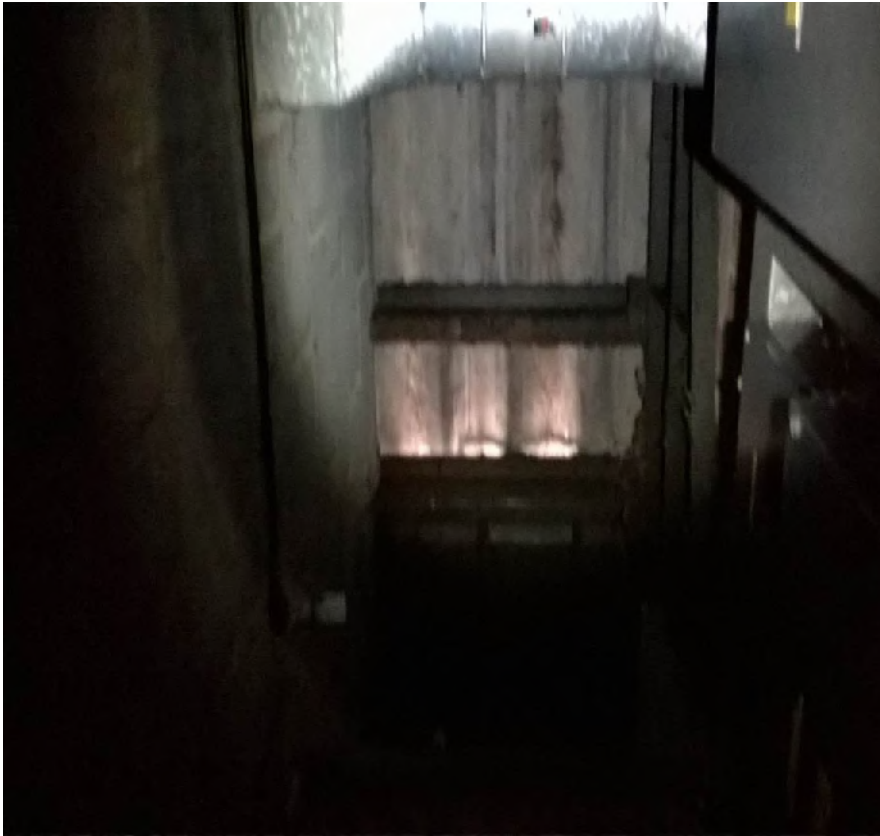
**PHOTOPLATE 113**

Ground Floor Store

Mark and manage

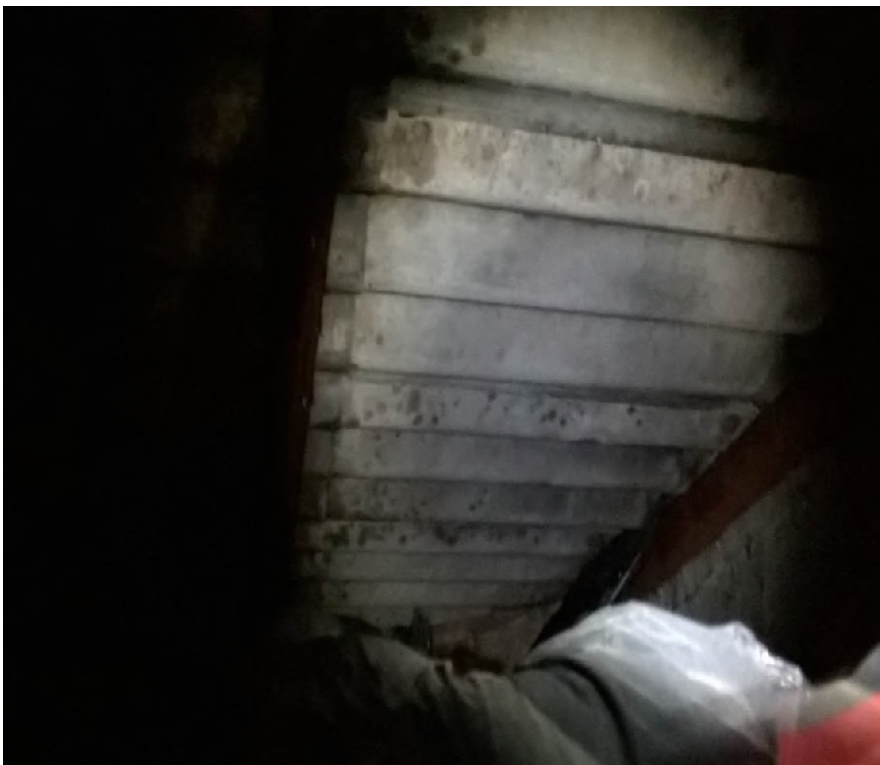
**PHOTOPLATE 114**

Ground Floor Roof Space

Mark and manage

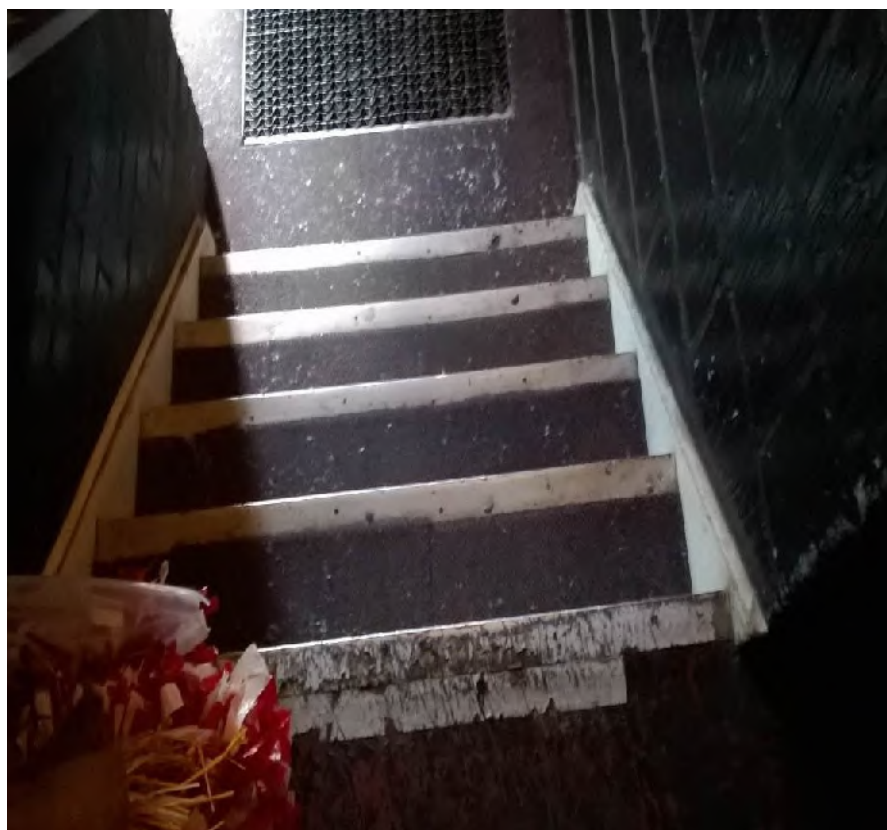
PHOTOPLATE 115

Ground Floor Stage

Mark and manage

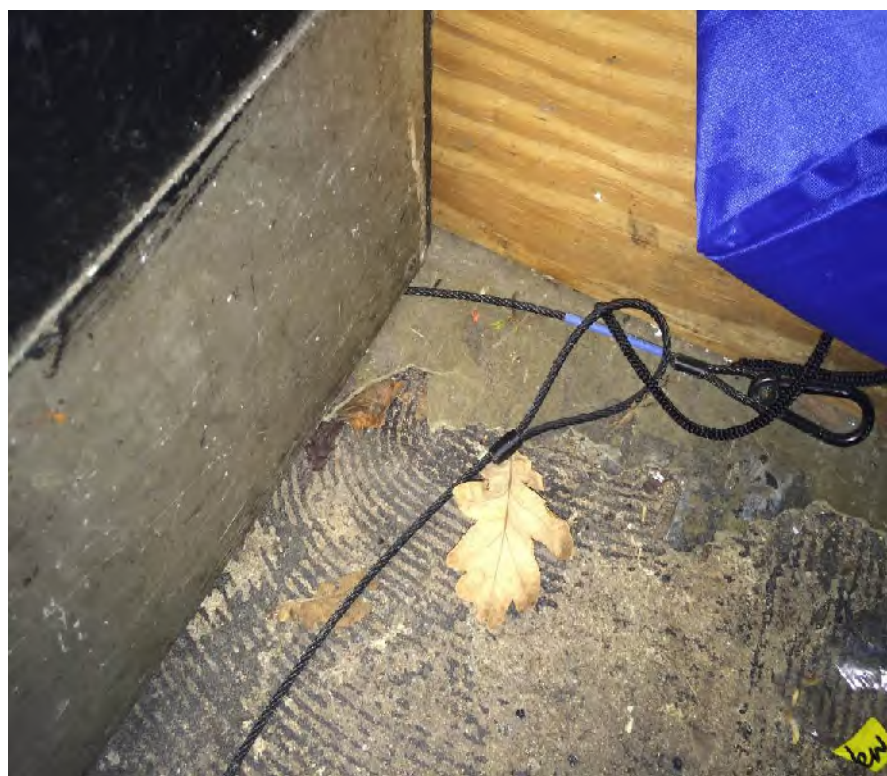
PHOTOPLATE 116

Ground Floor Store

Mark and manage

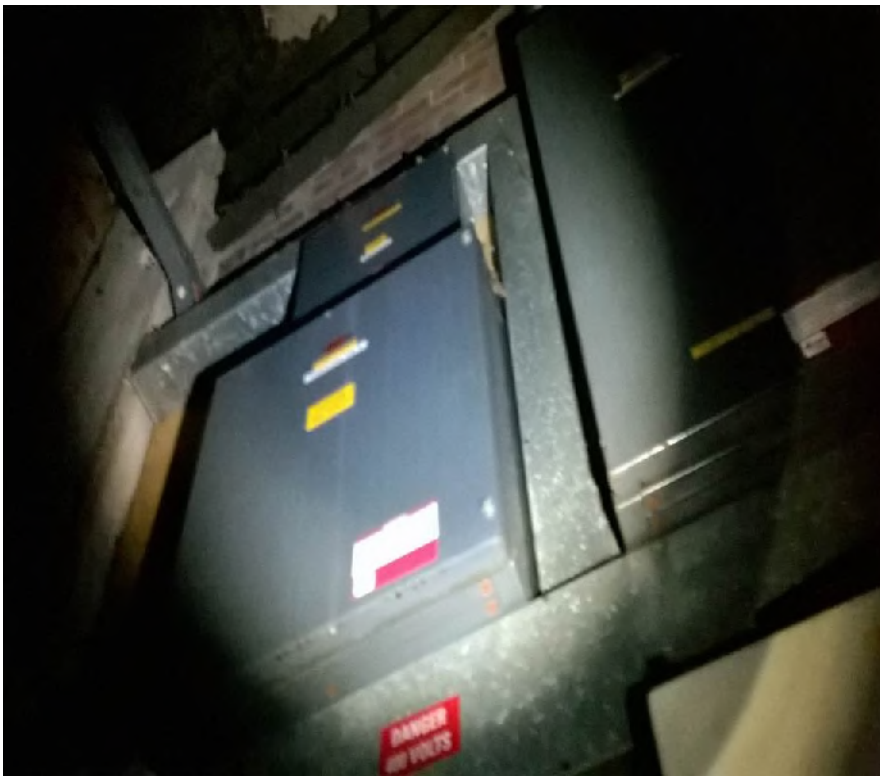
PHOTOPLATE 120

Ground Floor Store

Mark and manage

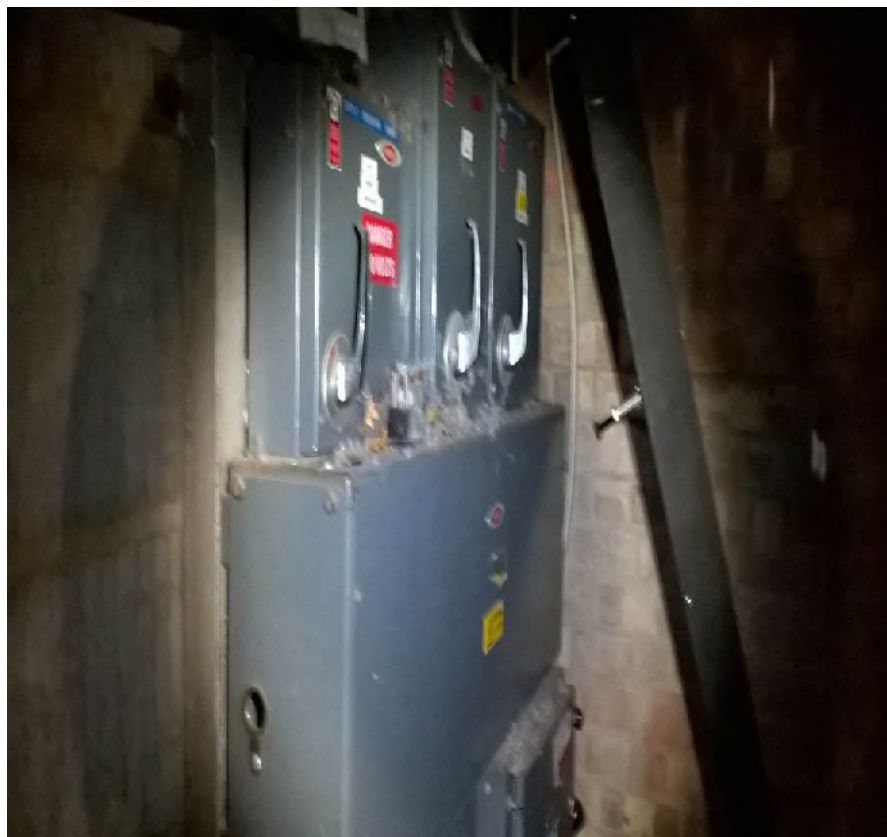
**PHOTOPLATE 121**

Ground Floor Store

Mark and manage

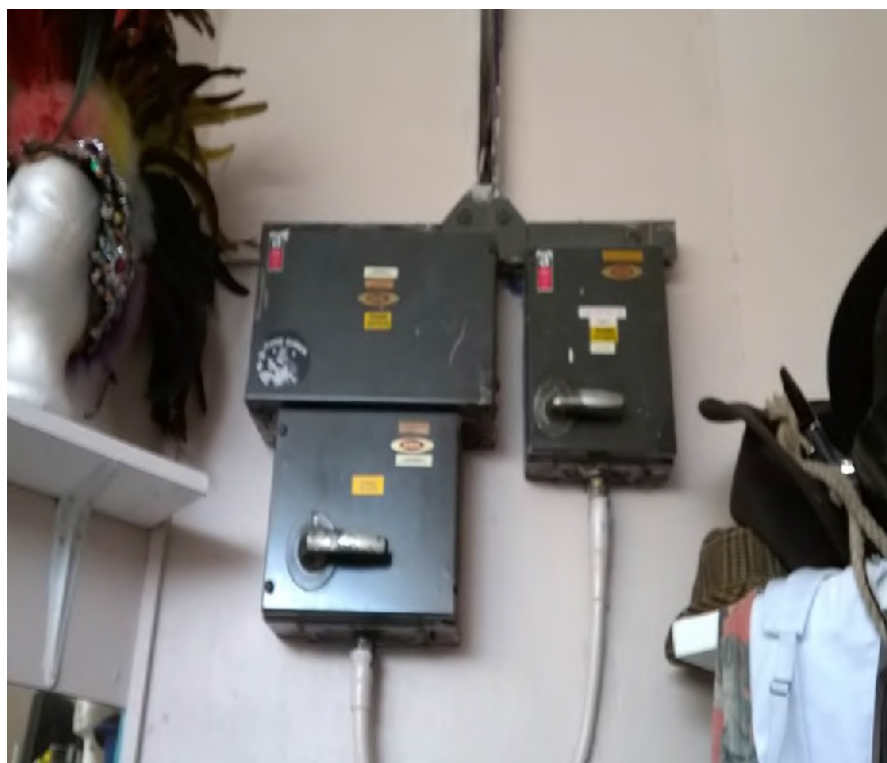
**PHOTOPLATE 122**

Ground Floor Dressing Room

Mark and manage

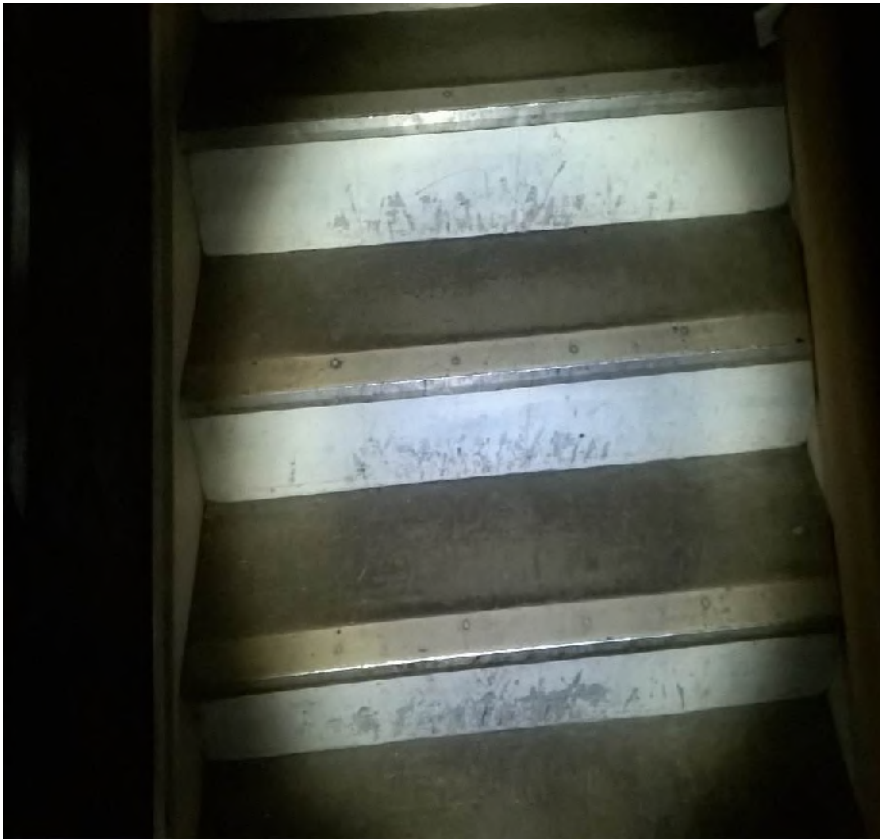
**PHOTOPLATE 123**

| Ground Floor Stage |

| Sample Reference (Bulk ID) |
| - |
| Mark and manage |
