### Asbestos Survey

### MANAGEMENT RE-INSPECTION SURVEY REPORT

**Report Number:** J4850  
**On behalf of** Away Resorts  
Mill Rythe Holiday Village, 16 Havant Road,  
Hayling Island, Hampshire PO11 0PB

**Mill Rythe Holiday Village**  
**16 Havant Road**  
**Hayling Island**  
**Hampshire**  
**PO11 0PB**

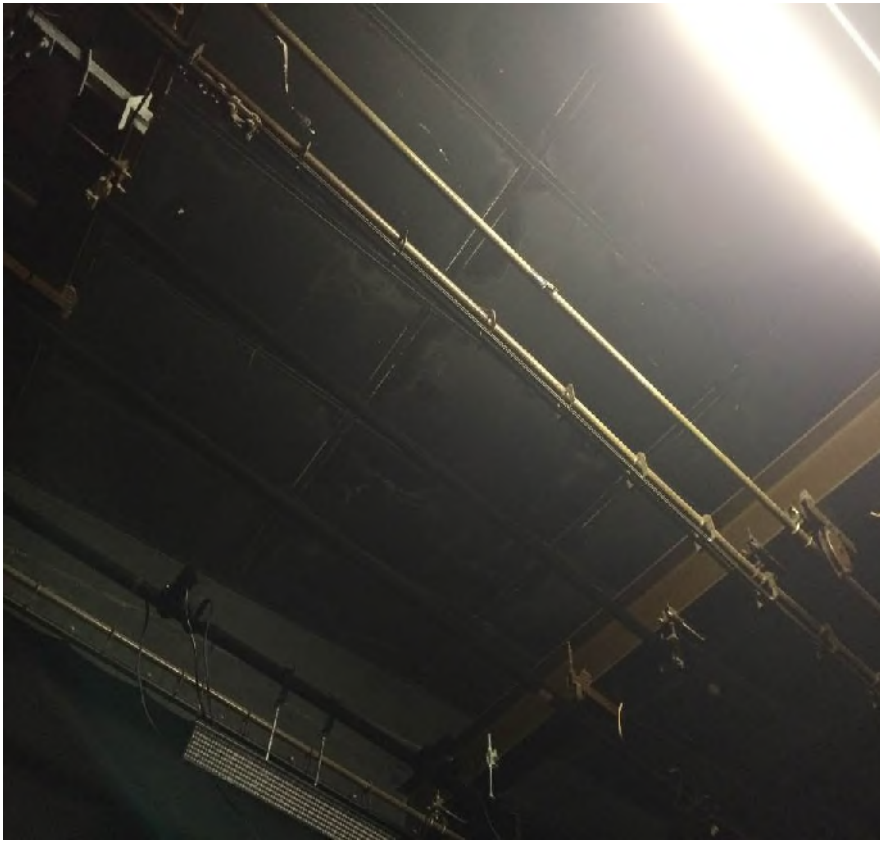
PHOTOPLATE 125

| Ground Floor Stage |

| Sample Reference (Bulk ID) |
| - |
| Mark and manage |

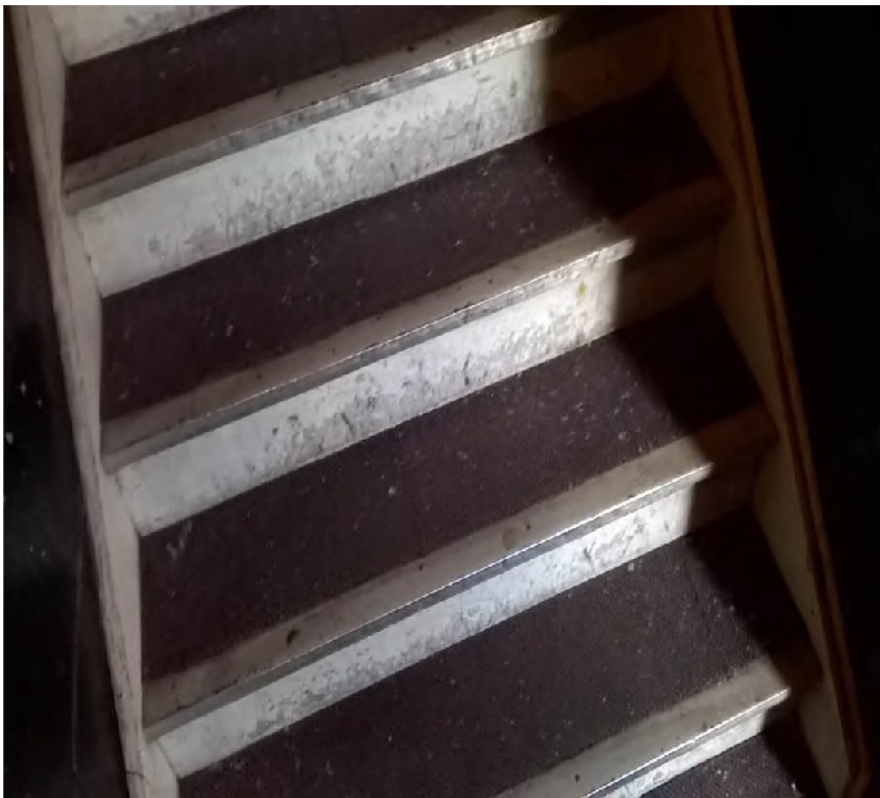
PHOTOPLATE 126

| Ground Floor stage |

| Sample Reference (Bulk ID) |
| - |
| Mark and manage |

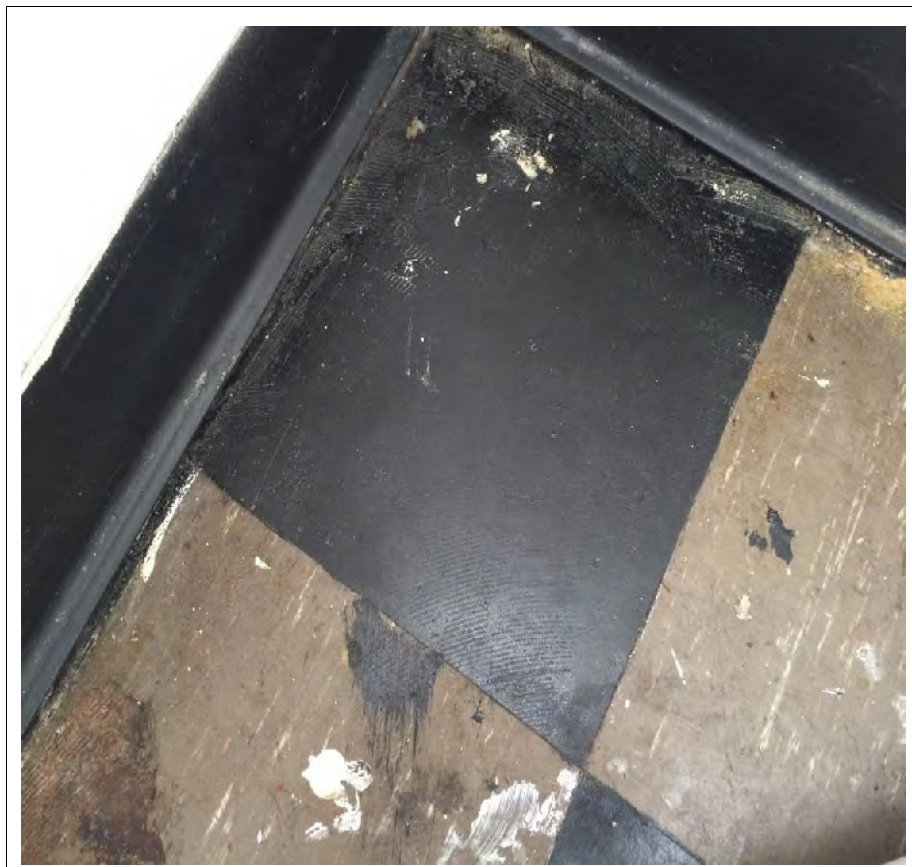
**PHOTOPLATE 127**

Ground Floor Office

Mark and manage

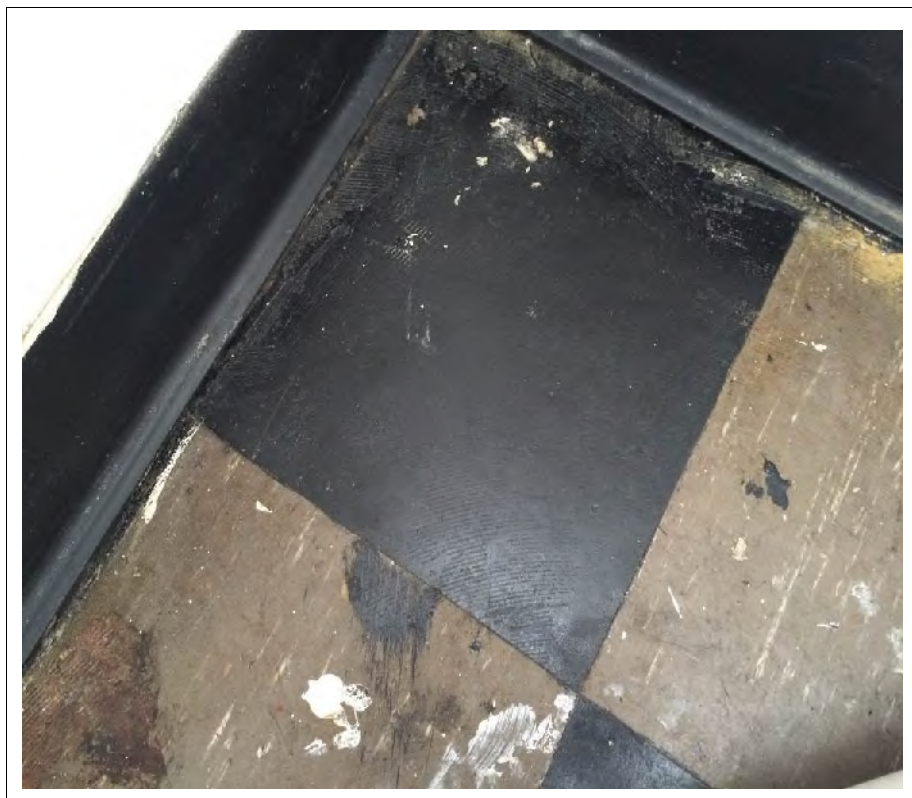
**PHOTOPLATE 128**

Ground Floor Office

Mark and manage

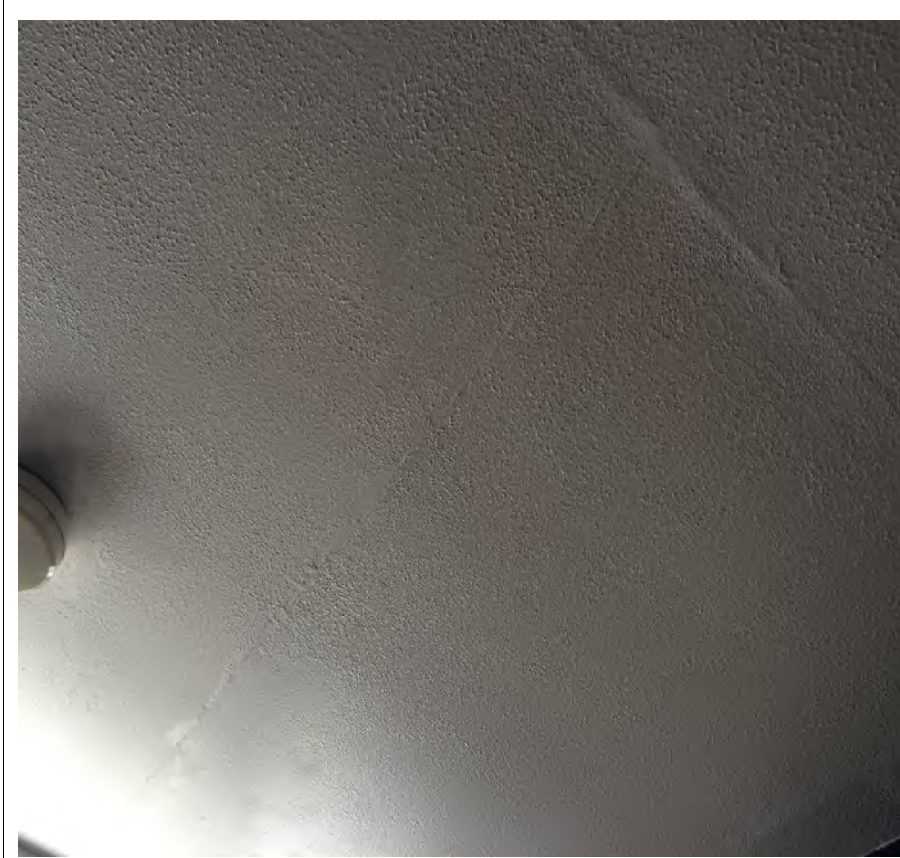
**PHOTOPLATE 129**

| Ground Floor Office |

| Sample Reference (Bulk ID) |
| - |
| Mark and manage |

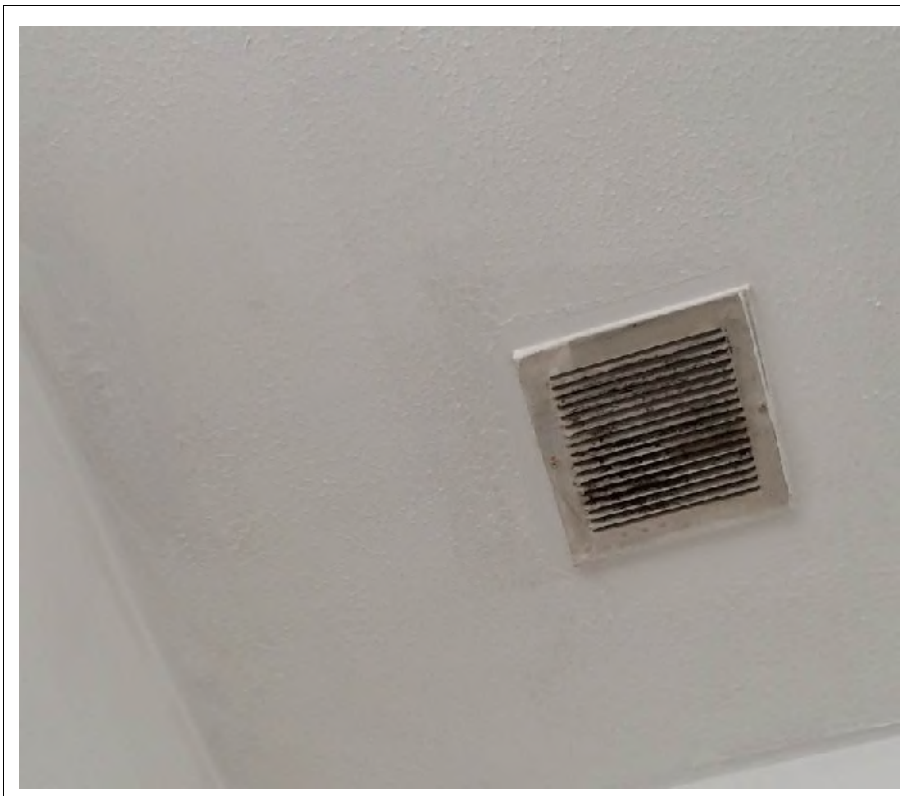
**PHOTOPLATE 130**

| Ground Floor Toilet |

| Sample Reference (Bulk ID) |
| - |
| Mark and manage |

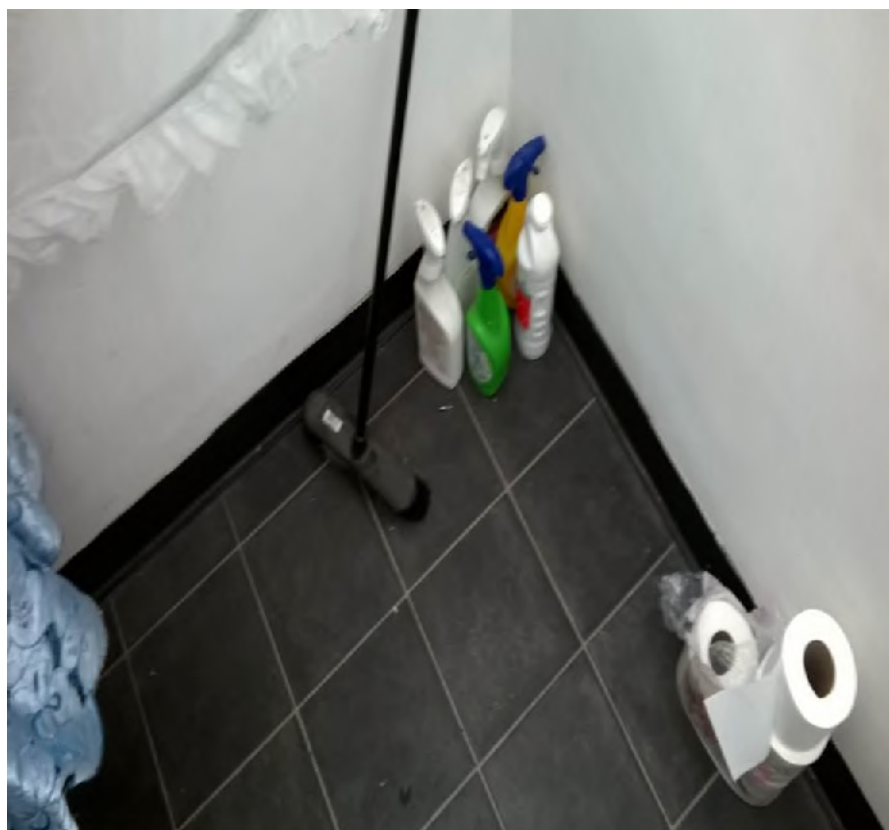
**PHOTOPLATE 131**

**Ground Floor Toilet**

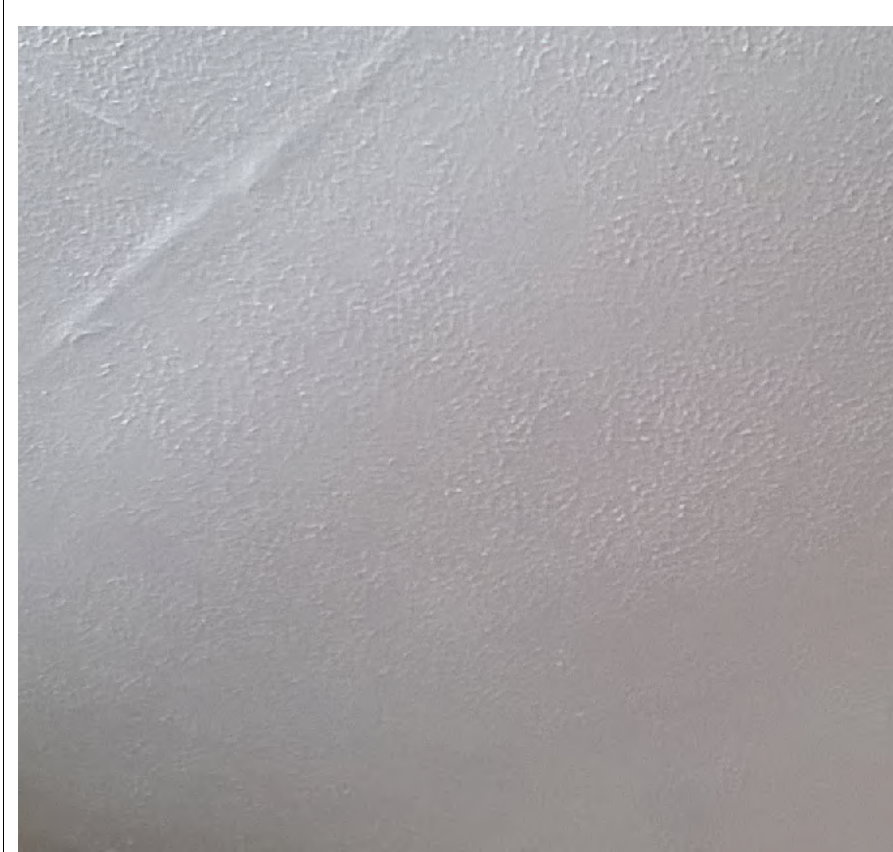
**PHOTOPLATE 133**

| Ground Floor Hall |

| Sample Reference (Bulk ID) |
| - |
| Mark and manage |

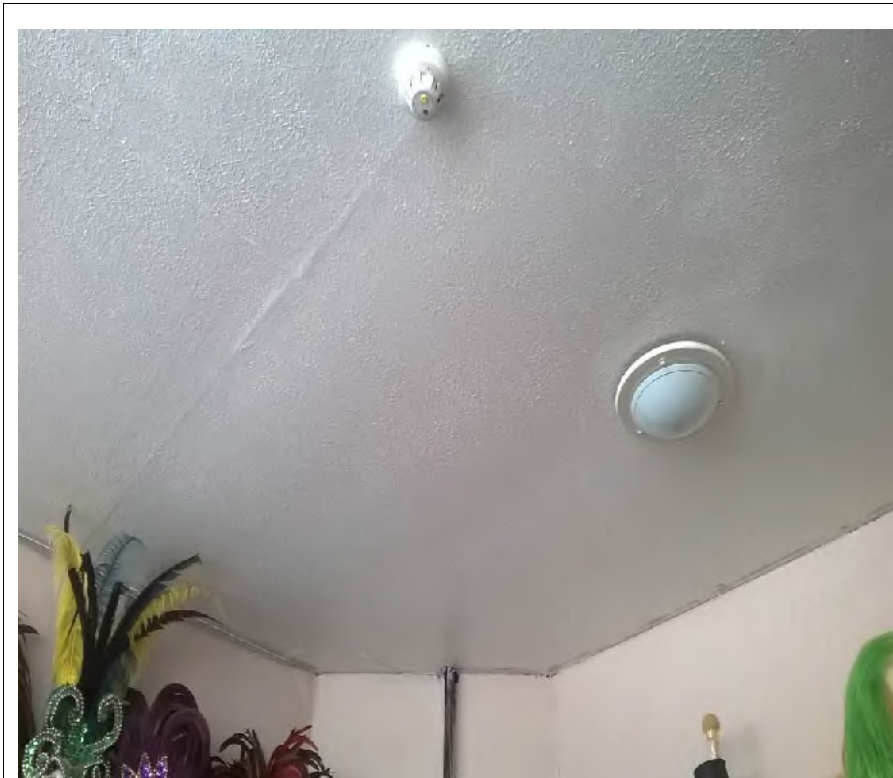
**PHOTOPLATE 134**

| Ground Floor Dressing Room |

| Sample Reference (Bulk ID) |
| - |
| Mark and manage |

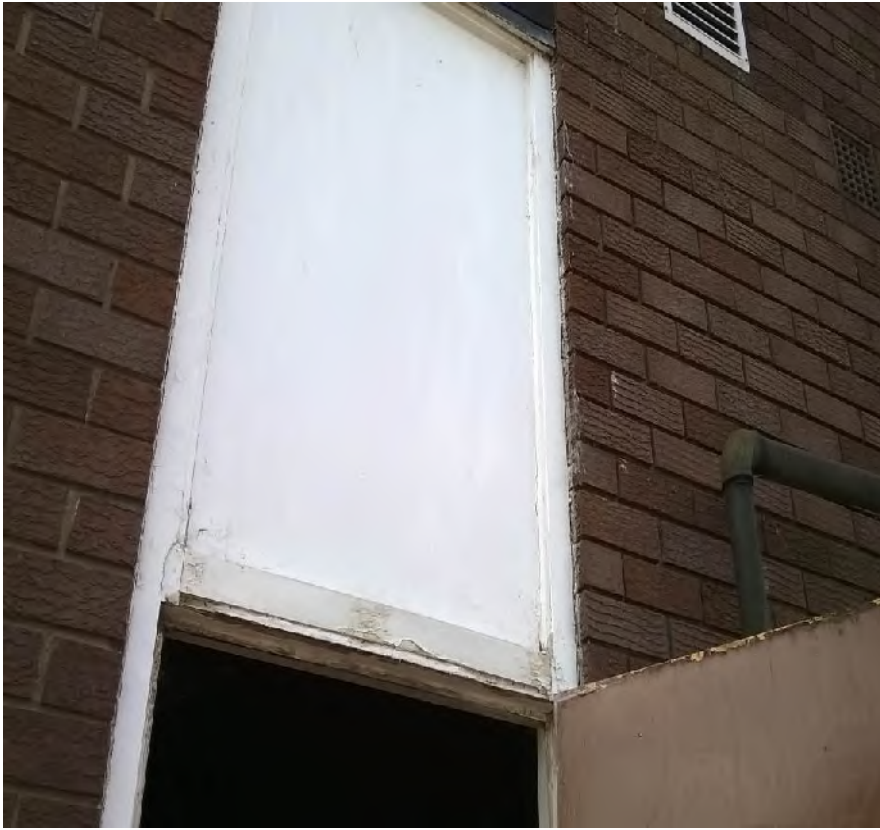
PHOTOPLATE 135

External Stage

Mark and manage

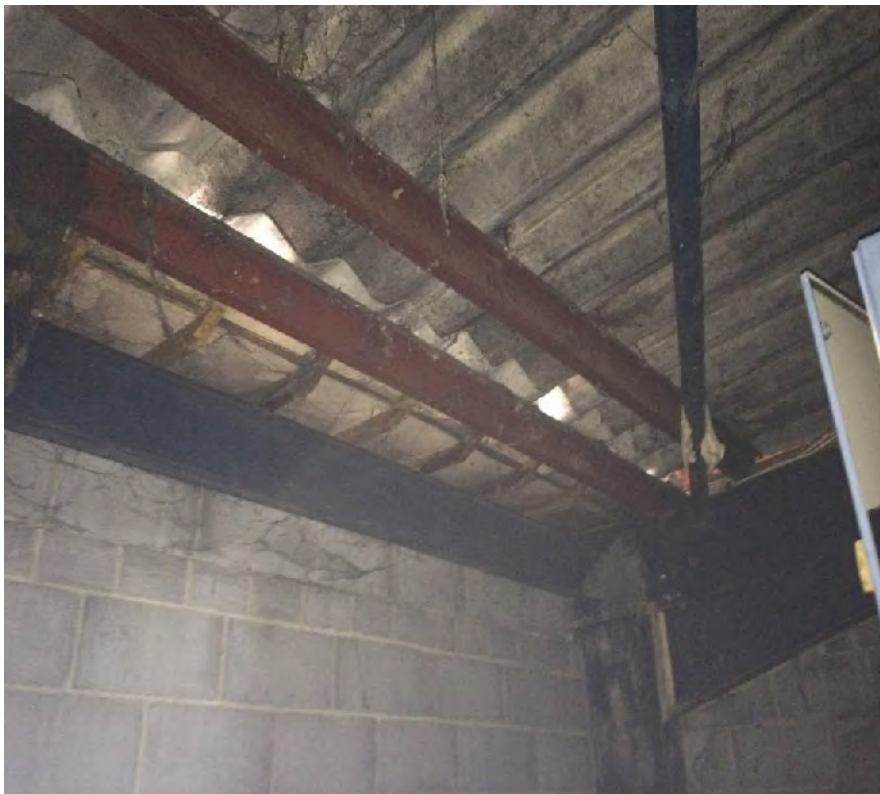
PHOTOPLATE 136

Ground Floor High Level Stores Above DJ  
Area

Mark and manage

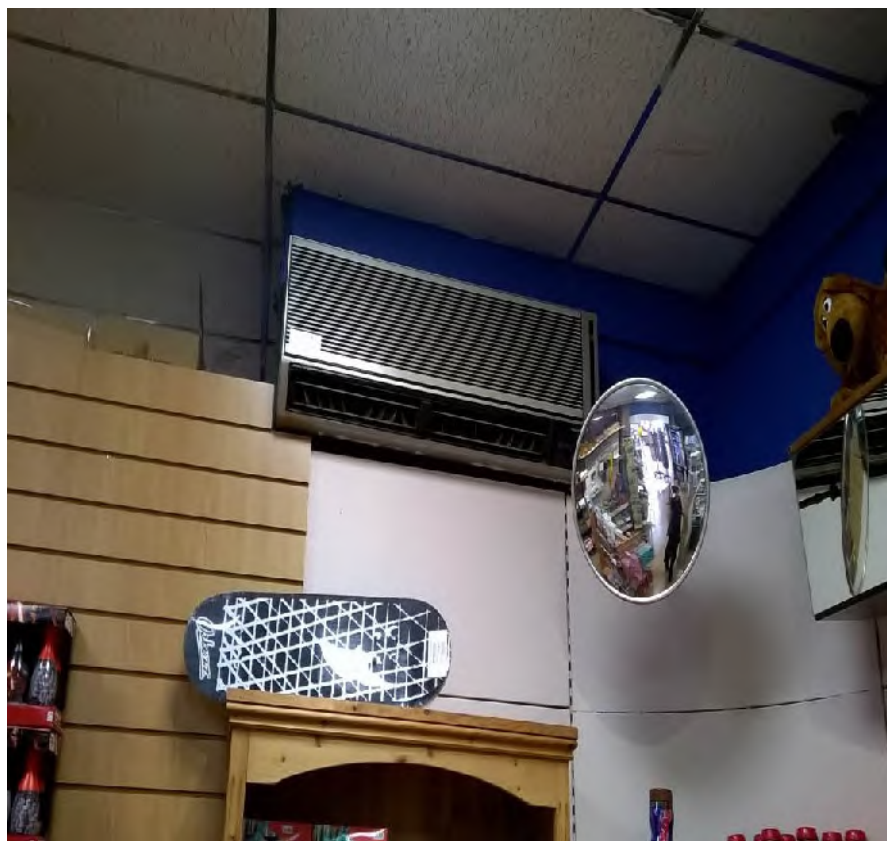
PHOTOPLATE 137

Ground Floor Gift Shop

Mark and manage

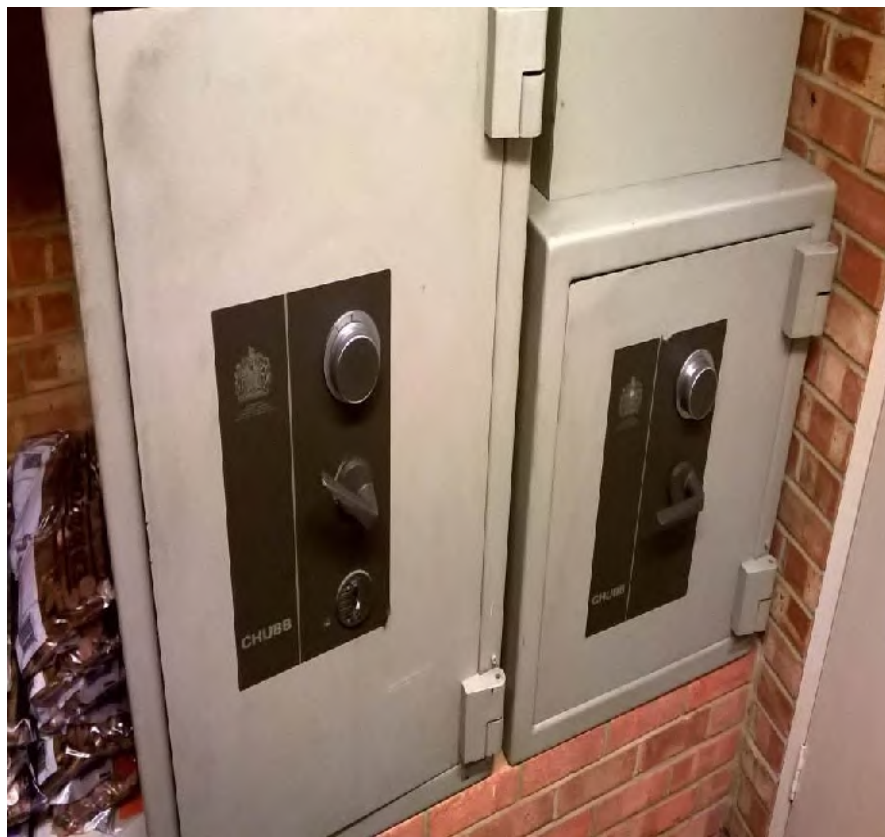
**PHOTOPLATE 139**

Ground Floor Office

Mark and manage

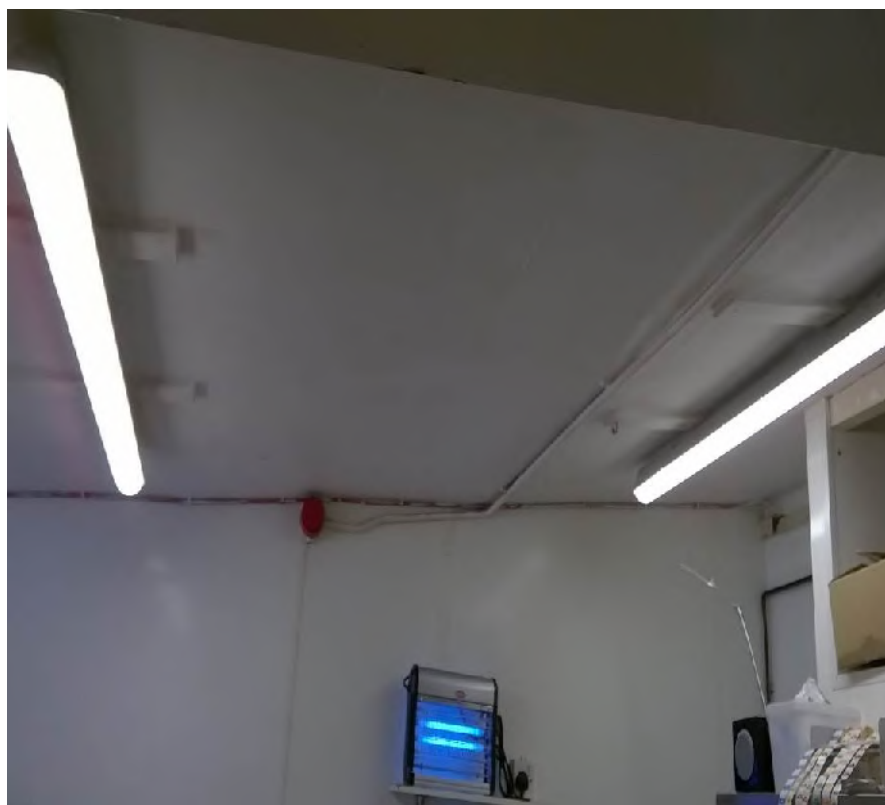
**PHOTOPLATE 140**

Ground Floor Rainbow Café

Mark and manage

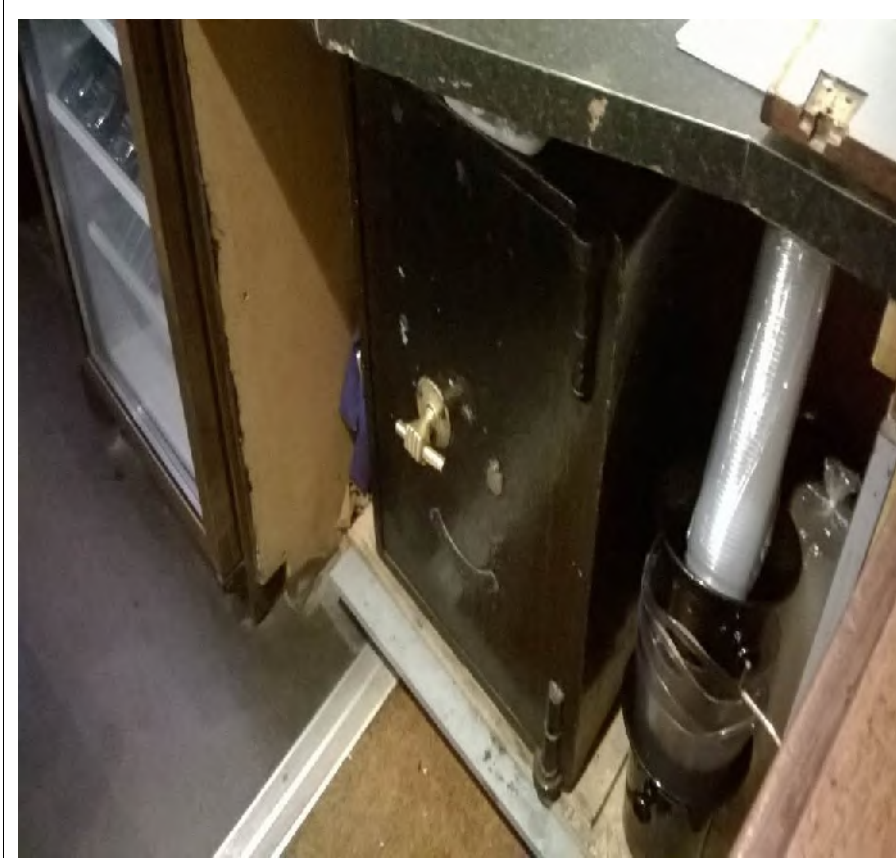
**PHOTOPLATE 141**

Ground Floor Bar

Mark and manage

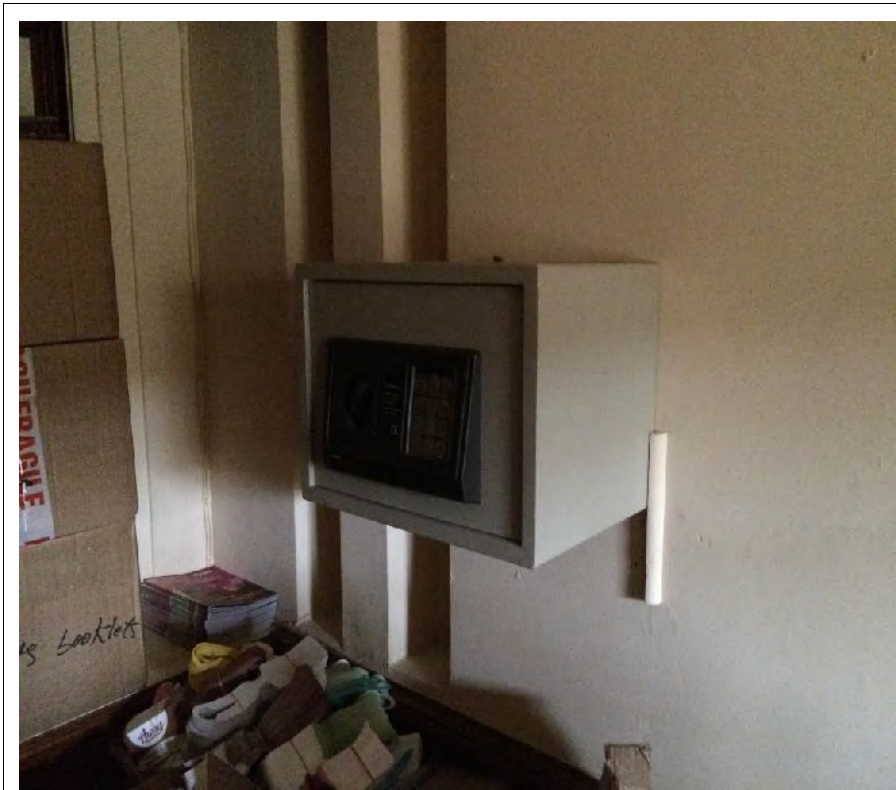
**PHOTOPLATE 142**

Ground Floor Store

Mark and manage

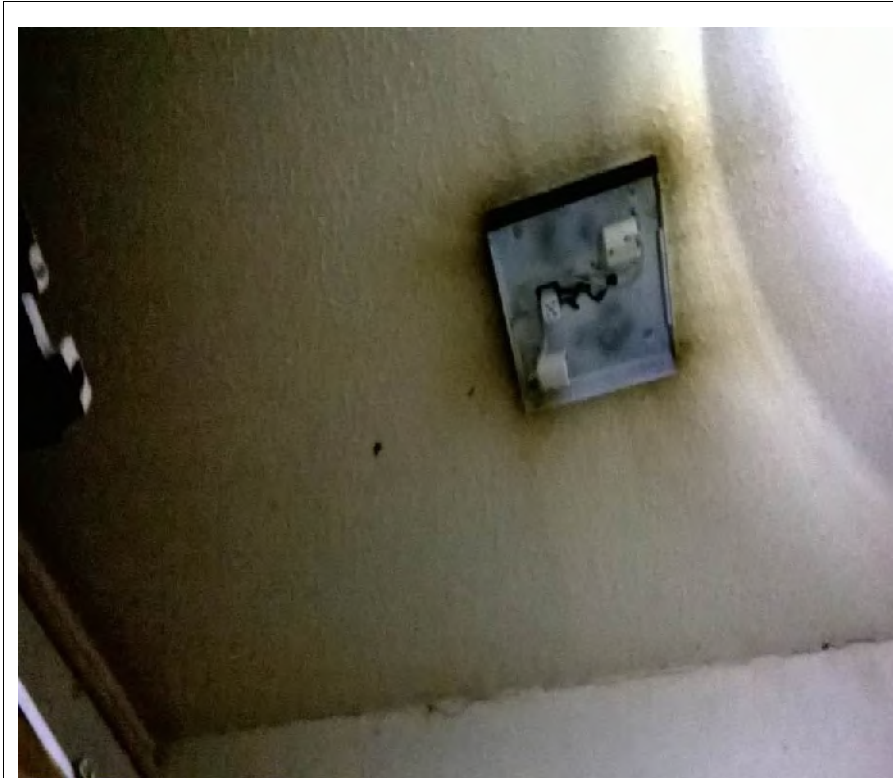
PHOTOPLATE 144

| Ground Floor Circulation |

| Sample Reference (Bulk ID) |
| - |
| Mark and manage |
