# Camera Survey Report

## **PFIZER**

New Lane Havant

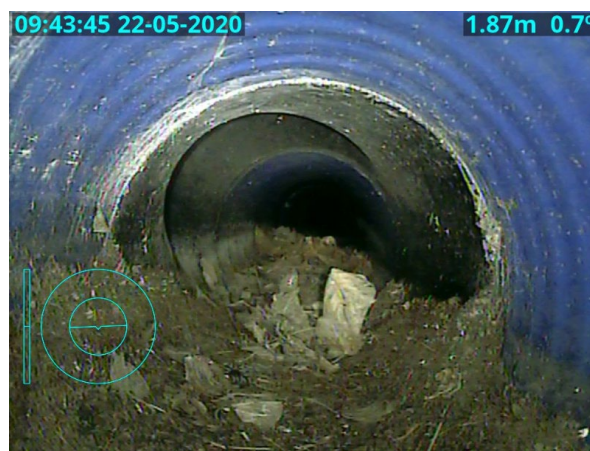
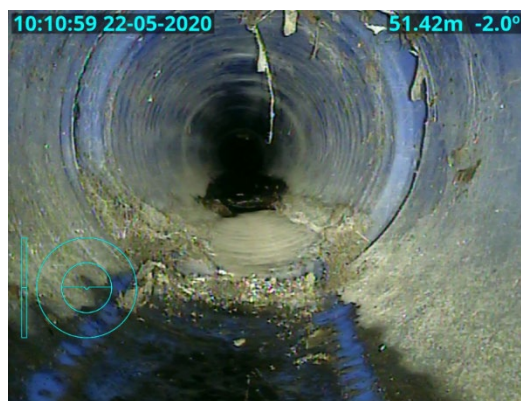
### Surface water lids 1 – 3 (Survey0000038/90137008)

These lids are not shown on the plans passed to SCC, from the camera survey undertaken this main run is a 300mm twin walled non perforated duct – commonly used by industry in the formation of Surface water systems. In the still photographs it clearly shows from the entrance to lid 1 towards lid 2 (approximately 12m) a build up of rubble and debris – this if not cleared may further build up or assist in an infestation of vermin. The joint at 54m towards lid 2 is not butted correctly and as a consequence stops the wheels of the surveyour, whilst not impacting on the flow within the network has allowed roots to enter – this will not improve if left unchecked.

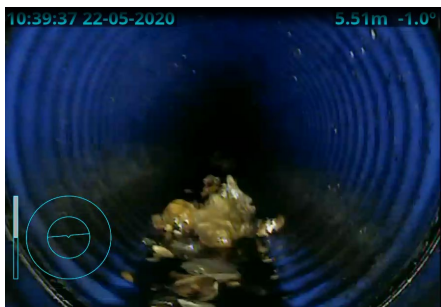
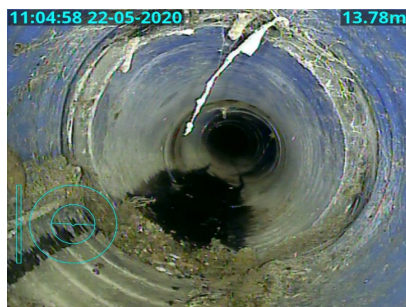
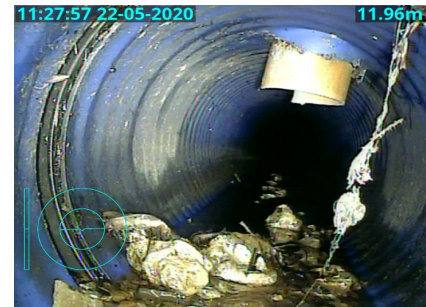
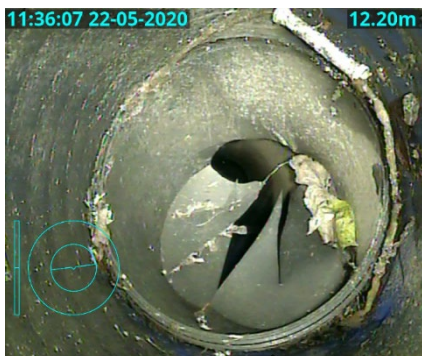
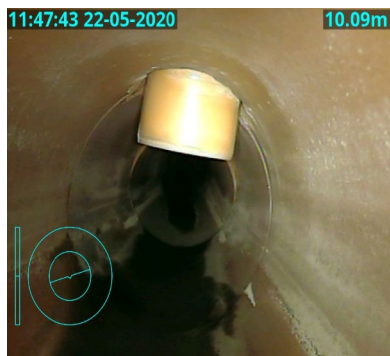
### Surface water lids 1 – 3 (Survey0000039/90140012)

Photographs taken within the video, these show debris contained within the network. The debris is falling from the roof into the dropouts at roof level, this is not causing flow issues at present but will not improve if left unchecked.

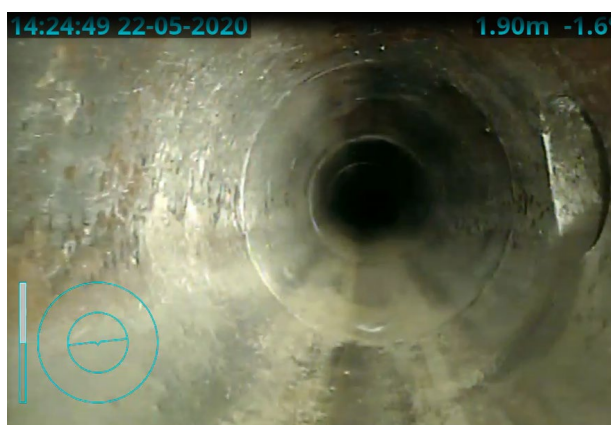
Surface Water Lids 36 – 47 Survey0000043/90153865

Pipework CLEAR

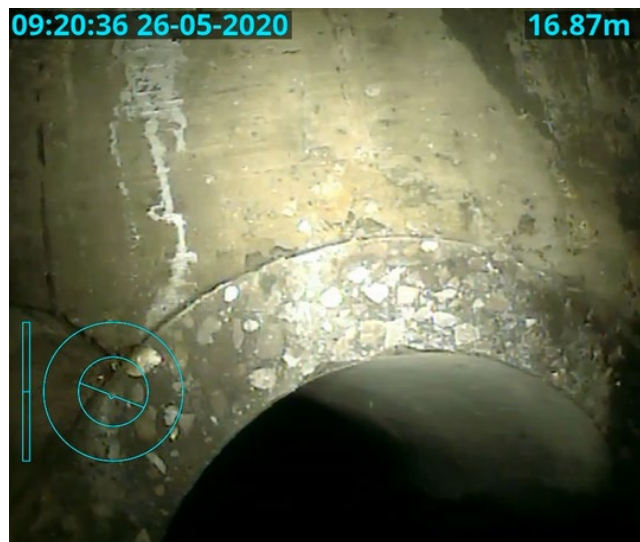
Pipework CLEAR

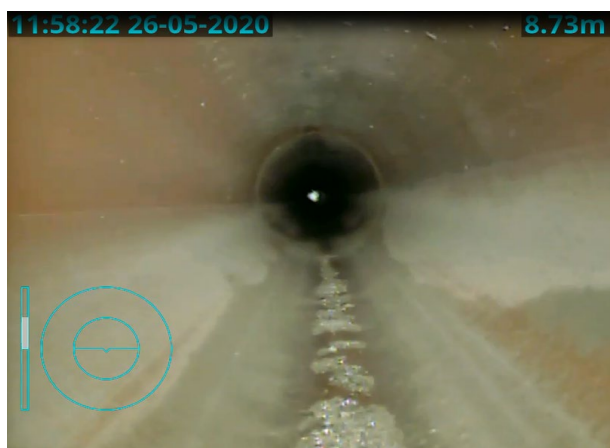
Surface Water Lids 394018 –368020 Survey0000056/90490631

Pipework shows SLIGHT SILTING

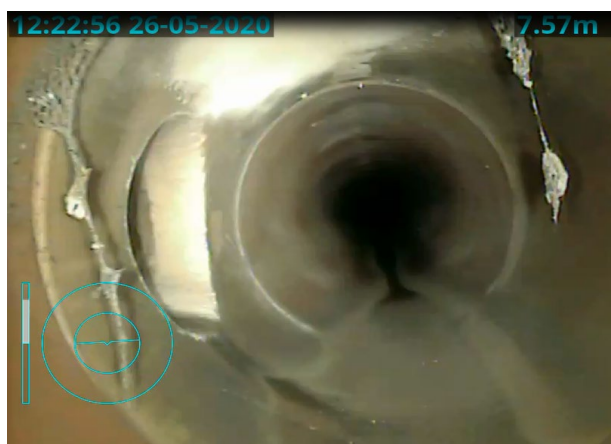
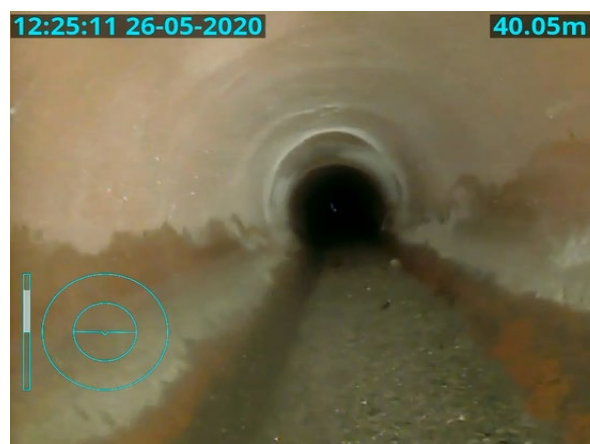
Surface Water Lids 368020 –370115 Survey0000058/90492149

| Lid ID (start) | Lid ID (finish) | Video | Issues Identified location | Material | Length (m) | Size (mm) | Map (sheet) |
|---|---|---|---|---|---|---|---|
| 368020 | 370115 | Survey0000058/90492149 | Light silt | CLAY | 85 | 6" | 7 |

Pipework shows LIGHT SILTING

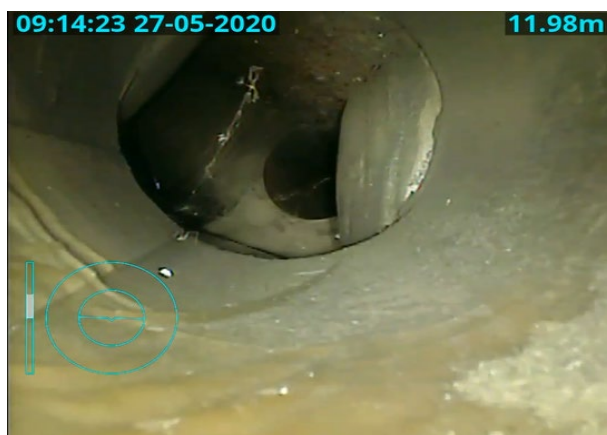
Surface Water Lids 397177 – 397177B Survey0000064/90567166

Pipework CLEAR
